Contract # : 04-0120E4
Cty SF Rte 80 PM 13.4. 13.8
File # 31 .25 B**QUALITY ASSURANCE - NONCONFORMANCE REPORT**

Location: Eaton Metal Products, Salt Lake City, Utah

Welding	<input checked="" type="checkbox"/>	Concrete	<input type="checkbox"/>	Other	<input type="checkbox"/>	
Welding:	<input type="checkbox"/>	Curing:	<input type="checkbox"/>	Procedural:	<input type="checkbox"/>	Bridge No.: 34-0006 L/R
Joint fit-up:	<input type="checkbox"/>	Coating:	<input type="checkbox"/>	Other:	<input type="checkbox"/>	Component: Pile Sleeve #T1-3.
Procedural:	<input checked="" type="checkbox"/>	Procedural:	<input type="checkbox"/>

Contract No. 04-0120E4
04-SF-80-13.4, 13.8
SAS T1 & E2 Foundations
SFOBB-ESSSP

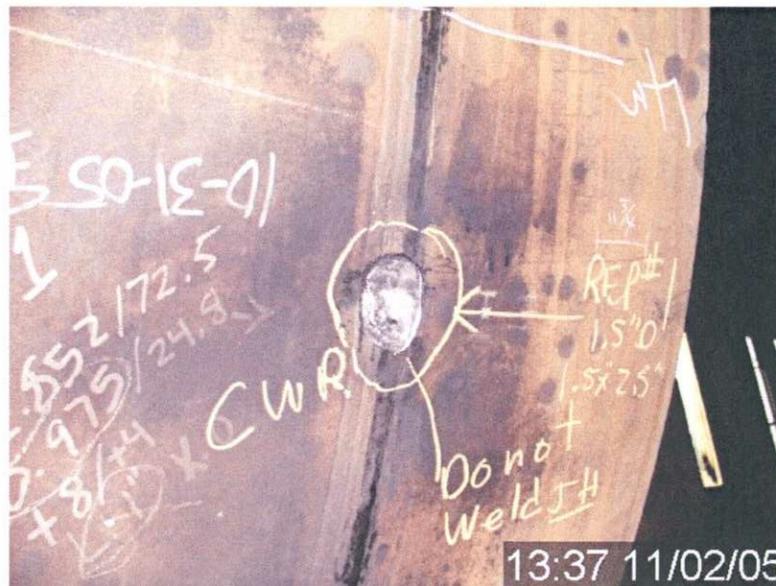
Description of Non-Conformance: Performing critical weld repair (CWR) excavation without approval of the Engineer. The critical weld repair location is on the outside diameter of girth seam weld (GS-4) of T1-3 Pile Sleeve, joining 90mm thick Mk#3 plate 15P to 50mm thick Mk#6 plate 72P. The depth of excavation is 43mm equal to approximately 85% of the 50mm weld thickness. See photo.

Contractor's proposal to correct the problem: Critical weld repair (CWR) excavation will not be welded prior submittal of CWR and engineers approval.

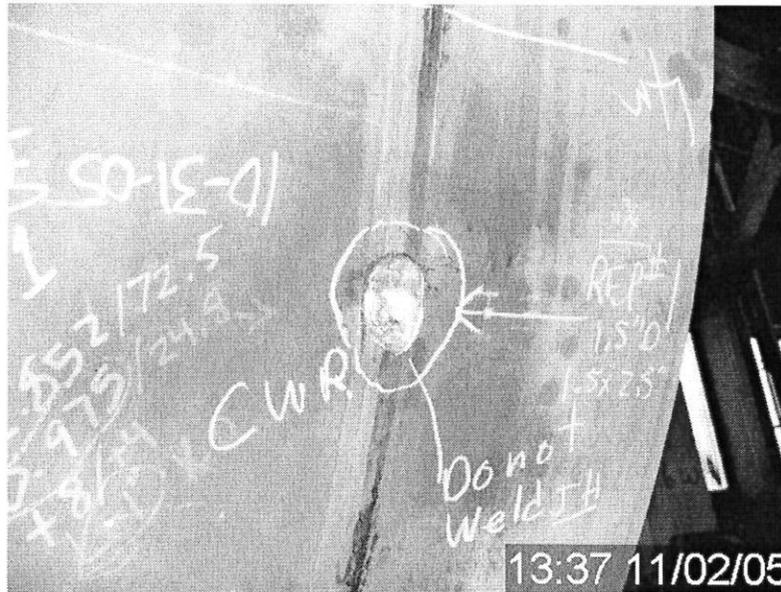
Description of Non-Conformance: Performing critical weld repair (CWR) excavation without approval of the Engineer. The critical weld repair location is on the outside diameter of girth seam weld (GS-4) of T1-3 Pile Sleeve, joining 90mm thick Mk#3 plate 15P to 50mm thick Mk#6 plate 72P. The depth of excavation is 43mm equal to approximately 85% of the 50mm weld thickness. See photo.

Contractor's proposal to correct the problem: Critical weld repair (CWR) excavation will not be welded prior submittal of CWR and engineers approval.
