Contract # : 04-0120E4
Cty SF Rte 80 PM 13.4. 13.8
File # 31 .25 B**QUALITY ASSURANCE - NONCONFORMANCE REPORT**

Contract # : 04-0120E4
 Cty SF Rte 80 PM 13.4. 13.8
 File # 31 .25 B

Contract No. 04-0120E4
04-SF-80-13.4, 13.8
SAS T1 & E2 Foundations
SFOBB-ESSSP

KFM SUBMITTAL 371-00 – EATON METAL PRODUCTS (EMP) RESPONSE TO CALTRANS NONCONFORMANCE REPORT (NCR) NO. 019

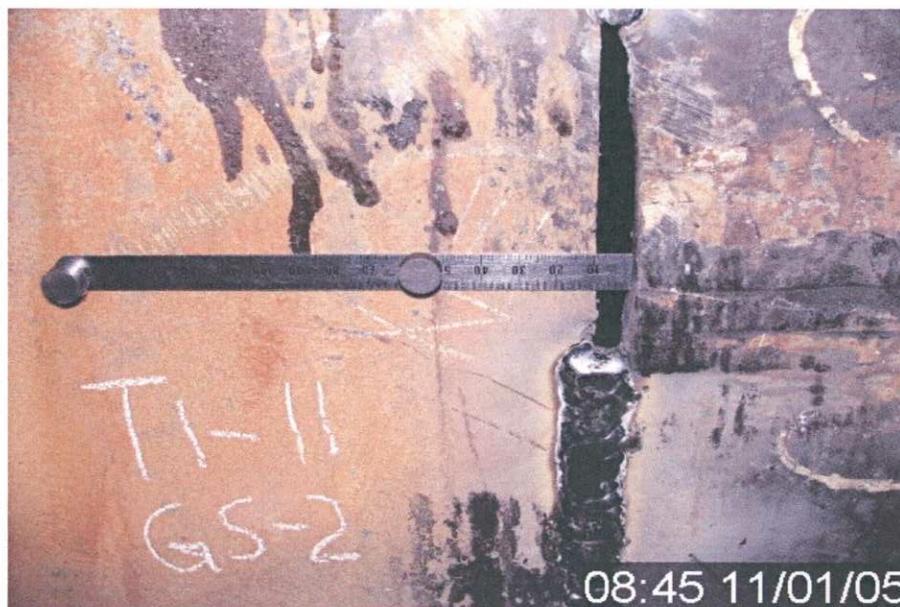
Description of Non-Conformance: Complete joint penetration Girth Seam (GS) fit-up is not in compliance with contract requirements. EMP WPS B-U2c-S-Z allows for maximum root opening of 3mm (1/8"). QA observed GS-2 in T1-11 pile sleeve that is fit-up and tacked in preparation for submerged arc welding (SAW) with a maximum root opening of 9mm (see photo below). QA observed in the T-1 pile sleeve that is in process of fit-up on this date, a maximum root opening of 7mm in GS-2 (joining 75mm pile sleeve sections Mk-4 plate 16P to Mk-5 plate 8P). Eaton Metal Products representative Mr. Jason Hart was informed that QA has observed root openings that exceed 1/8" and do not appear to be in compliance with contract documents. Mr. Hart stated that root openings vary as necessary to maintain overall pile sleeve length. Mr. Hart stated that prior to the welding of a SAW inside diameter (ID) root pass, a full-length FCAW tack weld is installed in the ID groove, and EMP considers that the flux cord arc welding (FCAW) pass closes the root opening.

As stated in EMP's letter dated February 27, 2006, the excessive root gap for GS No. 2 on pile sleeve T1-11 has been corrected and the material has been brought back into conformance with the approved WPS B-U2c-S-Z; thus OSM recommends NCR 019 be considered resolved.

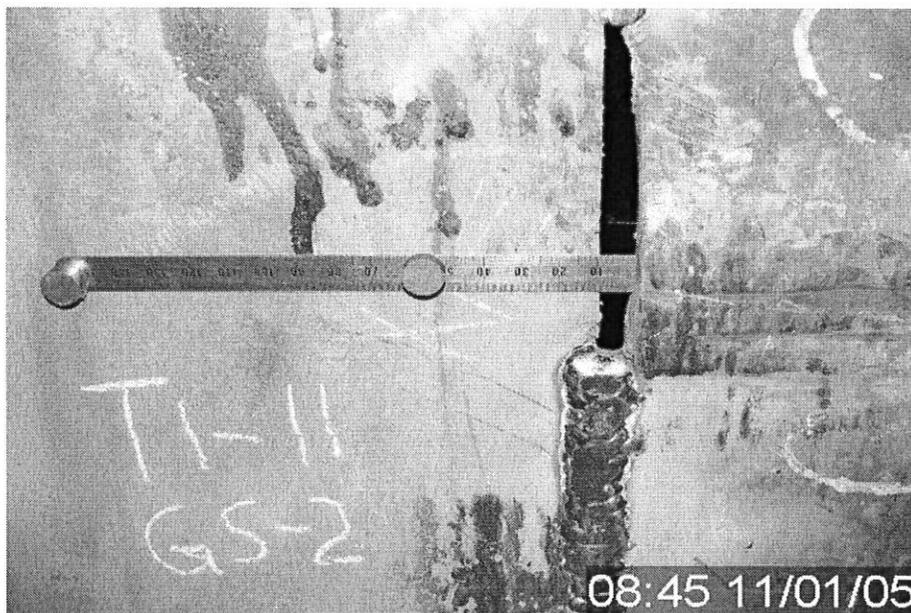
Description of Non-Conformance: Complete joint penetration Girth Seam (GS) fit-up is not in compliance with contract requirements. EMP WPS B-U2c-S-Z allows for maximum root opening of 3mm (1/8"). QA observed GS-2 in T1-11 pile sleeve that is fit-up and tacked in preparation for submerged arc welding (SAW) with a maximum root opening of 9mm (see photo below). QA observed in the T-1 pile sleeve that is in process of fit-up on this date, a maximum root opening of 7mm in GS-2 (joining 75mm pile sleeve sections Mk-4 plate 16P to Mk-5 plate 8P). Eaton Metal Products representative Mr. Jason Hart was informed that QA has observed root openings that exceed 1/8" and do not appear to be in compliance with contract documents. Mr. Hart stated that root openings vary as necessary to maintain overall pile sleeve length. Mr. Hart stated that prior to the welding of a SAW inside diameter (ID) root pass, a full-length FCAW tack weld is installed in the ID groove, and EMP considers that the flux cord arc welding (FCAW) pass closes the root opening.
