Contract # : 04-0120E4  
Cty SF Rte 80 PM 13.4/13.8  
File # 1 .25 B

**QUALITY ASSURANCE - NONCONFORMANCE REPORT**

**Location:** SFOBB E2/T1 Foundations

**NCR #**130

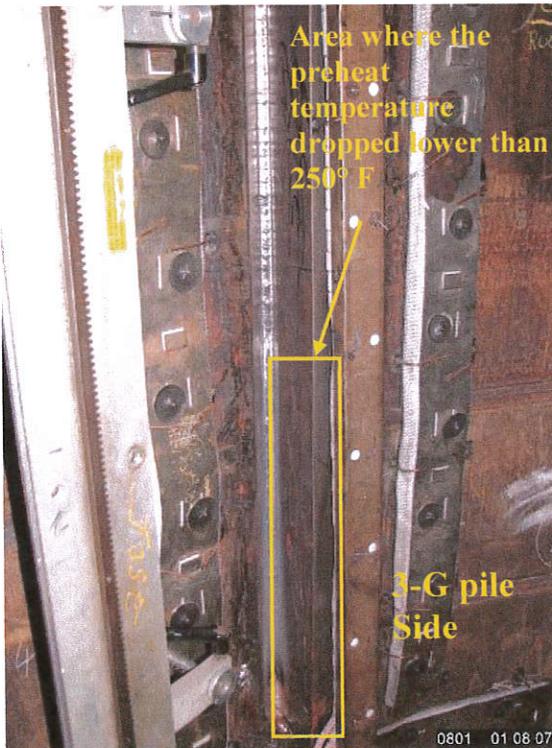
The Contractor failed to maintain the preheat temperature during the welding of several E2 pile head connection plates as required by the Special Provisions, Section 10-1.31, Field Welding of Pile/Sleeve Connector Plates, Line F. The loss in preheat temperature occurred at the following locations: Pile head connection plate 2-G weld 1 and 2 (all around), 3-G weld 3 and 4 (from 0 to approximately 700 mm from the bottom) and 3-H (top area only). The digital photographs below depict the areas where the temperature indicator shows a temperature less than 250°F.

The photograph # 1 below depicts the area where the temperature indicator crayon did not melt on the pile # 3-G.

1. Elevation of the issue to the supplier of the heating equipment in order to re-inspect the equipment and the Contractor's set-up.
2. Periodic monitoring of the preheat consoles and monitors by the night shift tug operators. The tug operators have been instructed to notify the Contractor in order to have someone repair the malfunction, should they witness any drop in temperature on the welds.
3. Increased checks by both the welder and the Quality Control inspector to ensure the heating equipment is working properly during welding operations. As stated in subsequent letters, the welders will be checking for burnt connectors and loose wires so that they can be replaced and/or corrected.

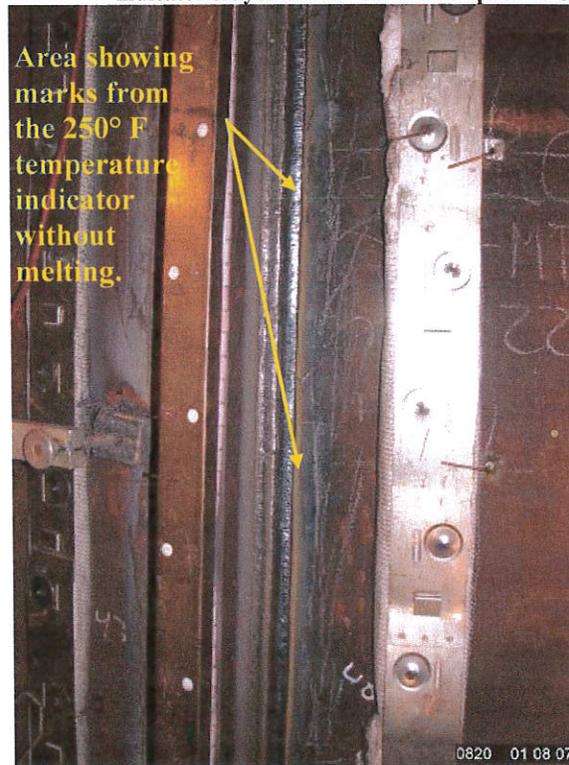
The photograph # 2 below depicts the area where the temperature indicator crayon did not melt on the pile # 2-G.
