Contract # : 04-0120E4
 Cty SF Rte 80 PM 13.4/13.8
 File # 1.25 B

QUALITY ASSURANCE - NONCONFORMANCE REPORT

Location: E2W Pile Head Connection Plates (PHCP) 4D-2**Date:** 05-30-07**Prime Contractor:** Kiewit/FCI/Manson-KFM-JV**NCR #170****Submitting Contractor:** Kiewit/FCI/Manson-KFM-JV**Type of problem:****Welding** **Concrete** **Other** **Welding:** **Curing:** **Procedural:** **Bridge No.** 34-0006 L / R**Joint fit-up:** **Coating:** **Other:** **Component:** E2W foundation footing**Procedural:** **Procedural:**

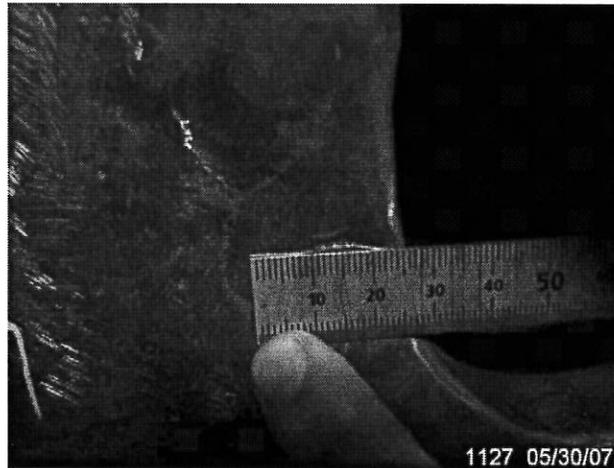
Description of Non-Conformance: The ISI Quality Control Inspector Andrew Coffman overlooked a transverse linear indication on the weld cover on 4D-2 bottom. The Quality Assurance Inspector discovered the indication while performing magnetic particle testing review, the indication was measured to be 9mm in length. The following digital photograph is an illustration of the indication discussed above.

**Applicable reference:** AWS D1.5 2002 Section 6.26.2.1 and 6.26.2.3**Who discovered the problem:** Quality Assurance Inspector, Raymond Lara**Name of individual from Contractor notified:** KFM, QC Inspector Terry Hipes and QCM Kevin Carpenter**Time and method of notification:** 05/30/07 at approximately 1130 via verbal notification.**Name of Caltrans Engineer notified:** Mark Vilcheck, Structure Representative**Time and method of notification:** 06/06/07 at approximately 1230 hours via verbal notification**QC Inspector's Name:** QC Andrew Coffman**Was the QC Inspector aware of problem:** No**Contractor's proposal to correct the problem:** Removed indications by grinding.

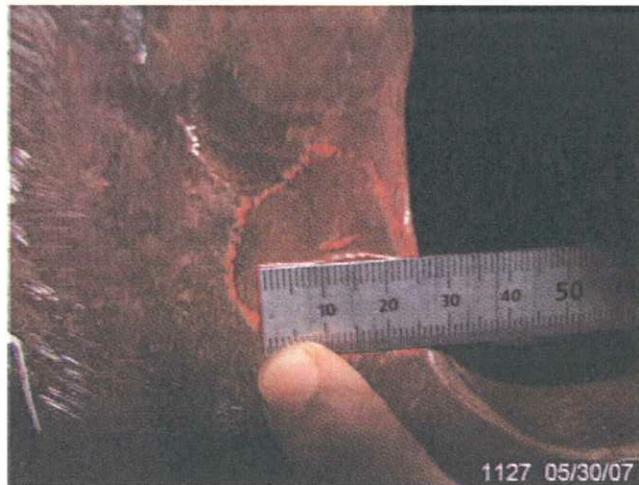
Description of Non-Conformance: The ISI Quality Control Inspector Andrew Coffman overlooked a transverse linear indication on the weld cover on 4D-2 bottom. The Quality Assurance Inspector discovered the indication while performing magnetic particle testing review, the indication was measured to be 9mm in length. The following digital photograph is an illustration of the indication discussed above.

Applicable reference: AWS D1.5 2002 Section 6.26.2.1 and 6.26.2.3**Who discovered the problem:** Quality Assurance Inspector, Raymond Lara**Name of individual from Contractor notified:** KFM, QC Inspector Terry Hipes and QCM Kevin Carpenter**Time and method of notification:** 05/30/07 at approximately 1130 via verbal notification.**Name of Caltrans Engineer notified:** Mark Vilcheck, Structure Representative**Time and method of notification:** 06/06/07 at approximately 1230 hours via verbal notification**QC Inspector's Name:** QC Andrew Coffman**Was the QC Inspector aware of problem:** No**Contractor's proposal to correct the problem:** Removed indications by grinding.
