Contract # : 04-0120E4
 Cty SF Rte 80 PM 13.4/13.8
 File # 1.25 B

QUALITY ASSURANCE - NONCONFORMANCE REPORT**Location:** T1 Pile Head Connection Plates (PHCP) 2E-1**Date:** 08-11-2007**Prime Contractor:** Kiewit/FCI/Manson-KFM-JV**NCR #190****Submitting Contractor:** Kiewit/FCI/Manson-KFM-JV**Type of problem:****Welding** **Concrete** **Other** **Welding:** **Curing:** **Procedural:** **Bridge No.** 34-0006 L / R**Joint fit-up:** **Coating:** **Other:** **Component:** T1 foundation footing**Procedural:** **Procedural:**

KFM LETTER 325 – RESPONSE TO METS NCR’S 183, 184, 187, AND 190

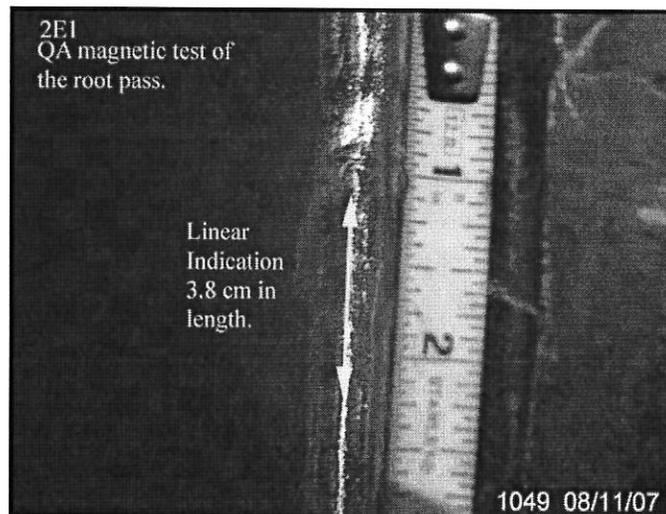
Description of Non-Conformance: KFM Quality Control Inspector, Gary Ehram, has overlooked multiple relevant Magnetic Particle (MT) indications while working on the E2/T1 project. Most recently this inspector overlooked a centerline linear indication in the root pass (3.8cm in length) of Pile Head Connection Weld 2E1. The indication was shown to the Quality Control Inspector and Mr. Ehram agreed the relevant indication was overlooked. The following digital photograph is an illustration of the indication discussed above.

**Applicable reference:** AWS D1.5 2002 Section 6.26.2.1 and 6.26.2.3**Who discovered the problem:** Quality Assurance Inspector Raymond Lara**Name of individual from Contractor notified:** ISI, QC Inspector Gary Ehram and QC Andrew Coffman**Time and method of notification:** 08/11/07 at approximately 1130 via verbal notification.**Name of Caltrans Engineer notified:** Caltrans Assistant Structures Representative, Thanh Le**Time and method of notification:** Verbal notification on 8-11-07**QC Inspector's Name:** ISI QC Inspector, Gary Ehram

Was the QC Inspector aware of problem: No

Contractor's proposal to correct the problem: Removed indications by grinding before welding commenced.

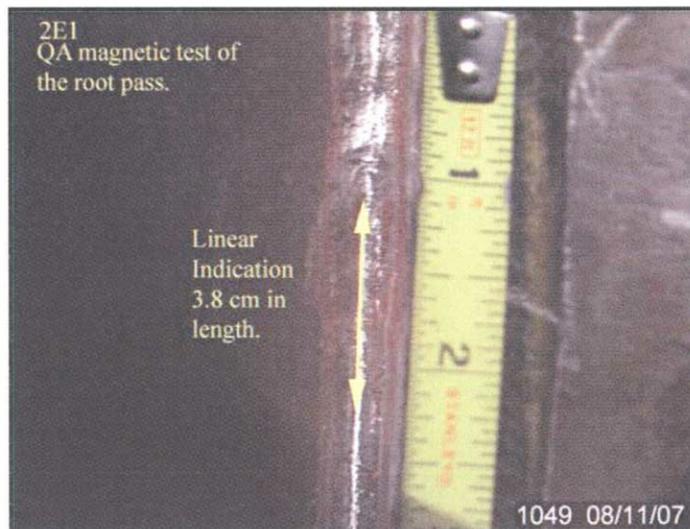
Description of Non-Conformance: KFM Quality Control Inspector, Gary Ehram, has overlooked multiple relevant Magnetic Particle (MT) indications while working on the E2/T1 project. Most recently this inspector overlooked a centerline linear indication in the root pass (3.8cm in length) of Pile Head Connection Weld 2E1. The indication was shown to the Quality Control Inspector and Mr. Ehram agreed the relevant indication was overlooked. The following digital photograph is an illustration of the indication discussed above.

Applicable reference: AWS D1.5 2002 Section 6.26.2.1 and 6.26.2.3**Who discovered the problem:** Quality Assurance Inspector Raymond Lara**Name of individual from Contractor notified:** ISI, QC Inspector Gary Ehram and QC Andrew Coffman**Time and method of notification:** 08/11/07 at approximately 1130 via verbal notification.**Name of Caltrans Engineer notified:** Caltrans Assistant Structures Representative, Thanh Le**Time and method of notification:** Verbal notification on 8-11-07**QC Inspector's Name:** ISI QC Inspector, Gary Ehram

Was the QC Inspector aware of problem: No

Contractor's proposal to correct the problem: Removed indications by grinding before welding commenced.
