Contract # : 04-0120E4
Cty SF Rte 80 PM 13.4, 13.8
File # 45.25 B**QUALITY ASSURANCE - NONCONFORMANCE REPORT****Location:** Kiewit Offshore Services**Date:** 05-13-2006 & 05-15-2006**Prime Contractor:** Kiewit/FCI/Manson (KFM) Joint Venture**NCR # 87****Submitting Contractor:** Kiewit Offshore Services**Type of problem:** Welding of twelve (12) stiffener plate Weld Access Junction with Diaphragm Plate to Bottom Plate Partial Joint Penetration Groove Weld**Welding** **Concrete** **Other** **Welding:** **Curing:** **Procedural:** **Bridge No.** 34-0006L/R**Joint fit-up:** **Coating:** **Other:** **Component:** P260-34, 36, 38, 1, 3, 5, 44, 42, 40 and P258-30, 26 & 28.**Procedural:** **Procedural:** **Description of Non-Conformance:** KOS Quality Control has allowed KOS welders to deviate from the approved shop drawings and weld-out the weld access area (cope hole) in the location where the Stiffener plate P258-30 joints the bottom and the diaphragm plates.

QUALITY ASSURANCE - NONCONFORMANCE REPORT

Type of problem: Welding of fifteen (15) stiffener plate Weld Access Junction with Diaphragm Plate to Bottom Plate Partial Joint Penetration Groove Weld

Contract No. 04-0120E4
04-SF-80-1

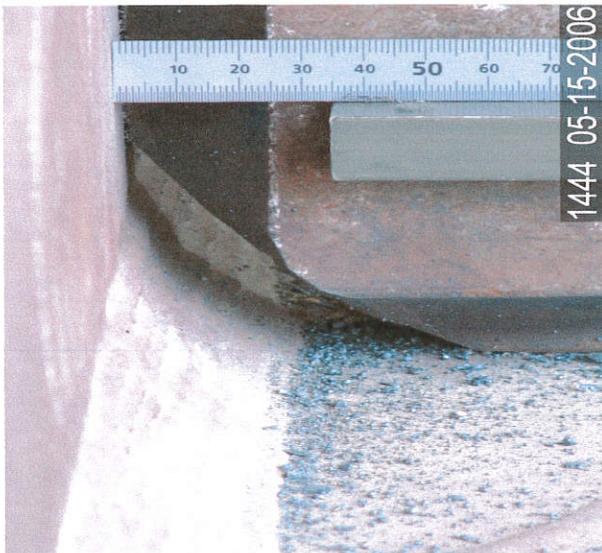
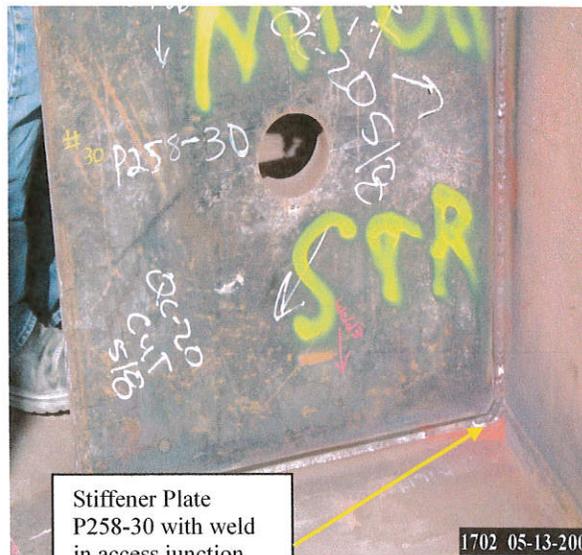
**Applicable reference:** Approved shop drawing sheet A44 Revision 3 Detail A-A for Stiffener Plate to Bottom Plate Assembly and sheet S258 Stiffener Plate Detail.**Who discovered the problem:** Caltrans Quality Assurance Inspector Mike Hasler**Name of individual from Contractor notified:** Quality Control Inspector Eric Beckford/ QCM George Barnhill**Time and method of notification:** 1715 hours, verbal notification, May 13, 2006**Name of Caltrans Engineer notified:** Mark Vilcheck, Structure Representative**Time and method of notification:** May 15, 2006, 15:40 via phone conversation

Contractor's proposal to correct the problem: Submit a "Request For Information" that requests that the welded areas in the weld access junctions be accepted as is.

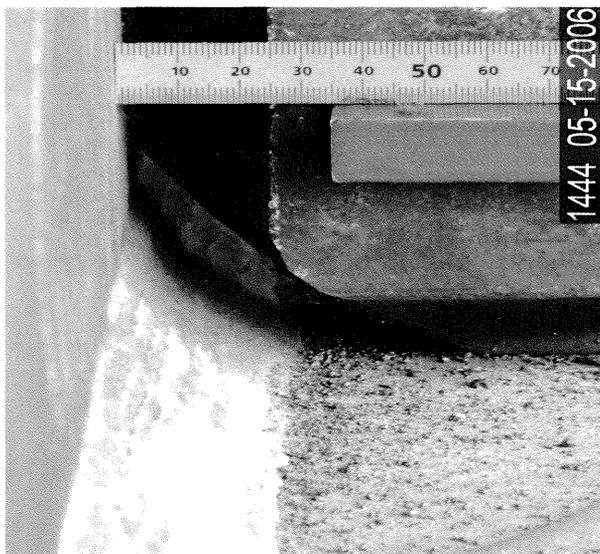
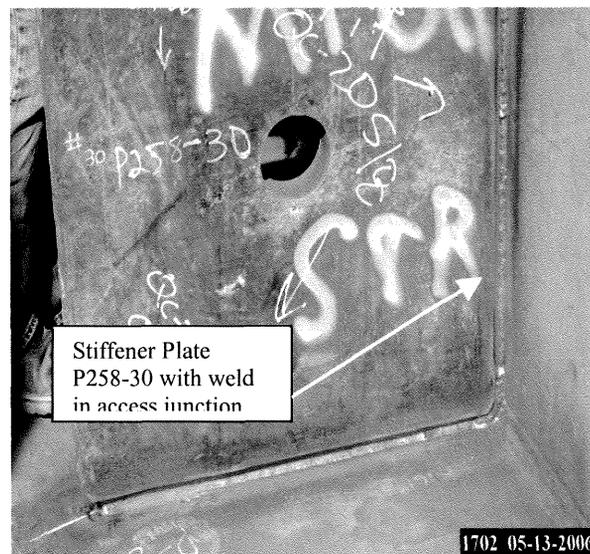
Description of Non-Conformance: KOS Quality Control has allowed KOS welders to deviate from the approved shop drawings and weld-out the weld access areas (“snipes”) in the locations where fifteen stiffener plates (P258-7, P258-9, P258-11, P258-26, P258-28, P258-30, P260-1, P260-3, P260-5, P260-34, P260-36, P260-38, P260-40, P260-42, and P260-44) join the bottom plate and diaphragm plates.

Applicable reference: Approved shop drawing sheet A44 Revision 3 Detail A-A for Stiffener Plate to Bottom Plate Assembly and sheet S258 Stiffener Plate Detail.

Contractor's proposal to correct the problem: Submit a "Request For Information" that requests that the welded areas in the weld access junctions be accepted as is.

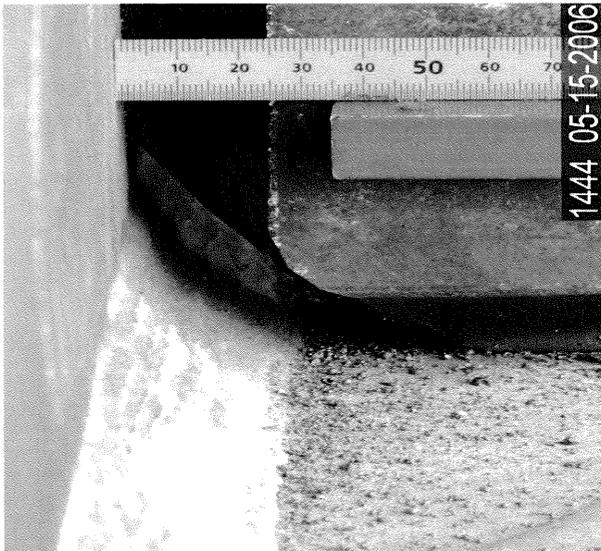
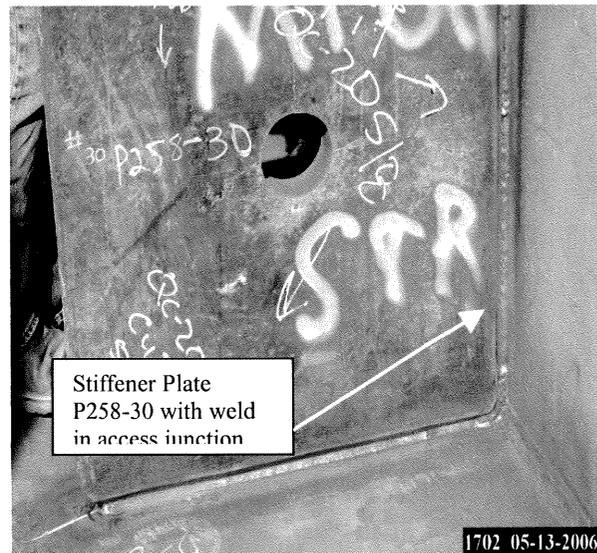
Type of problem: Welding of twelve (12) stiffener plate Weld Access Junction with Diaphragm Plate to Bottom Plate Partial Joint Penetration Groove Weld

Description of Non-Conformance: KOS Quality Control has allowed KOS welders to deviate from the approved shop drawings and weld-out the weld access area (cope hole) in the location where the Stiffener plate P258-30 joints the bottom and the diaphragm plates.

Applicable reference: Approved shop drawing sheet A44 Revision 3 Detail A-A for Stiffener Plate to Bottom Plate Assembly and sheet S258 Stiffener Plate Detail.

Contractor's proposal to correct the problem: Submit a "Request For Information" that requests that the welded areas in the weld access junctions be accepted as is.
