Contract # : **04-0120E4**
 Cty **SF** Rte **80** PM **13.4, 13.8**
 File # **45.25 B**

QUALITY ASSURANCE - NONCONFORMANCE REPORT

Location: Kiewit Offshore Services (KOS)**Date:** 05-19-06**Prime Contractor:** Kiewit/FCI/Manson (KFM) Joint Venture**NCR #** 90**Submitting Contractor:** Kiewit Offshore Services (KOS)**Type of problem:****Welding** **Concrete** **Other** **Welding:** **Curing:** **Procedural:** **Bridge No.** 34-0006L/R**Joint fit-up:** **Coating:** **Other:** **Component:** Diaphragm Plate identified as P68-1**Procedural:** **Procedural:**

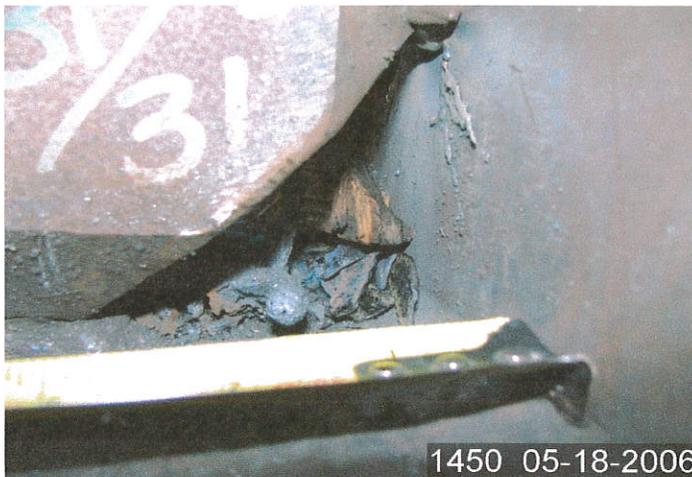
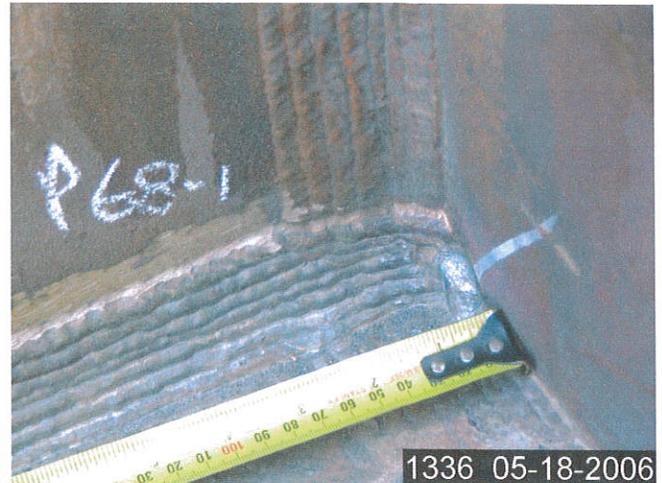
Description of Non-Conformance: KOS Quality Control (QC) has allowed KOS welders to deviate from the approved shop drawings and weld-out the weld access area ("snipe") in the location where the diaphragm plate (P68-1) joins the bottom plate and pile sleeve (Pa903).

**Applicable reference:** Approved shop drawing S68, revision 2 shows the corners coped back 75mm x 75mm.**Who discovered the problem:** Caltrans Quality Assurance Inspector David Flygare**Name of individual from Contractor notified:** KOS Quality Control Representative (QC) George Barnhill**Time and method of notification:** 1730 hour, telephoned George Barnhill, 05-19-06**Name of Caltrans Engineer notified:** Mark Vilcheck, Structure Representative**Time and method of notification:** May 22, 2006, 14:15 via phone conversation**QC Inspector's Name:** Eloy Gonzales**Was the QC Inspector aware of problem:** No

Contractor's proposal to correct the problem: Unknown at this time.

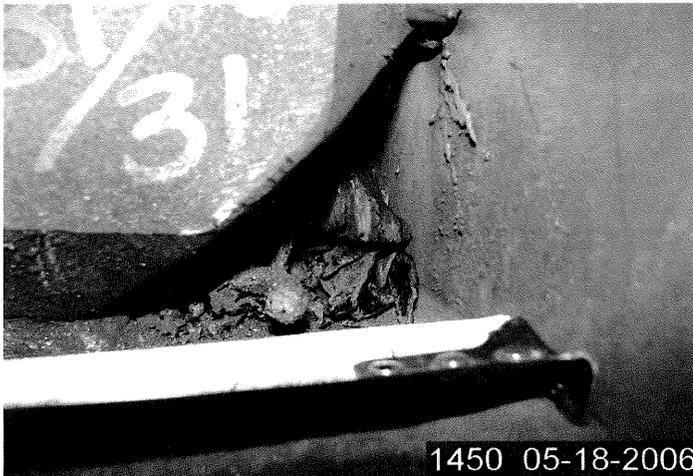
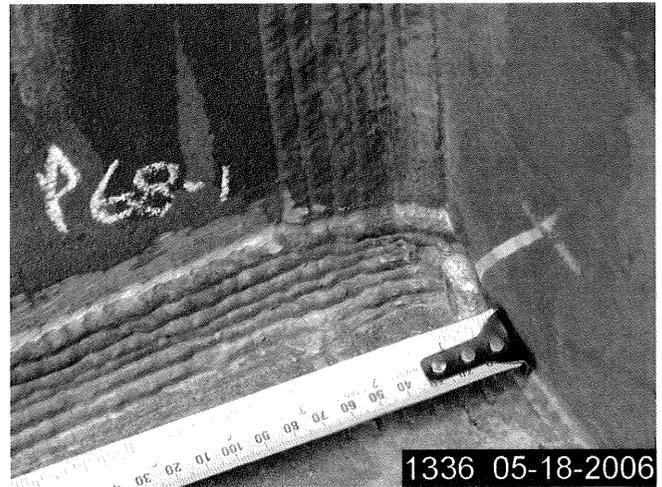
Description of Non-Conformance: KOS Quality Control (QC) has allowed KOS welders to deviate from the approved shop drawings and weld-out the weld access area ("snipe") in the location where the diaphragm plate (P68-1) joins the bottom plate and pile sleeve (Pa903).

Applicable reference: Approved shop drawing S68, revision 2 shows the corners coped back 75mm x 75mm.

Contractor's proposal to correct the problem: Unknown at this time.

The Contractor's response to the NCR 090 states that the weld access area is no longer welded shut at the connection referenced above and is now in conformance with the approved shop drawings. Additionally the Contractor indicates that the area was examined by Magnetic Particle Testing (MT), as required by the contract specifications for Partial Joint Penetration (PJP) welds. The results of these examinations were included in the subject submittal.
