Contract # : **04-0120E4**
 Cty **SF** Rte **80** PM **13.4/13.8**
 File # **45.25 B**

QUALITY ASSURANCE - NONCONFORMANCE REPORT

Welding	<input checked="" type="checkbox"/>	Concrete	<input type="checkbox"/>	Other	<input type="checkbox"/>	
Welding:	<input type="checkbox"/>	Curing:	<input type="checkbox"/>	Procedural:	<input type="checkbox"/>	Bridge No.: #34-0006L/R
Joint fit-up:	<input type="checkbox"/>	Coating:	<input type="checkbox"/>	Other:	<input type="checkbox"/>	Component: #T1 Foundation Footing
Procedural:	<input type="checkbox"/>	Procedural:	<input type="checkbox"/>

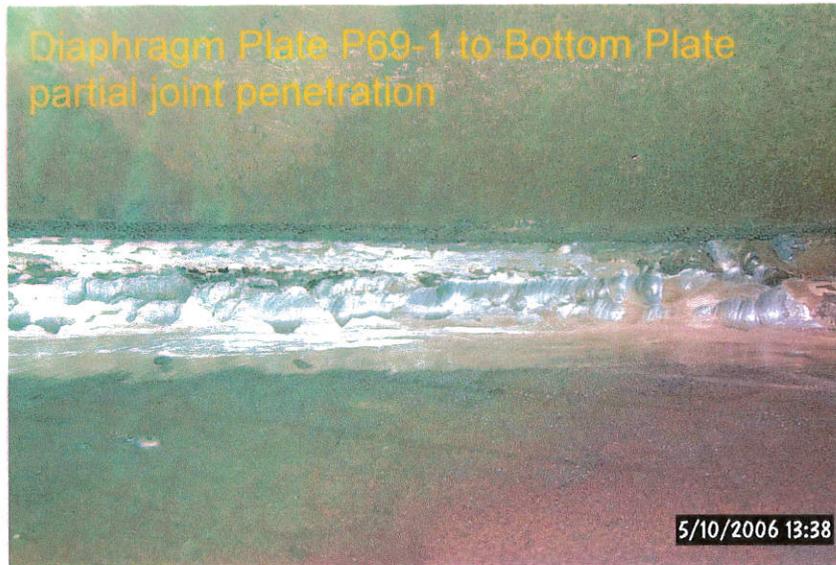
- 1.) On May 10, 2006, Mr. Deets accepted weld preparation that was out of compliance with the Special Provisions and KOS approved shop drawings. A digital photograph below shows a partial penetration weld joint joining diaphragm plate P69-1 and the bottom plate with insufficient grinding after air carbon arc gouging. Mr. Deets visually accepted this weld joint on the above listed date.

Contractor's proposal to correct the problem: KOS QCM George Barnhill will review these issues with Mr. Deets and provide further training to alleviate future occurrences.

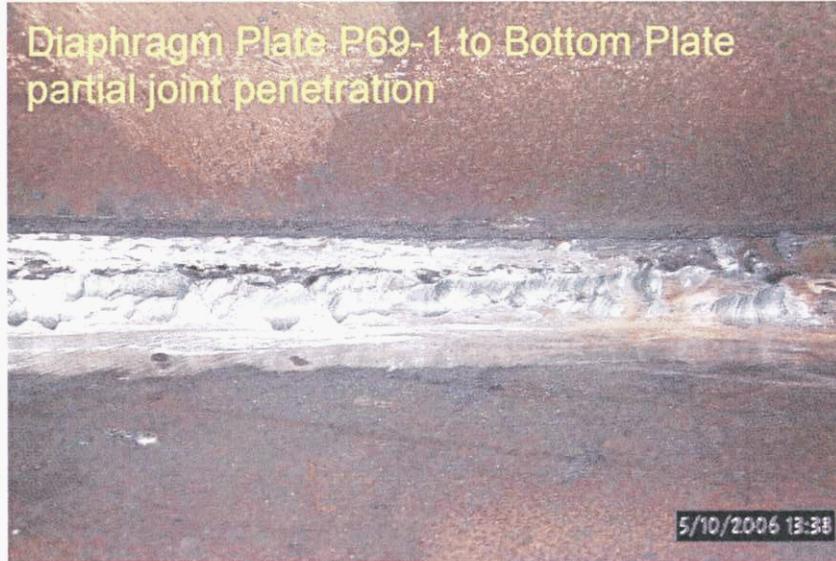
- 1.) On May 10, 2006, Mr. Deets accepted weld preparation that was out of compliance with the Special Provisions and KOS approved shop drawings. A digital photograph below shows a partial penetration weld joint joining diaphragm plate P69-1 and the bottom plate with insufficient grinding after air carbon arc gouging. Mr. Deets visually accepted this weld joint on the above listed date.

Contractor's proposal to correct the problem: KOS QCM George Barnhill will review these issues with Mr. Deets and provide further training to alleviate future occurrences.
