**DEPARTMENT OF TRANSPORTATION**

Contract # : **04-0120E4**
Cty **SF** Rte **80** PM **13.4/13.8.**
File # **45.25 B**

QUALITY ASSURANCE - NONCONFORMANCE REPORT

NCR #107

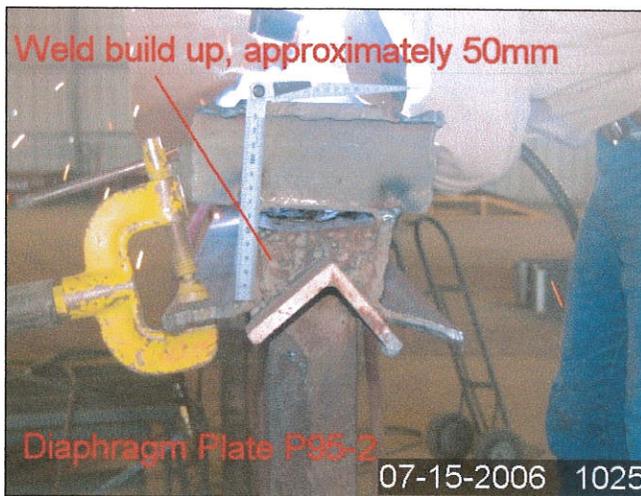
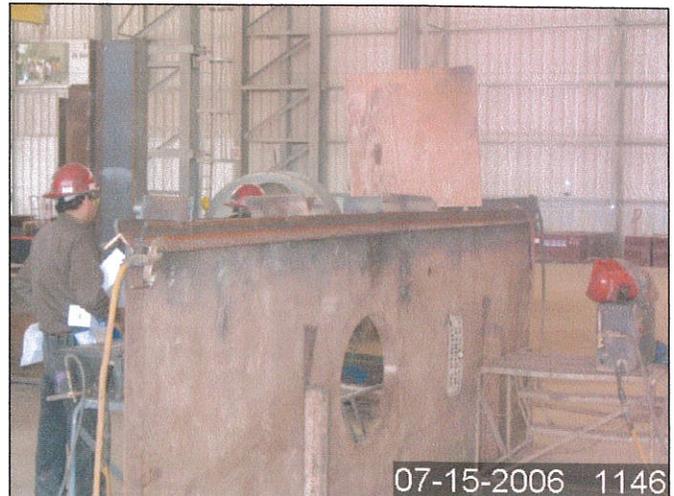
- 1.) KOS Quality Control (QC) Representative allowed KOS to build up diaphragm plate P95-2 by welding for the full length of 5320mm and a depth of approximately 50mm without prior approval from the Engineer.
- 2.) KOS Quality Control (QC) Inspector was not aware that KOS was welding on the identified diaphragm plate until the Caltrans Quality Assurance (QA) Inspector brought it to his attention at approximately 1045 hours. The shift on this date began at 0700 hours.
- 3.) The Caltrans QA Inspector measured the interpass temperature at KOS welder Mr. Pecina's station and found that it did not meet the minimum requirement of 107 degrees Celsius, using a 107 degree Celsius temperature indicating crayon.

Applicable reference: 1) AWS D1.5 2002 section 3.3.4.2 "Root openings larger than those allowed in 3.3.4.1 may be corrected by welding only with the approval of the engineer." Section 3.3.4.1 states "Root openings larger than those allowed in 3.3.4, but not greater than twice the thickness of the thinner part or 20 mm [3/4 in.], whichever is

1. Both magnetic particle testing and ultrasonic testing of the buttered areas shall be performed as required by AWS D1.5:2002, Section 6.7.3.
2. Rejectable indications located in the buttered area during the nondestructive testing of the completed weld shall not be considered base metal indications and shall be repaired in accordance with the AWS D1.5:2002.

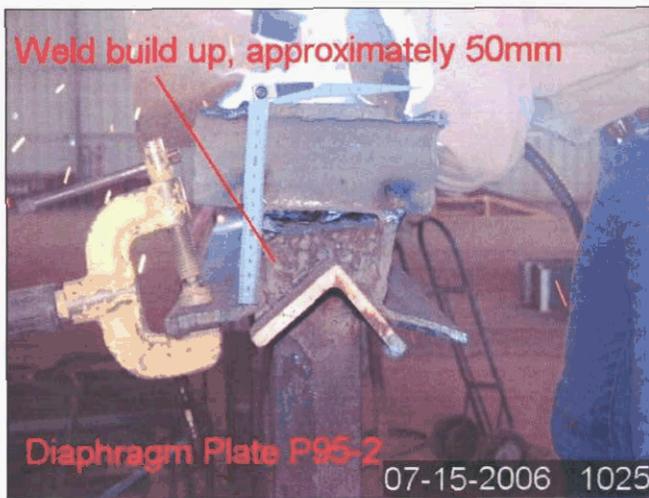
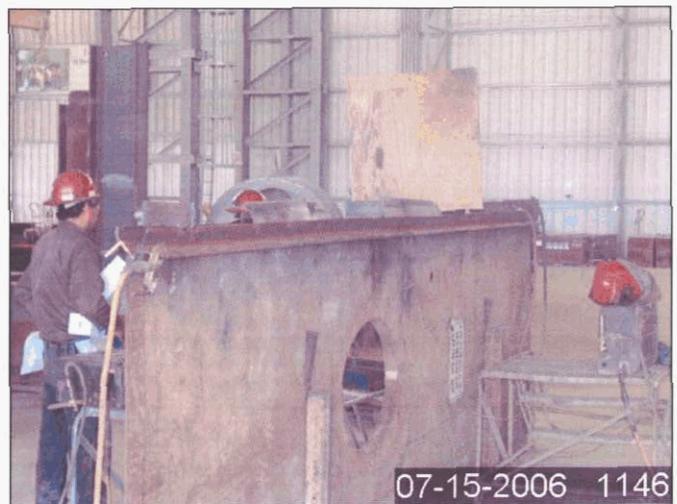
- 1.) KOS Quality Control (QC) Representative allowed KOS to build up diaphragm plate P95-2 by welding for the full length of 5320mm and a depth of approximately 50mm without prior approval from the Engineer.
2.) KOS Quality Control (QC) Inspector was not aware that KOS was welding on the identified diaphragm plate until the Caltrans Quality Assurance (QA) Inspector brought it to his attention at approximately 1045 hours. The shift on this date began at 0700 hours.
3.) The Caltrans QA Inspector measured the interpass temperature at KOS welder Mr. Pecina's station and found that it did not meet the minimum requirement of 107 degrees Celsius, using a 107 degree Celsius temperature indicating crayon.

Applicable reference: 1) AWS D1.5 2002 section 3.3.4.2 "Root openings larger than those allowed in 3.3.4.1 may be corrected by welding only with the approval of the engineer." Section 3.3.4.1 states "Root openings larger than
