Contract #: **04-0120E4**  
 Cty **SF** Rte **80** PM **13.4/13.8**  
 File # **45.25 B**

## QUALITY ASSURANCE - NONCONFORMANCE REPORT

**Location:** Kiewit Offshore Services**Date:** August 31, 2006**Prime Contractor:** Kiewit/FCI/Manson (KFM) Joint Venture**NCR #119****Submitting Contractor:** Kiewit Offshore Services**Type of problem:**

KFM SUBMITTAL 1126-00 –KIEWIT OFFSHORE SERVICES (KOS) RESPONSE TO NONCONFORMANCE REPORTS 119

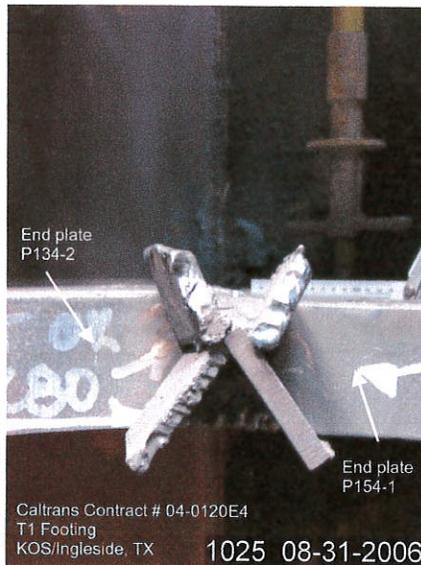
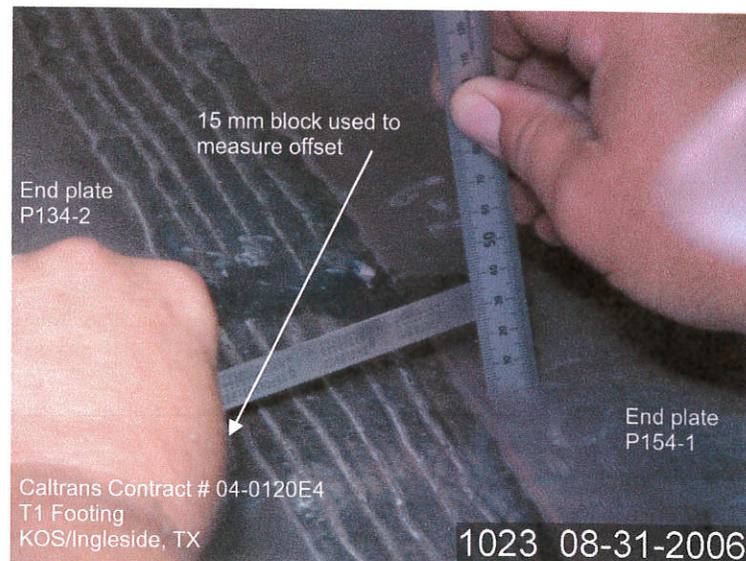
**Description of Non-Conformance:** KOS Quality Control has allowed the welding of a complete joint penetration weld joining end plates P154-1 and P134-2 with an offset (misalignment) varying between approximately seven and ten millimeters. The misalignment is outside the tolerances set in AWS D1.5-2002, Section 3.3.3.

**Applicable reference:** AWS D1.5 2002 section 3.3.3**Who discovered the problem:** Caltrans Quality Assurance Inspector, David Flygare**Name of individual from Contractor notified:** KOS Quality Control Representative, Mr. George Barnhill**Time and method of notification:** 1600, verbal notification to Mr. George Barnhill on 08-31-2006.**Name of Caltrans Engineer notified:** Mark Vilcheck, Structural Representative**Time and method of notification:** September 1, 2006, 1340 via telephone conversation**QC Inspector's Name:** KOS Quality Control Representative Mr. George Barnhill**Was the QC Inspector aware of problem:** Yes

**Contractor's proposal to correct the problem:** The Contractor has stated they will submit an RFI detailing their proposal to correct the misalignment.

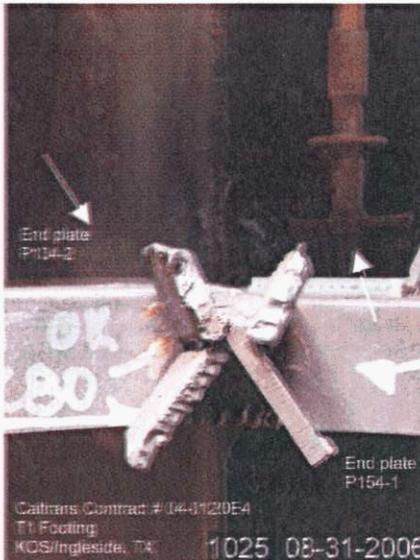
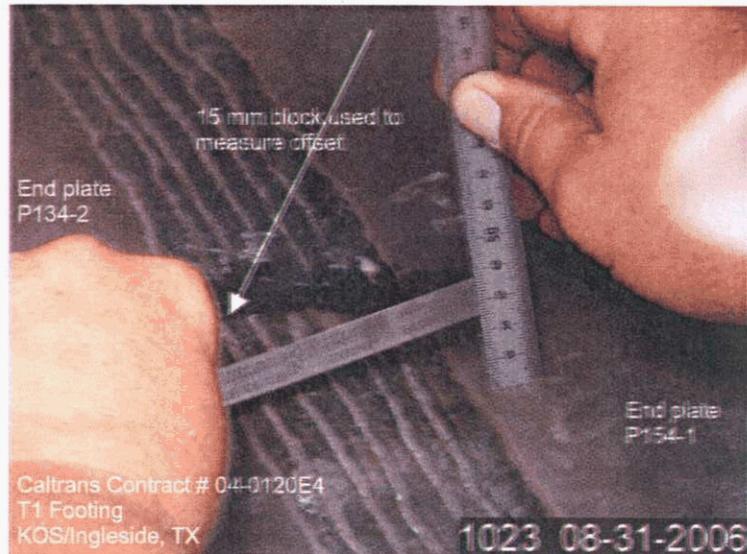
**Description of Non-Conformance:** KOS Quality Control has allowed the welding of a complete joint penetration weld joining end plates P154-1 and P134-2 with an offset (misalignment) varying between approximately seven and ten millimeters. The misalignment is outside the tolerances set in AWS D1.5-2002, Section 3.3.3.

**Applicable reference:** AWS D1.5 2002 section 3.3.3

The AWS D1.5-2002 Code, Section 3.3.3 and Figure 3.2 allows parts to be joined by groove welds which have an offset from theoretical alignment not exceed 10 percent of the thickness of the thinner part joined, but in no case shall be more than 3 mm. In August 2006, METS documented that the Contractor elected to proceed with welding the joint connecting P154-1 to P134-2 with misalignment measured at 7-10mm. The Contractor indicated that this condition occurred during the fit-up of a subassembly due to their efforts to maintain the correct alignment of existing anchor bolt holes in the endplates.

**Contractor's proposal to correct the problem:** The Contractor has stated they will submit an RFI detailing their proposal to correct the misalignment.

As stated in Contractor's response to NCR 119, METS also documented excessive misalignment in the welds connecting end plates P154 and P156, P157 and P155, & P157 and P147. In order to repair these areas, the Contractor submitted KFM RFI's 288, 293, and 297 requesting to correct the alignment of these members by transitioning the complete joint penetration (CJP) butt welds at 2.5:1 slope. The Department approved the Contractor's request in State Letter 05.003.01-001966 provided that additional measures were met in order to prevent the misalignment from adversely affecting the performance of the anchor rods adjacent to the CJP weld.

As of the date of this memorandum, the Contractor has completed the repairs in accordance with State Letter 05.003.01-001966 and the repairs have been verified by METS. Based on the comments above, METS considers NCR 119 to be closed at this time.
