Contract #: **04-0120E4**
 Cty **SF** Rte **80** PM **13.4/13.8.**
 File # **45.25 B**

QUALITY ASSURANCE - NONCONFORMANCE REPORT

NCR #125

Welding **Concrete** **Other**
Welding: **Curing:** **Procedural:** **Bridge No.:** #34-0006L/R
Joint fit-up: **Coating:** **Other:** **Component:** #T1 Foundation Footing
Procedural: **Procedural:**

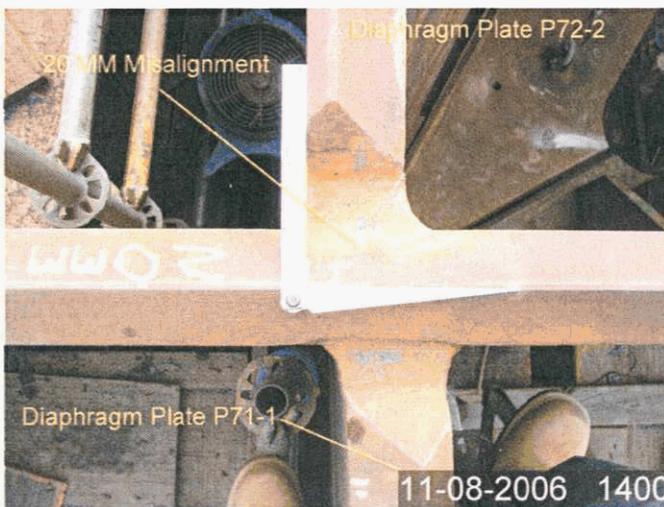
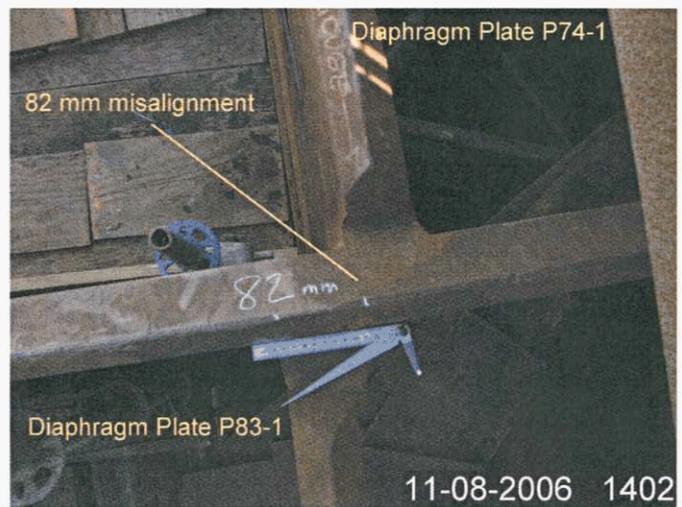
Description of Non-Conformance: KOS Quality Control has allowed the fit-up and welding of misaligned discontinuous diaphragm plates that exceed the five-millimeter maximum as required by the contract Special Provisions. Below are the locations affected:

- Location 1) Diaphragm Plate P71-1 to Diaphragm Plate P72-1 has 20 millimeters of misalignment.
- Location 2) Diaphragm Plate P83-1 to Diaphragm Plate P74-1 has 82 millimeters of misalignment.
- Location 3) Diaphragm Plate P83-2 to Diaphragm Plate P94-2 has 49 millimeters of misalignment.
- Location 4) Diaphragm Plate P91-1 to Diaphragm Plate P92-1 has 23 millimeters of misalignment.

Below are digital photographs of the discrepancies described above at two locations.

Applicable reference: Special Provisions Section 10-1.31-Shop Welding paragraph H. Dimensional Tolerances, states “Where a discontinuous member provides a continuous load path on either side of a through member, the method of marking and ensuring alignment shall be described in the dimensional control procedure. Misalignment

between discontinuous members shall not exceed 30% of the thickness of the thinner member or 5 mm, whichever is less.”

The Department understands that the Contractor has corrected the misalignment by transitioning the weld on both sides of the discontinuous members at a 2.5 to 1 slope and examined 100% of the weld with ultrasonic examination. The amount of misalignment in the P71/P72-1 connection was verified by the Contractor to be less than 5 mm between the end plate and the base plate, thus per the discussion between the Department and the Contractor of January 11, 2007, additional weld metal in this area is not necessary.

As indicated in the KOS letter dated December 27, 2006, the Contractor has corrected the misalignment by transitioning the weld on both sides of the discontinuous members at a 2.5 to 1 slope and examined 100% of the weld with Ultrasonic Examination (UT) (per State Letter 05.003.01-002440). However, as discussed during the onsite meeting between the Department and the Contractor on January 11, 2007, the Contractor was only required to transition the offset plates for the full height of the web on the P92-1/P91-1 connection. The amount of misalignment in the P71-1/P72-1 connection was verified by the Contractor to be less than 5mm between the end plate and the base plate, thus additional weld metal in this area was not deemed necessary by the Design Team.

1. Diaphragm plate P71-1 to diaphragm plate P72-1 has 20 millimeters of misalignment.
KOS will transition the weld at this location with a 1 on 2.5 transition weld. As stated in State Letter Number 05.003.01-002440

4. Diaphragm plate P91-1 to diaphragm plate P92-1 has 23 millimeters of misalignment.
KOS will transition the weld at this location with a 1 on 2.5 transition weld. As stated in State Letter Number 05.003.01-002440

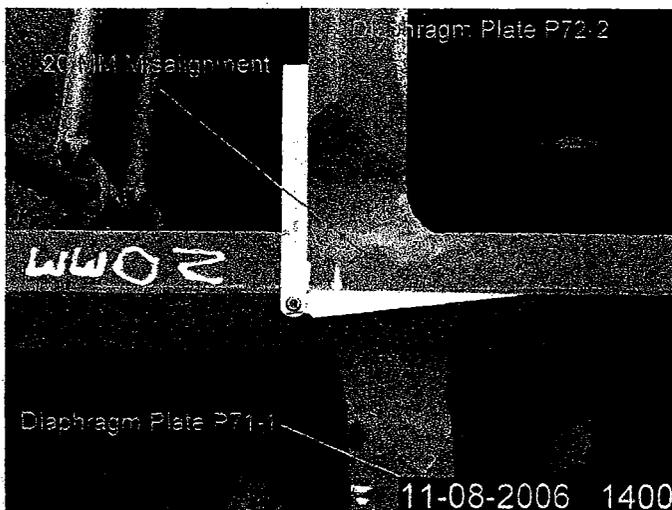
Description of Non-Conformance: KOS Quality Control has allowed the fit-up and welding of misaligned discontinuous diaphragm plates that exceed the five-millimeter maximum as required by the contract Special Provisions. Below are the locations affected:

Location 1) Diaphragm Plate P71-1 to Diaphragm Plate P72-1 has 20 millimeters of misalignment.
 Location 2) Diaphragm Plate P83-1 to Diaphragm Plate P74-1 has 82 millimeters of misalignment.
 Location 3) Diaphragm Plate P83-2 to Diaphragm Plate P94-2 has 49 millimeters of misalignment.
 Location 4) Diaphragm Plate P91-1 to Diaphragm Plate P92-1 has 23 millimeters of misalignment.

Below are digital photographs of the discrepancies described above at two locations.

Applicable reference: Special Provisions Section 10-1.31-Shop Welding paragraph H. Dimensional Tolerances, states "Where a discontinuous member provides a continuous load path on either side of a through member, the method of marking and ensuring alignment shall be described in the dimensional control procedure. Misalignment

between discontinuous members shall not exceed 30% of the thickness of the thinner member or 5 mm, whichever is less.”
