**DEPARTMENT OF TRANSPORTATION - District 4 Toll Bridge Program**

Contract No. 04-0120E4  
04-SF-80-13.4, 13.8  
SAS T1 & E2 Foundations  
SFOBB-ESSSP

Subject: NCR - Oregon Iron Works, 02/27/06 (Welding Over Crack)

<b>Critical Weld Repair Report(CWR)</b>		DATE: Thursday, March 02, 2006
San Francisco Oakland Bay Bridge / E-2 Pile Cap		Report #
CALTRANS #04-0120E4	KFM JOB#364 / 4347	2083-016
Sub-Assembly Title: Exterior Diagonal Girder Half Pod Assy	Quality Control Representative	
Drawing # 2083-E-0	Don Cox	
O.I.W. Mark# G101-S-A1	Quality Assurance Manager-Approval	
Candraft # N/A	Nate Lindell	
OIW DWG# 2083-G-101		REV# 0

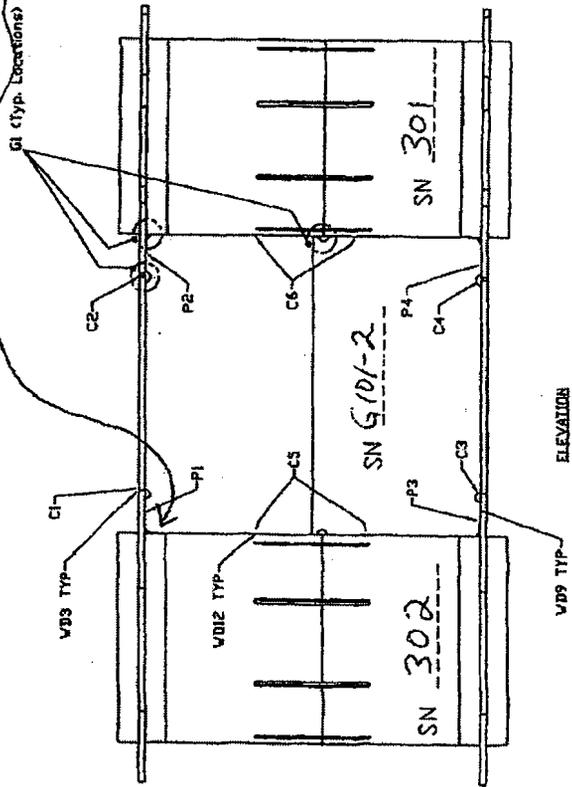
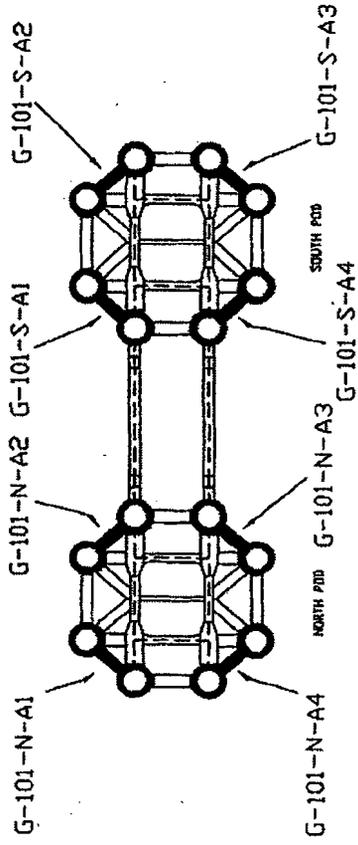
QCMK-G-101-S-A1

\* Location of CRACK  
 33mm Long, 58mm Deep  
 START 38mm From Top of Weld  
 WJ C5

Check All Apply			Description of Condition
Receipt Insp.		Inspection Method	Weld crack 33mm L X 58mm D (WJ C5) Located 38mm from end of weld on web 103b to pile sleeve 501d
In Process Insp.		Visual	
Repair Insp.		Mag. Particle	
Base Material		Ultrasonic	
Weld Metal	√	Other	See Attached Drawing for Location
Following original excavation of a linear indication OIW production deposited approximately three passes on top of the linear indication to avoid blowing thru the weld joint.			
Production and QC have been counseled on the requirements of not welding over linear indications.			
OIW has addressed the root cause of the linear indication and have taken measures to increase preheat.

Check All Apply			Specific Instruction
Defect Removal Method		Post-Removal NDE	OIW proposes to excavate by scarfing back to the known depth of defect, remove defect by grinding and MT excavated area to verify complete removal of indication. OIW will then repair the area using WPS 3246. OIW QC will perform VT, MT and UT to verify weld soundness. QA shall be notified prior to performing excavation and welding.
Grinding	√	Visual	
Carbon /Air Arc	√	Mag. Particle	
Other		Ultrasonic	
		Other	
Additional Notes / Comments:

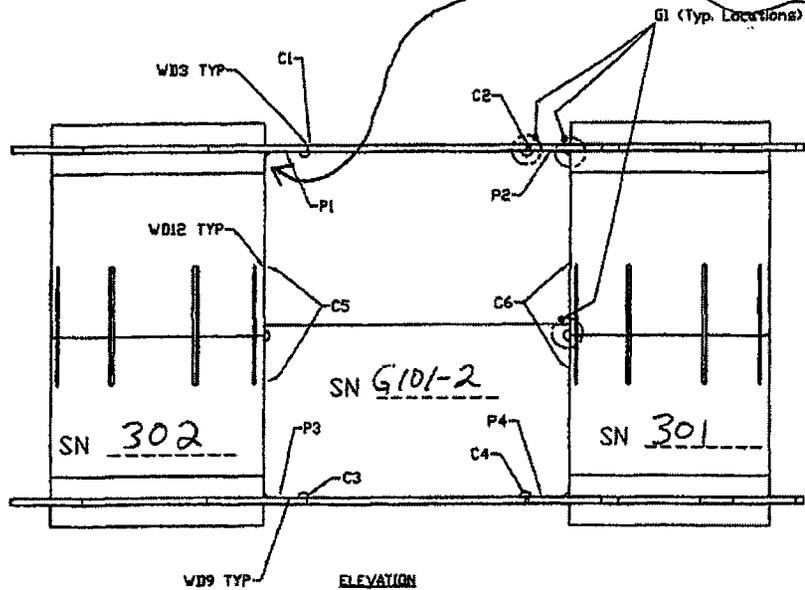
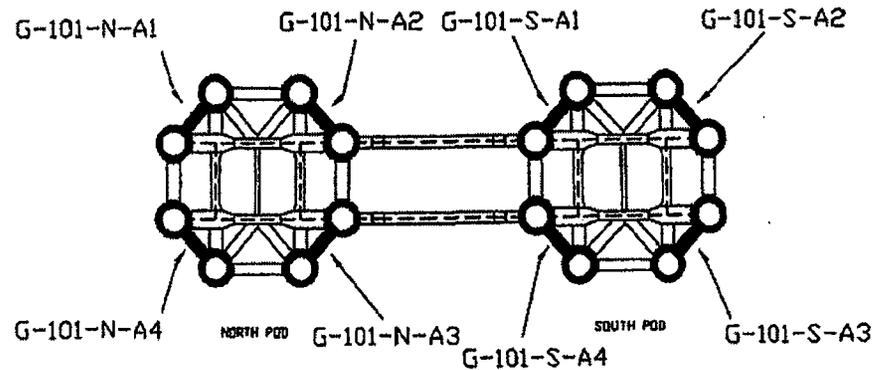
QCMK-G-101-S-A1

\* LOCATION OF CRACK  
 33mm Long, 58mm Deep  
 START 38mm From Top of Weld  
 WJ C5

Check All Apply			Description of Condition
Receipt Insp.		Inspection Method	After the affected area was repaired following the specific instruction in CWR# 2083-016, UT inspection revealed a rejectable indication.  See Attached Drawing for Location
In Process Insp.		Visual	
Repair Insp.	✓	Mag.Particle	
Base Material		Ultrasonic	
Weld Metal		Other

Check All Apply			Specific Instruction
Defect Removal Method		Post-Removal NDE	OIW proposes to excavate by scarfing back to the known depth of defect, remove defect by grinding and MT excavated area to verify complete removal of indication. OIW will then repair the area using WPS 3246. OIW QC will perform VT, MT and UT to verify weld soundness. QA shall be notified prior to performing excavation and welding.
Grinding	✓	Visual	
Carbon /Air Arc	✓	Mag.Particle	
Other		Ultrasonic	
Additional Notes / Comments:
