Contract #: 04-0120E4  
Cty SF Rte 80 PM.13.4, 13.8  
File # 13.25B**QUALITY ASSURANCE - NONCONFORMANCE REPORT**

NCR 21

Contract #: 04-0120E4
Cty SF Rte 80 PM.13.4, 13.8
File # 13.25B

Contract No. 04-0120E4  
04-SF-80-13.4, 13.8  
SAS T1 & E2 Foundations  
SFOBB-ESSSP

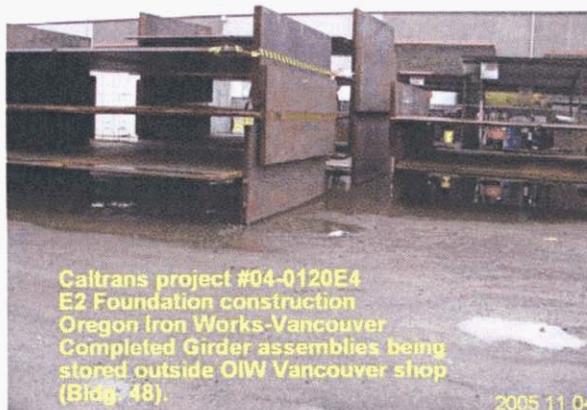
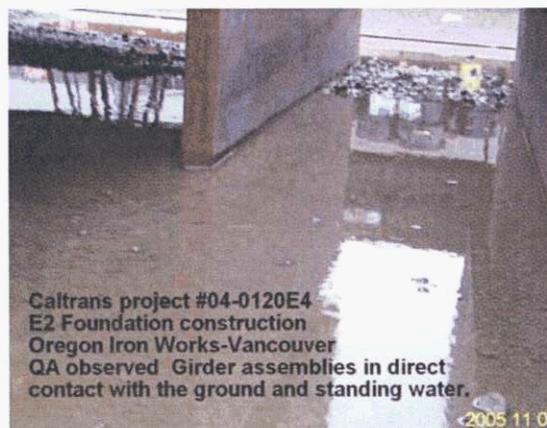
**Description of Non-Conformance:** OIW is storing completed Girder assemblies in direct contact with the ground and standing water. As defined in the Standard Specifications: "Material to be stored shall be placed above the ground upon platforms, skids, or other supports, and shall be kept free from dirt, grease, and other foreign material and properly drained and protected from corrosion". QA observed this discrepancy at OIW-Vancouver storage yard, behind Main building #48. Quality Control Manager (QCM) Mike Houston informed QA that he would address this situation with OIW production. **Attached pictures from this observation.**

**Applicable reference:** 1999 Standard Specifications section 55-1.04**Who discovered the problem:** QA Joe Adame**Name of individual from Contractor notified:** Quality Control (QC) Inspector Russ Lynch, QCM Mike Houston**Time and method of notification:** In person at 0830 with the QC Inspector. Phone call at 0900 with the QCM.**Name of Caltrans Engineer notified:** Mark Woods, Senior Structure Representative**Time and method of notification:** 1530 hours, November 7, 2005 via email**QC Inspector's Name:** Russ Lynch

Corrective action taken: Non-conforming material was placed on metal supports off the ground.
