DEPARTMENT OF TRANSPORTATIONDIVISION OF ENGINEERING SERVICES
MATERIALS ENGINEERING AND TESTING SERVICES

Contract #: **04-0120E4**
Cty **SF** Rte **80** PM **13.4,13.8**
File # **13.25 B****QUALITY ASSURANCE - NONCONFORMANCE REPORT****Location:** Vancouver, WA**Date:** 7/12/2006**Prime Contractor:** Kiewit, FCI & Manson Joint Venture**NCR #106****Submitting Contractor:** Oregon Iron Works**Type of problem:****Welding** **Concrete** **Other** **Welding:** **Curing:** **Procedural:** **Bridge No.** 34-0006**Joint fit-up:** **Coating:** **Other:** **Component:** E2**Procedural:** **Procedural:**

Contract No. 04-0120E4
04-SF-80-13.4, 13.8
SAS T1 & E2 Foundations
SFOBB-ESSSP

Subject: Response to Submittal No. 881, Revision No. 00 (Oregon Iron Works Response to NCR Generated by State Letter 1536)

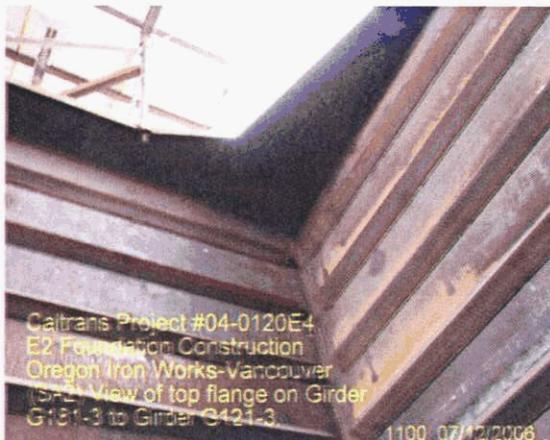
Description of Non-Conformance: Oregon Iron Works (OIW) Quality Control Inspector William Bartlett allowed OIW Welder Dan Schurman (welder identification S-75) to perform welding on wet surfaces. The welding was being performed with the flux core arc welding process on a partial joint penetration tie in weld in the overhead position. Welding location was on the South Pod Assembly (SA2) – Girder 181-3 to Girder G121-3 top flange. The Quality Assurance Inspector observed steam and water on the topside of the flange directly above the point of welding. *Attached pictures from this observation.*

**Applicable reference:** AWS D1.5-2002, Sec.3.1.3, Contract 04-0120E4, Special Provisions Section 8.3.**Who discovered the problem:** QA Inspector Joe Adame**Name of individual from Contractor notified:** QC Inspector Russ Lynch**Time and method of notification:** 7/12/2006 1115, in person.**Name of Caltrans Engineer notified:** Mark Vilcheck, Structure Representative**Time and method of notification:** July 13, 2006 at approximately 1100 hours via verbal notification**QC Inspector's Name:** QC Inspector Russ Lynch

14. NCR 106 was issued to document the Contractor allowing the welding of G181-3 to G121-3 without maintaining the required preheat. The insufficient preheat was apparent as the top flange of G121-3 was remained wet during the welding operations. In discussions with the Contractor regarding this issue, OIW stated that the proper preheat temperature was maintained on the bottom side of the G121-3 flange during the entire time the joint was welded. Additionally, OIW has provided the NDT reports for this joint and they appear to be acceptable. METS considers this NCR to be resolved at this time.

The Department has reviewed Kiewit-FCI-Manson (KFM) Submittal No. 881, Revision No. 00, dated September 8, 2006, which responded to the Department's Letter No. 1536 dated July 19, 2006, which notified KFM of a Non-conformance Report (NCR) for Oregon Iron Works (OIW) dated July 12, 2006. The Department hereby approves Submittal No. 881, Revision No. 00, pursuant to Section 8-3.01, "Welding," of the Special Provisions. The NCR for OIW dated July 12, 2006, is considered to be resolved.
