**DEPARTMENT OF TRANSPORTATION**DIVISION OF ENGINEERING SERVICES  
MATERIALS ENGINEERING AND TESTING SERVICES

Contract #: **04-0120E4**Cty **SF** Rte **80** PM **13.4,13.8**File # **13.25 B****QUALITY ASSURANCE - NONCONFORMANCE REPORT****Location:** Vancouver, WA.**Date:** 8/25/2006**Prime Contractor:** Kiewit, FCI & Manson Joint Venture**NCR #116****Submitting Contractor:** Oregon Iron Works**Type of problem:****Welding**  **Concrete**  **Other** **Welding:**  **Curing:**  **Procedural:**  **Bridge No.** 34-0006**Joint fit-up:**  **Coating:**  **Other:**  **Component:** E2**Procedural:**  **Procedural:** RECEIVED  
005176 SEP-19

Contract No. 04-0120E4  
04-SF-80-13.4, 13.8  
SAS T1 & E2 Foundations  
SFOBB-ESSSP

Subject: Response to Submittal No. 884, Revision No. 00 (Oregon Iron Works Response to METS NCR #116 (QA/QC Issue #47))

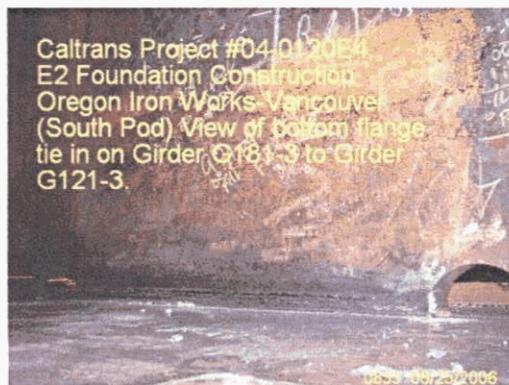
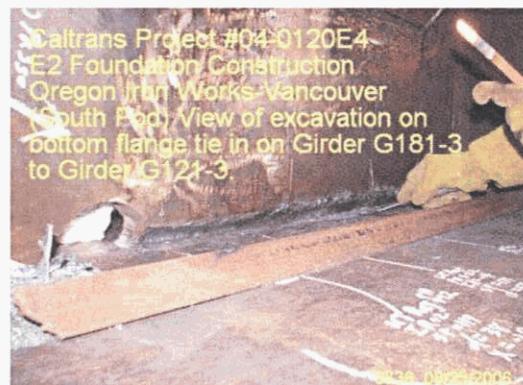
**Description of Non-Conformance:** Oregon Iron Works (OIW) Quality Control allowed OIW Welder Ron Bauer welder identification B-43 to perform a critical weld repair without receiving the Engineers approval. This was performed on Interior Longitudinal Girder Inter -Tie Girder G181-3 to Interior Transverse Girder G121-4 weld. The weld was excavated form one side, welded, and excavated beyond exceeded 65% of the specified weld size from the other side. OIW Quality Control was unaware that this repair exceeded non-critical requirements. *Attached pictures from this observation.*

**Applicable reference:** AWS D1.5-2002, Contract 04-012024 Special Provisions- Welding Quality Control Plan Requirements, note P.

**Contractor's proposal to correct the problem:** No corrective proposal has been submitted at this time.

11. NCR 116 was issued to document the Contractor proceeding with a CWR without approval by the Engineer. In accordance with OIW's response letter to NCR 116, dated September 7, 2006, METS understands that OIW proceeded with the G181-3/G121-3 connection as a result of a misunderstanding that it had been approved

with multiple other repairs that had been submitted the same day. METS believes this to be an isolated instance and does not expect it to be a reoccurring issue as the Contractor typically obtains approval before proceeding with CWRs. METS considers this NCR to be resolved at this time.
