Contract #: 04-0120E4
Cty SF Rte 80 PM 13.4, 13.8
File # 13.25 B

QUALITY ASSURANCE - NONCONFORMANCE REPORT

NCR #118

Description of Non-Conformance: Oregon Iron Works Quality Control Department allowed a second time repair of the Support Beam to Pile Sleeve 306-1 complete joint penetration weld on the G111 side of the support, without the Engineer's approval.

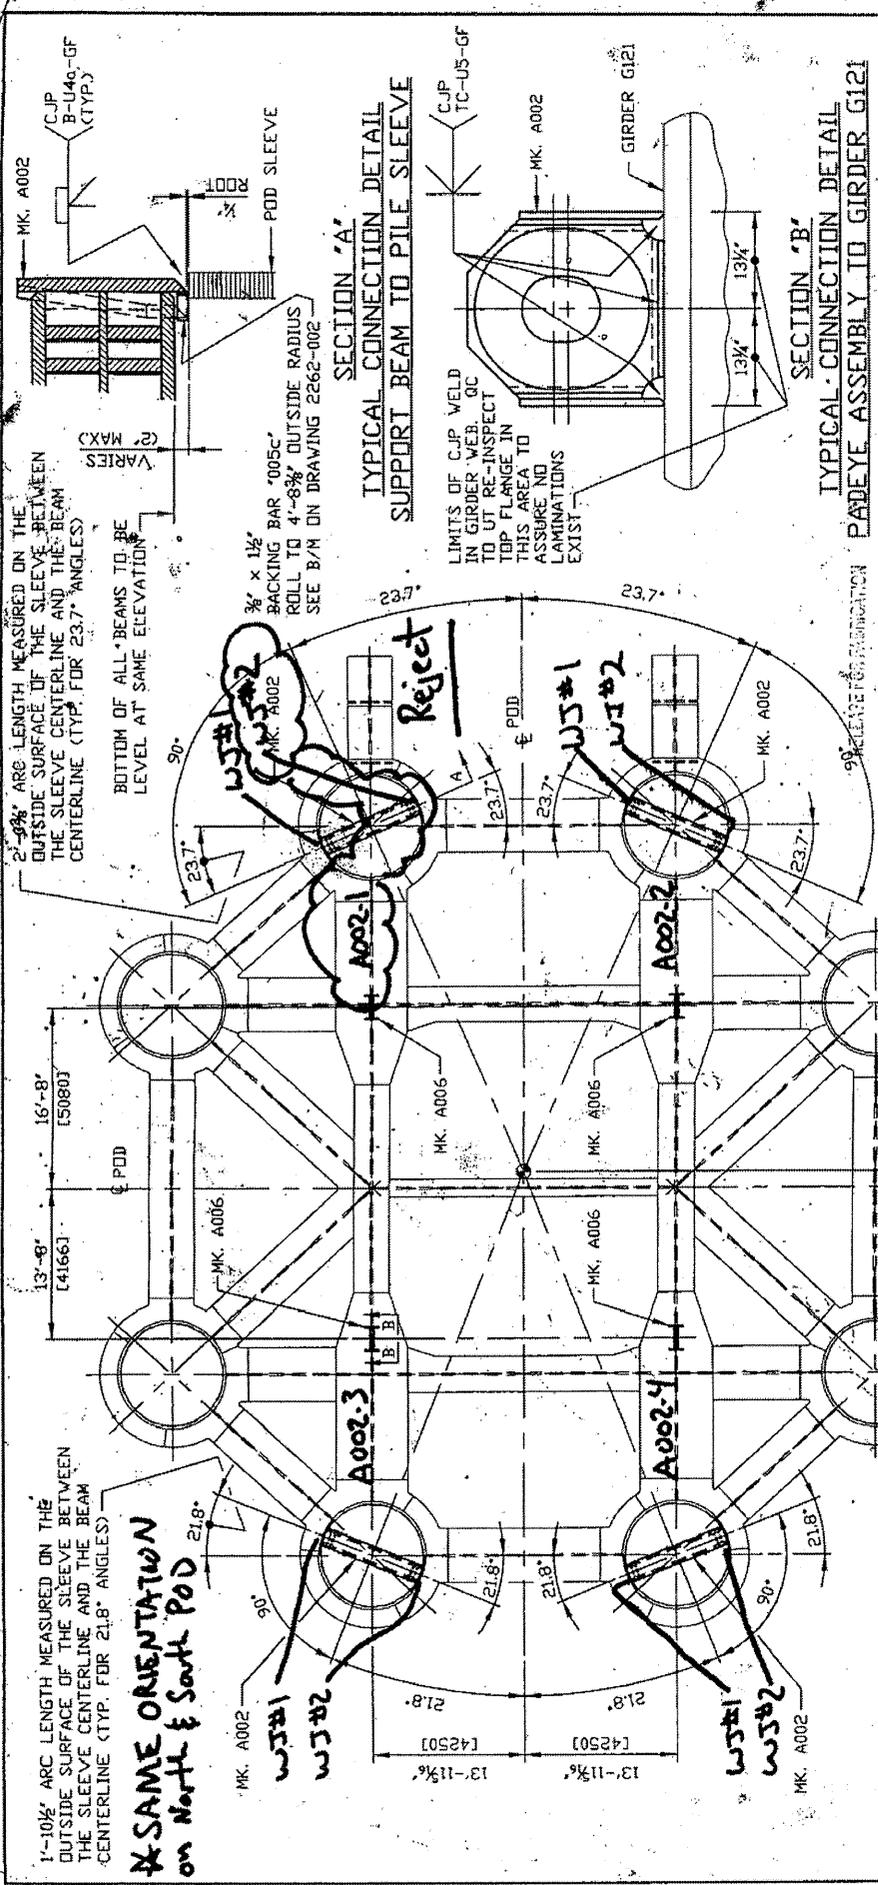
SECTION 'A'
 TYPICAL CONNECTION DETAIL
 SUPPORT BEAM TO PILE SLEEVE

Reject

LIMITS OF CJP WELD IN GIRDER WEB, QC TO UT RE-INSPECT TOP FLANGE IN THIS AREA TO ASSURE NO LAMINATIONS EXIST
