Contract # : **04-0120E4**Cty **SF** Rte **80** PM **13.4, 13.8**File # **20.25 B****QUALITY ASSURANCE - NONCONFORMANCE REPORT****Location:** Trans Bay Steel, Napa, CA.**Date:** 05-25-2006**Prime Contractor:** Kiewit, FCI, Manson, (KFM) Joint Venture**NCR #093****Submitting Contractor:** Trans Bay Steel**Type of problem:****Welding** **Concrete** **Other** **Welding:** **Curing:** **Procedural:** **Bridge No.** 34-0006**Joint fit-up:** **Coating:** **Other:** **Component:** CISS Pile E2-1 tops**Procedural:** **Procedural:** Performing UT with the incorrect testing angle and incomplete and inaccurate UT Reports.

QUALITY ASSURANCE - NONCONFORMANCE REPORT

KFM SUBMITTALS FOR TRANS BAY STEEL (TBS) RESPONSE TO NCRs

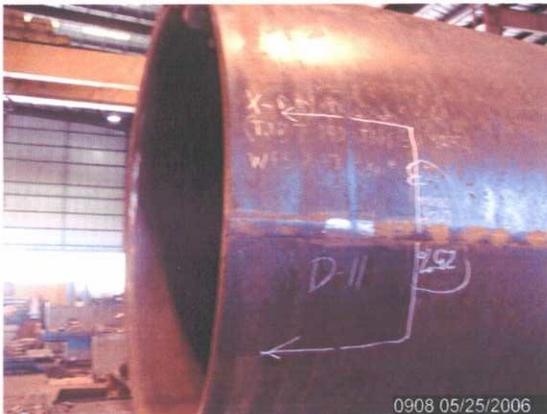
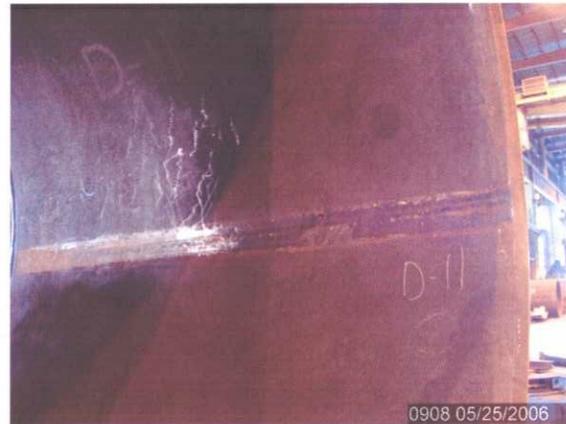
Description of Non-Conformance: TBS Quality Control Level II Technician Berchel White was performing ultrasonic testing without a submitted and approved procedure for the 85mm thick segments D-11 and E-8. Additionally, the technician was observed using a transducer angle (70 degrees) which does not allow full examination of the entire volumetric weld section due to the curvature and geometry of the weld joint. The pictures below denote that the piles were only examined from Face B (outside) and not Face A (inside).

1. In accordance with the TBS letter dated July 21, 2006, all long seam welds in pile sections D11 and E8 examined by Mr. Berchel White were reexamined by an approved Ultrasonic Testing (UT) Technician with an approved UT procedure. The documentation for this reexamination has been verified by METS in the Certificate of Compliance for the E2-5T. Additionally, TBS has indicated (both verbally and through the letter mentioned above) they have counseled Mr. White regarding the proper methods for performing UT inspection on the long seams of the piles. METS considers this NCR to be closed at this time.
