Cty SF Rte 80 PM 13.4/13.8File # 20.25B**QUALITY ASSURANCE - NONCONFORMANCE REPORT****Location:** Trans Bay Steel (TBS) 1025 Kaiser Road Napa, CA**Date:** 10-30-2006**Prime Contractor:** Keiwit, FCI, Manson, (KFM)- Joint Venture**NCR #124****Submitting Contractor:** Trans Bay Steel (TBS)**Type of problem:****Welding** **Concrete** **Other** **Welding:** **Curing:** **Procedural:** **Bridge No.** 34-0006**Joint fit-up:** **Coating:** **Other:** **Component:** CIDH Steel Pile Casing T1-5**Procedural:** **Procedural:**

Contract No. 04-0120E4
04-SF-80-13.4, 13.8
SAS T1 & E2 Foundations
SFOBB-ESSSP

Subject: NCR - Trans Bay Steel, 10/30/06 (Girth Seam Alignment with Excessive Radial Offset)

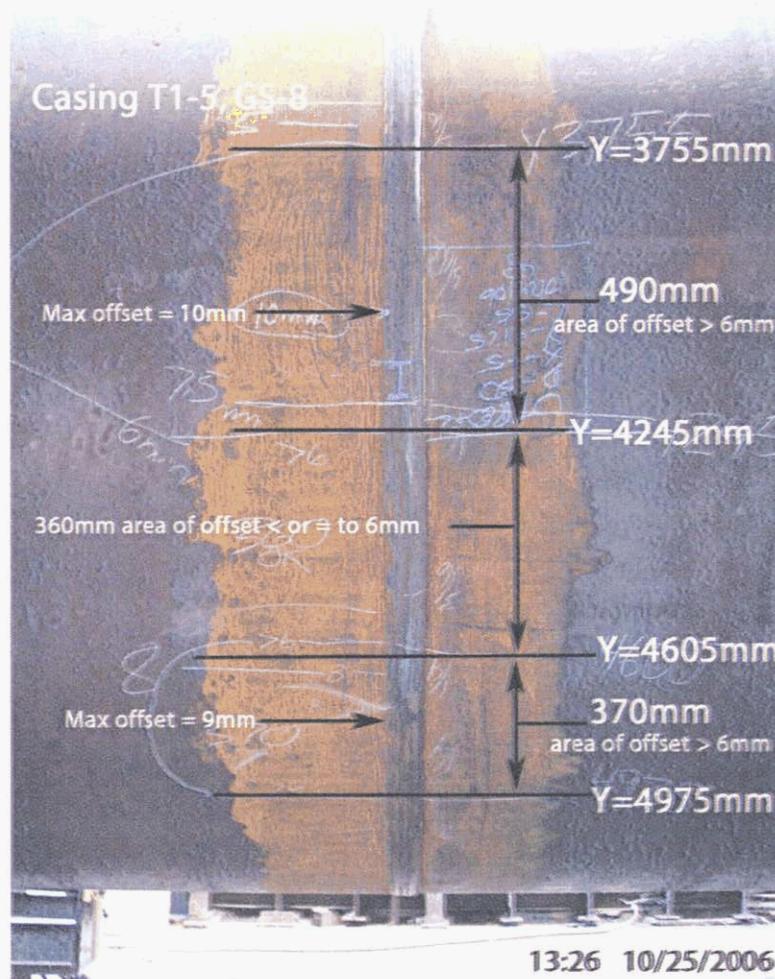
Contract # : 04-0120E4
Cty SF Rte 80 PM 13.4/13.8
File # 20.25B**QUALITY ASSURANCE - NONCONFORMANCE REPORT****Location:** Trans Bay Steel (TBS) 1025 Kaiser Road Napa, CA**Date:** 10-30-2006**Prime Contractor:** Keiwit, FCI, Manson, (KFM)- Joint Venture**NCR # (124)****Submitting Contractor:** Trans Bay Steel (TBS)**Type of problem:****Welding** **Concrete** **Other** **Welding:** **Curing:** **Procedural:** **Bridge No.** 34-0006**Joint fit-up:** **Coating:** **Other:** **Component:** CIDH Steel Pile Casing T1-5**Procedural:** **Procedural:** **Description of Non-Conformance:** Trans Bay Steel completed fabrication welding of the T1-5 steel pile casing girth seam No. 8 and the girth weld alignment (radial alignment) appears to be in excess of the maximum radial offset permitted by the contract documents.

Measurements were observed and recorded as follows: Two localized areas were identified with an offset in excess of 6mm; area #1 between "Y" locations 3755mm to 4245mm (490mm total length with a maximum radial offset measured to be 10mm) and area #2 between "Y" locations 4605mm and 4975mm (370mm total length with a maximum radial offset measured to be 9mm). An acceptable area of GS-8 with a total length of 360mm separated the two localized areas described above. See photo below. The contract documents allow one localized area with a maximum offset of 10mm provided the localized area is under 8T in length and filler metal should be added to provide a 4 to 1 transition. AWS D1.1 2002 allows the one localized area with the approval of the engineer and API Specification 2B contains the same language but does not require approval of the engineer.

Contractor's proposal to correct the problem: On 10/25/06, TBS General Manager Mr. Bill Kavicky stated to the area lead Quality Assurance Inspector and OSM representative Mr. James Cochran, that TBS considers API specification 2B to be the applicable document. Mr. Kavicky stated that TBS does not need to submit an RFI to request approval of the engineer. Mr. Kavicky stated that TBS will remove 3mm of the base metal adjacent to the girth weld at area #2 which will bring the area #2 offset into compliance with the contract specifications. Mr. Kavicky stated that area #1 will then be in compliance with the 8T length requirement and will also be in compliance with API specification 2B.
