Contract #: 04-0120F4Cty: SF/ALA Rte: 80 PM: 13.2/13.9File #: 1x.25B**QUALITY ASSURANCE -- NON-CONFORMANCE REPORT****Location:** W2 Cap Beam, SFOBB**Report No:** NCR-000187**Prime Contractor:** American Bridge/Fluor Enterprises, a JV**Date:** 27-Aug-2008**Submitting Contractor:** American Bridge/Fluor Enterprises, a JV**NCR #:** ABF-0005**Type of problem:**

Welding	Concrete	Other	
Welding	Curing	Procedural	Bridge No: 34-0006
Joint fit-up	Coating	Other	Component: W2 Cap Beam, #43 HRC Couplers
Procedural	Procedural	Descriptor:

Subject: NCR No. ABF-0005

Contract #: 04-0120F4Cty: SF/ALA Rte: 80 PM: 13.2/13.9File #: xx.25A**QUALITY ASSURANCE -- NON-CONFORMANCE RESOLUTION****Location:** W2 Cap Beam, SFOBB**Report No:** NCS-000102**Prime Contractor:** American Bridge/Fluor Enterprises, a JV**Date:** 03-Oct-2008**Submitting Contractor:** American Bridge/Fluor Enterprises, a JV**NCR #:** ABF-0005**Type of problem:**

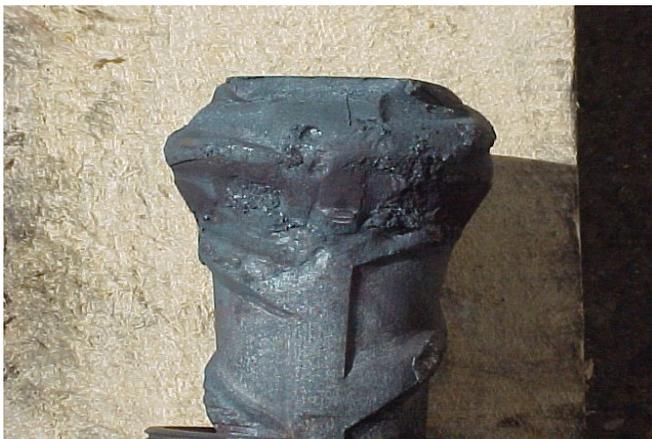
ABF and Regional Steel QC turned over incomplete work to Caltrans/METS for sampling and testing. For the W2 Cap Beam, Pour 3, top mat, the Contractor fabricated non-conforming male coupler heads for #43 transverse rebar HRC couplers at the job site, which were then tested as completed work. Each of four Quality Assurance (QA) samples failed QA testing for slip, the smallest margin of failure, 60%; the largest, approximately 300%. Evaluation of the samples found defective workmanship permitted to pass by QC, including ridges not ground and improperly formed "mushroom" heads; please see picture. The Contractor has stated that a large proportion of male heads are believed to have ridges not properly ground, which was also passed by QC. ABF-RFI-1494 states that because of these problems, the work is incomplete, and requests re-sampling and re-testing.

Re-work coupler heads to bring them into conformance. METS understands that the Engineer will revoke relevant fabrication operator qualifications and work will proceed per METS response to ABF-RFI-1494, as previously agreed:

1. The Contractor shall disassemble all coupler heads and inspect, repair, and if necessary re-work all noncompliant heads.
2. The Contractor shall complete work with qualified and/or re-qualified operators.

3. The Contractor shall submit all standards for QC and QA sampling and testing in conformance with the contract requirements to inspect completed heads, including the relevant dimensions and drawings.

4. Couplers shall then be re-installed upon acceptance of re-worked heads and clearing of the to-be-issued Non-Conformance Reports (NCR).
5. Re-work is considered submission of new work to the Department, and will require both QA and QC testing.

6. Should either of the QC or QA tests fail, the Contractor shall remove and discard all the heads and re-do the work.
7. Written authorization from HRC is required to re-use the currently installed couplers. If such authorization is received, all coupler components shall be inspected by the Contractor for damage such as, but not limited to, gouges, bending, dents, etc.

8. Couplers may only be re-installed upon acceptance of the reworked heads and clearing of all NCRs.
