**DEPARTMENT OF TRANSPORTATION**

**Job Name:** SAS Superstructure

**QUALITY ASSURANCE -- NON-CONFORMANCE REPORT**

**Report No:** NCR-000159

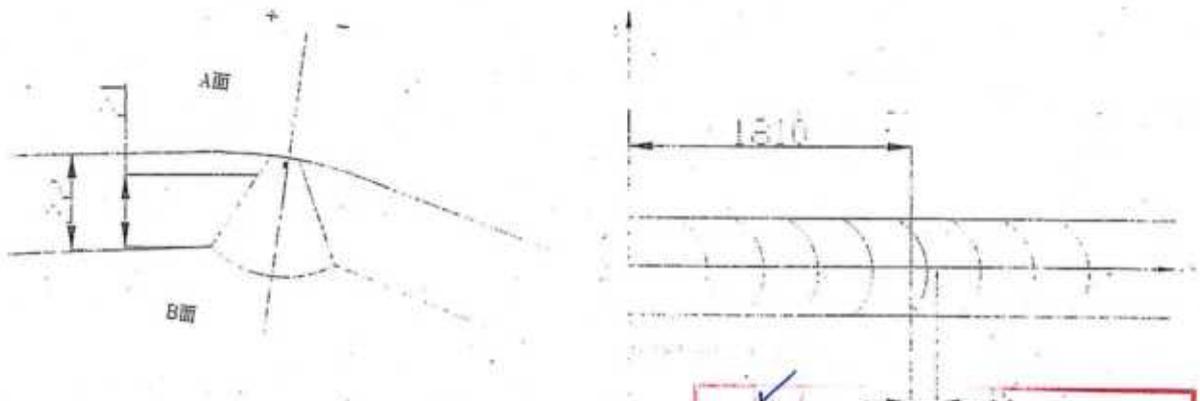
WELD NUMBER: SEG016A-008

Rejected indication found by ultrasonic inspection is less than the maximum allowance aggregate length.

(UT探伤发现的缺陷总长度小于最大允许长度。)SEG016A-008

- 1、焊道未及时处理干净。
- 1. Did not clear the weld pass completely in time.

- 1. 从A面采用打磨的方法去除焊缝缺陷;
  - 2. 参照返修焊接工艺规程 (WPS) 准备正确的接头型式, 预热和焊接;
  - 3. 焊前对修补区域进行VT/MT检测保证缺陷完全被清除;
  - 4. 将修补区域打磨到与母材或邻近焊缝平齐;
  - 5. 根据批准的车间图纸检查焊缝.
- 
- 1. Grind from face A to remove all defects;
  - 2. Follow repair WPS for joint preparation, preheat, and weld deposit;
  - 3. Verify with VT/MT no defects remain in the weld joint prior to welding;
  - 4. Grind the repaired area flush with base metal or the adjacent weld;
  - 5. Check the welds according to the working drawings.
