Contract #: 04-0120F4Cty: SF/ALA Rte: 80 PM: 13.2/13.9File #: 69.25B**QUALITY ASSURANCE -- NON-CONFORMANCE REPORT****Location:** Changxing Island, Shanghai, PRC**Report No:** NCR-000207**Prime Contractor:** American Bridge/Fluor Enterprises, a JV**Date:** 21-Oct-2008**Submitting Contractor:** Zhenhua Port Machinery Company, Ltd (ZPMC), Changxing Island**NCR #:** ZPMC-0184**Type of problem:**

**Job Name:** SAS Superstructure

**Subject:** NCR No. ZPMC-0184

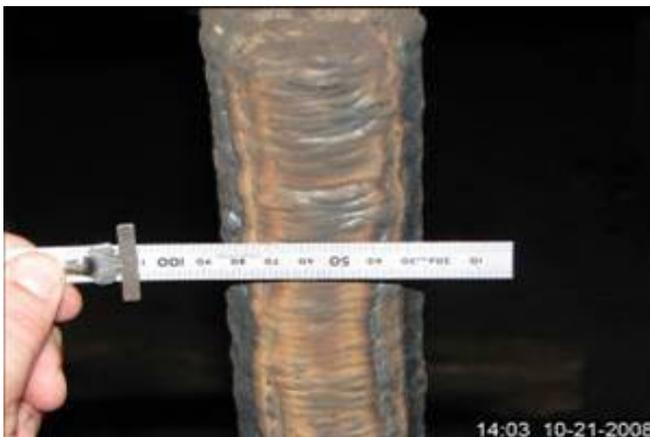
ABF/ZPMC was welding outside the parameters of their WPS to build up the joints on the East Shaft, Skin E, Lift 1 and South Shaft, Skin C, Lift 1, Longitudinal Stiffeners. The Contractor was utilizing a weave bead technique which is outside the tolerances of the WPS-345-FCAW-3G-3F-Repair for travel speed thus modifying their Heat Input into the material. The width of the weave bead observed was approximately 50 millimeters. Below is a digital photograph illustrating the welding performed on Skin Plate C of the South Shaft, lift 1 and what was observed on the East Shaft, Skin E, (Lift 1) on 10-20-2008.

Propose a resolution for the identified non-conformance with revised procedures to prevent future occurrences.

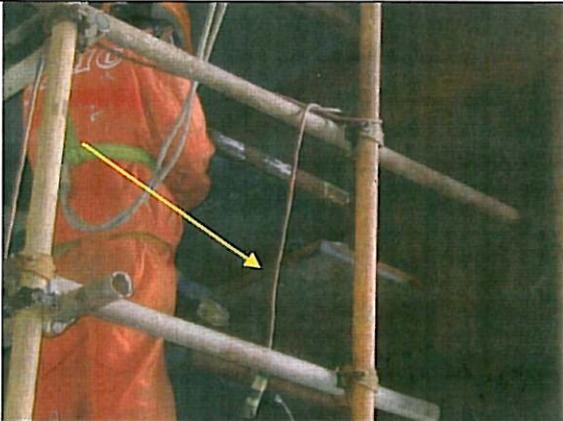
Tested Long Stiff in Skin C

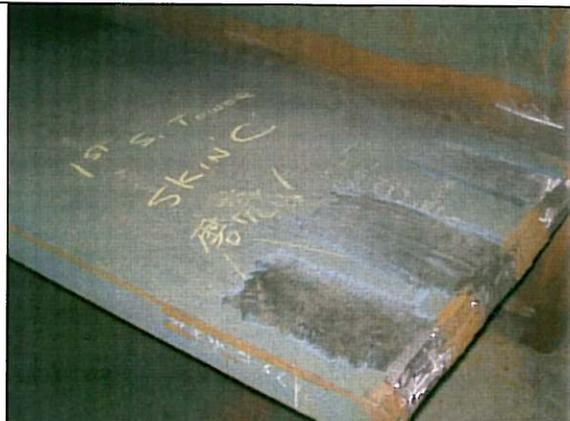
Tested Locations

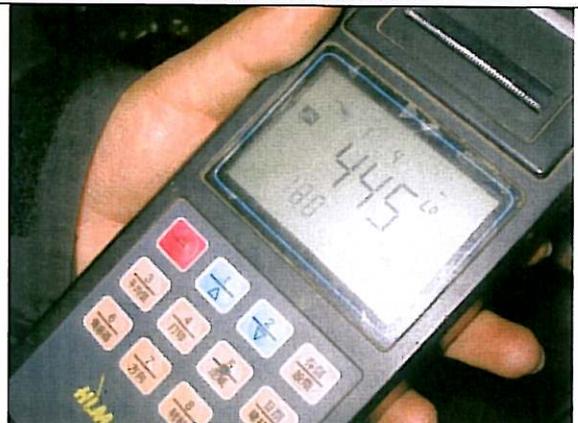
Hardness reading ( Hv 180 ) in weld

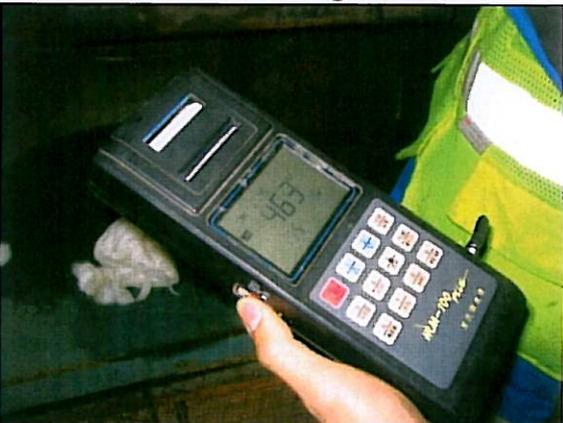
Hardness Reading ( Hv 195 ) in HAZ

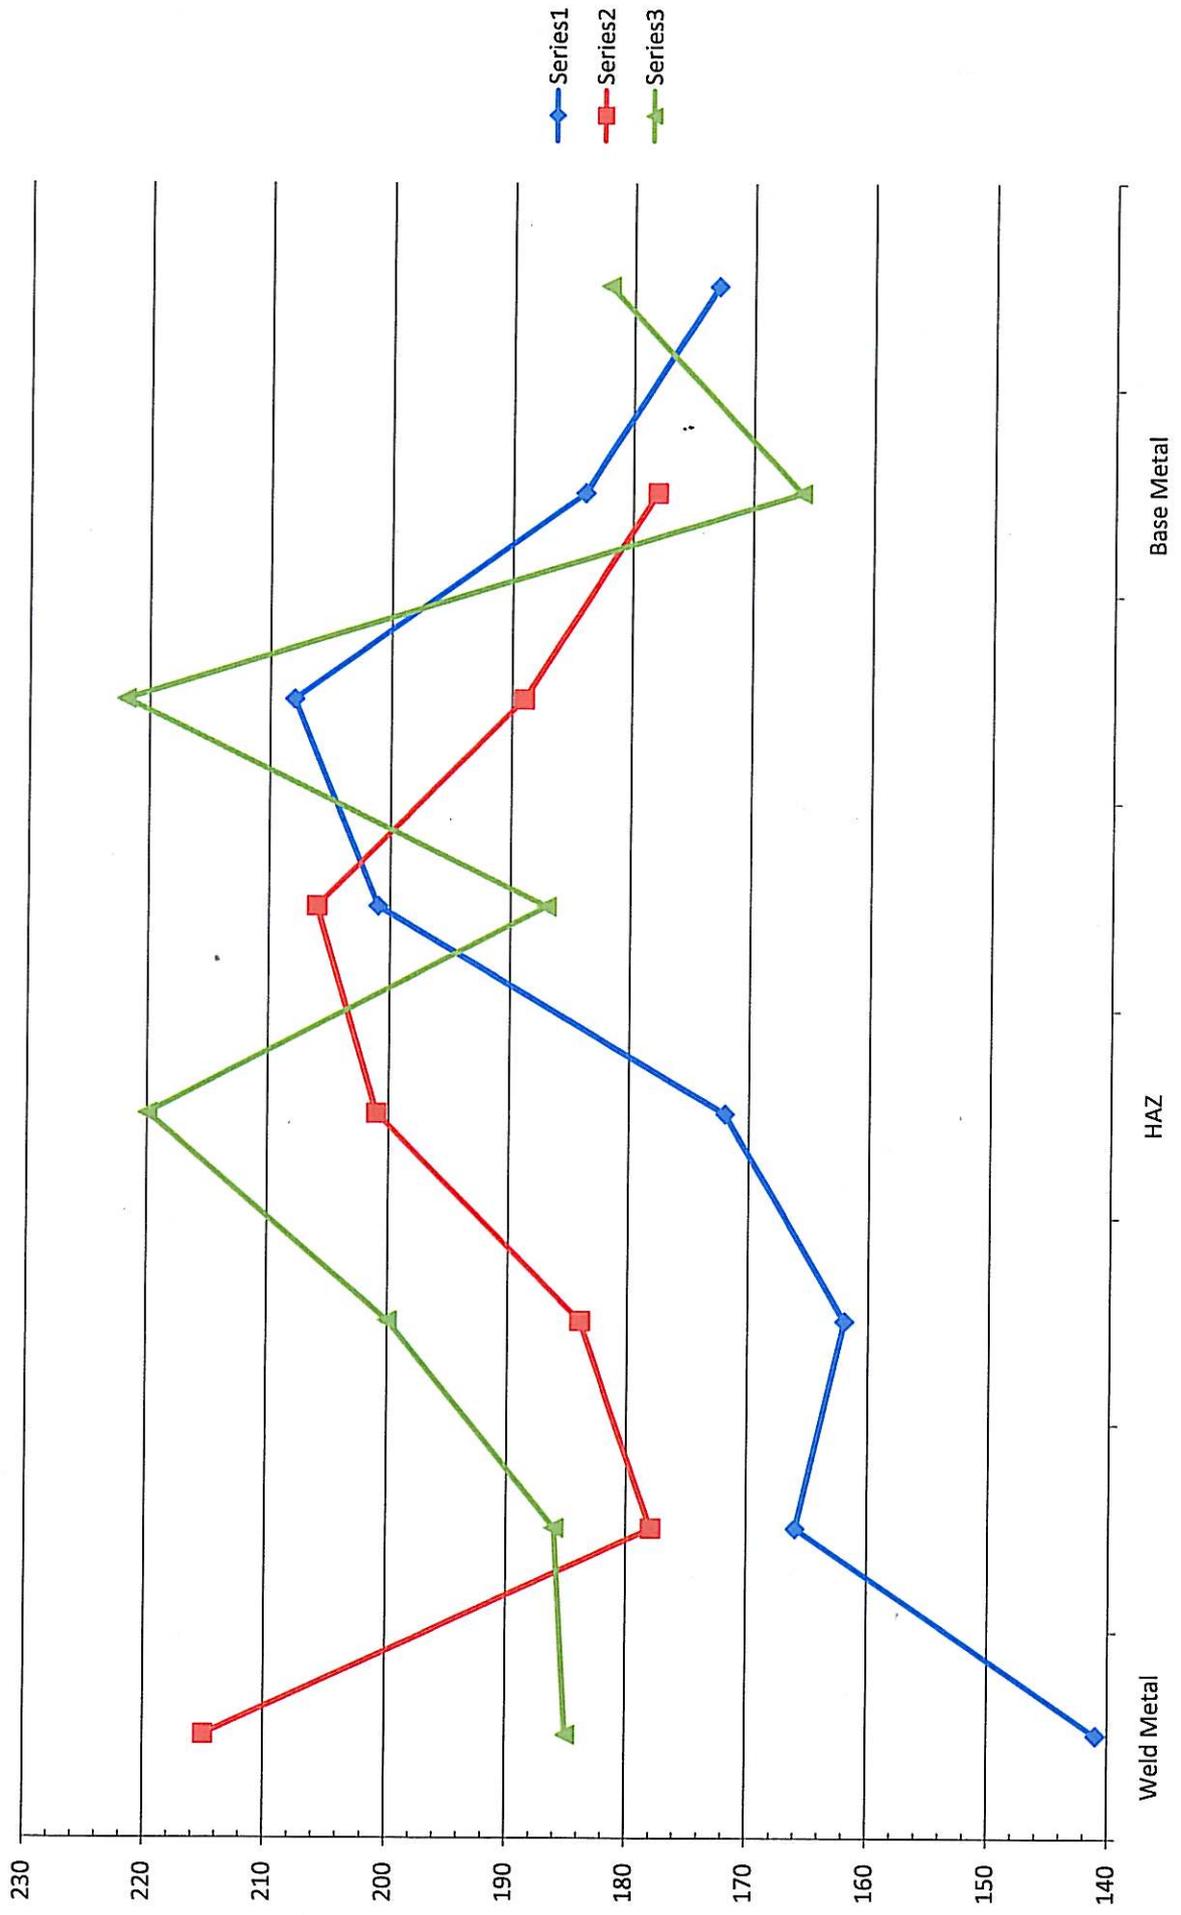
# Vickers Hardness - South Shaft Buttering - 4/28/2009

141	215	185	Weld Metal
166	178	186	
162	184	200	
172	201	220	HAZ
201	206	187	
208	189	222	
184	178	166	
173		182	Base Metal

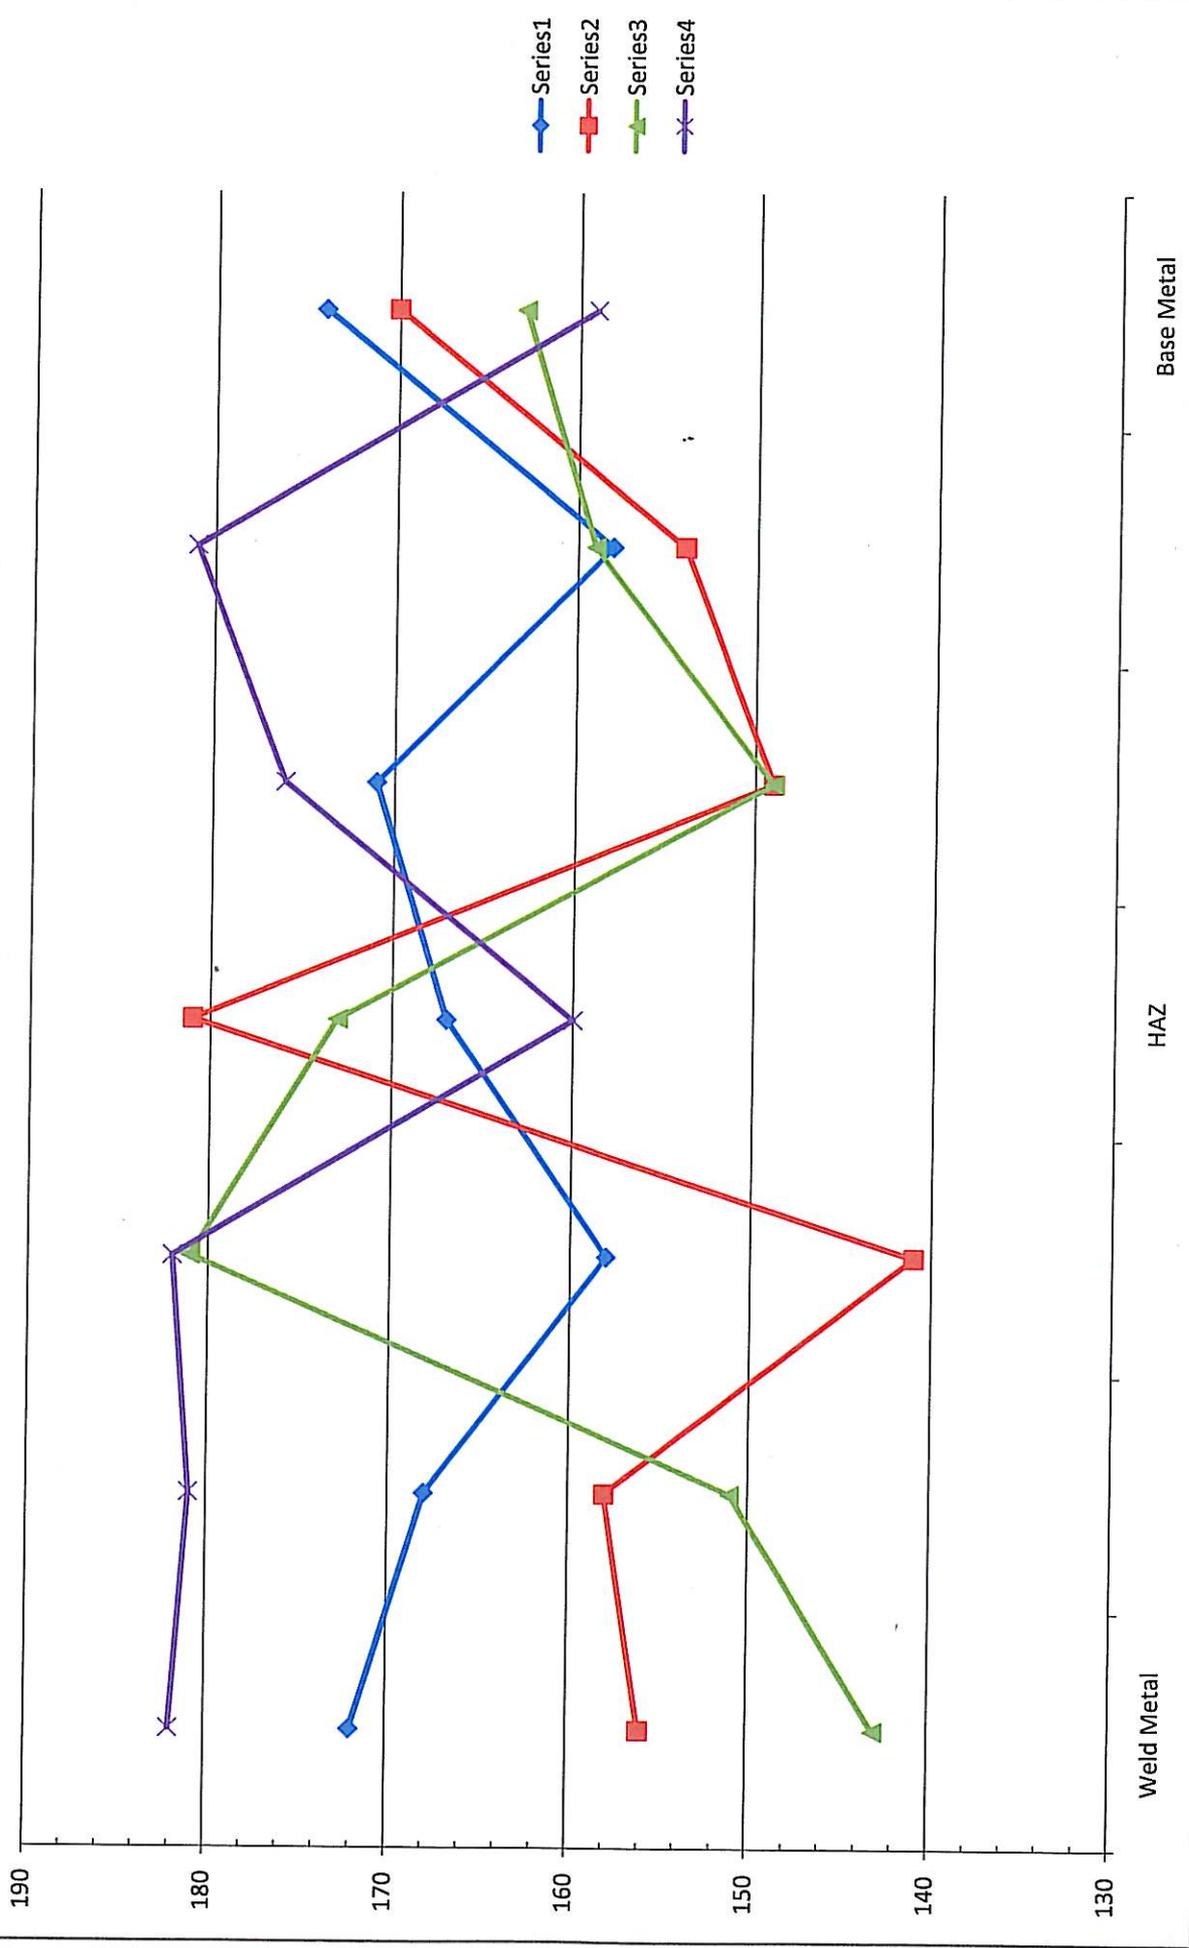
# Brinnell Hardness - East Shaft Buttering - 5/5/2009

172	156	143	182	Weld Metal
168	158	151	181	
158	141	181	182	
167	181	173	160	HAZ
171	149	149	176	
158	154	159	181	
174	170	163	159	Base Metal
