Contract #: 04-0120F4Cty: SF/ALA Rte: 80 PM: 13.2/13.9File #: 69.25B**QUALITY ASSURANCE -- NON-CONFORMANCE REPORT****Location:** Changxing Island, Shanghai, PRC**Report No:** NCR-000210**Prime Contractor:** American Bridge/Fluor Enterprises, a JV**Date:** 03-Nov-2008**Submitting Contractor:** Zhenhua Port Machinery Company, Ltd (ZPMC), Changxing Island**NCR #:** ZPMC-0187**Type of problem:**

**Reference Description:** Crack indication overlooked by Quality Control**Description of Non-Conformance:**

**Job Name:** SAS Superstructure

**Subject:** NCR No. ZPMC-0187

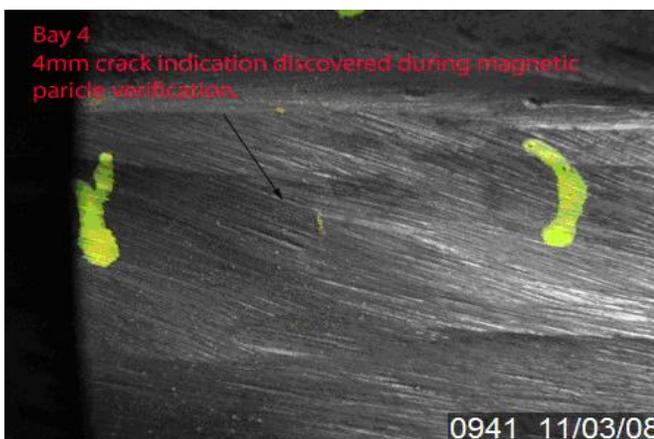
The Quality Assurance Inspector discovered a crack indication overlooked by Quality Control while performing magnetic particle verification on partial joint penetration (PJP) weld ESDI SA411-2 located on the 62 meter East Tower Diaphragm. The Quality Assurance Inspector informed American Bridge/Fluor Quality Assurance Inspector Zhang Huilong about the crack indication overlooked by ZPMC Quality Control Inspectors. Mr. Huilong agreed with the Quality Assurance Inspector and informed ZPMC Quality Control Inspectors about the overlooked crack indication. The Quality Assurance Inspector observed ZPMC personnel removed 6mm of filler metal by grinding before the crack was removed. Mr. Huilong informed the Quality Assurance Inspector a critical weld repair will be issued prior to welding the repair.

Propose a resolution for the identified non-conformance that addresses the failure of Quality Control to identify the linear indication (NDT). Provide documentation of the steps taken by the Quality Control Manager to prevent future occurrences. Recent failures by Quality Control to identify linear indications have resulted in the issuance of NCR ZPMC-0179 and two incident reports concerning missed indications on 09/26/08 (OBG) and 10/20/08 (Tower).

ZPMC has issued an internal NCR to enhance on-site inspection and control inspection speed. ZPMC has provided dry Magnetic Particle Testing (MT) training to its Non-Destructive Testing (NDT) operators. ZPMC has also submitted a sign-in log of all attendees and the material covered. The welds in question have been repaired and the relevant VT and MT reports, indicating sound welds, have been submitted.

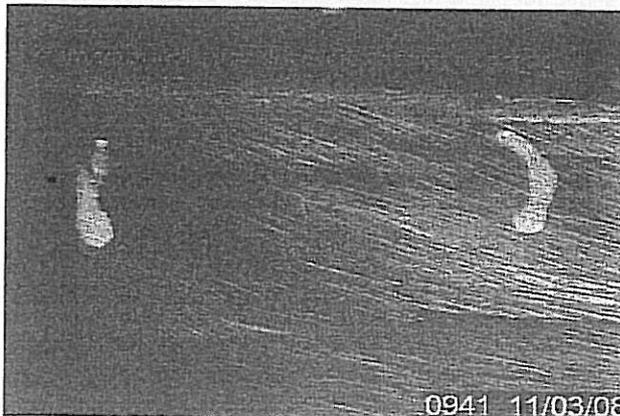
The Quality Assurance Inspector discovered a crack indication overlooked by Quality Control while performing magnetic particle verification on partial joint penetration (PJP) weld ESDI SA411-2 located on the 62 meter East Tower Diaphragm. The Quality Assurance Inspector informed American Bridge/Fluor Quality Assurance Inspector Zhang Huilong about the crack indication overlooked by ZPMC Quality Control Inspectors. Mr. Huilong agreed with the Quality Assurance Inspector and informed ZPMC Quality Control Inspectors about the overlooked crack indication. The Quality Assurance Inspector observed ZPMC personnel removed 6mm of filler metal by grinding before the crack was removed. Mr. Huilong informed the Quality Assurance Inspector a critical weld repair will be issued prior to welding the repair.

钢网裂缝没有检测到  
The crack was so thick that didn't inspect it.
