Contract #: 04-0120F4Cty: SF/ALA Rte: 80 PM: 13.2/13.9File #: 69.25B**QUALITY ASSURANCE -- NON-CONFORMANCE REPORT****Location:** Changxing Island, Shanghai, P.R. China**Report No:** NCR-000240**Prime Contractor:** American Bridge/Fluor Enterprises, a JV**Date:** 18-Mar-2009**Submitting Contractor:** Zhenhua Port Machinery Company, Ltd (ZPMC), Changxing Island**NCR #:** ZPMC-0214**Type of problem:****Welding****Concrete****Other****Welding****Curing****Procedural****Bridge No:** 34-0006**Joint fit-up****Coating****Other****Component:** Segment 1BE, FB053-007/CA97A**Procedural****Procedural****Description:****Reference Description:** Unapproved base metal repair, 1BE**Description of Non-Conformance:**

Job Name: SAS Superstructure

Subject: NCR No. ZPMC-0214

Reference Description: Unapproved base metal repair, 1BE

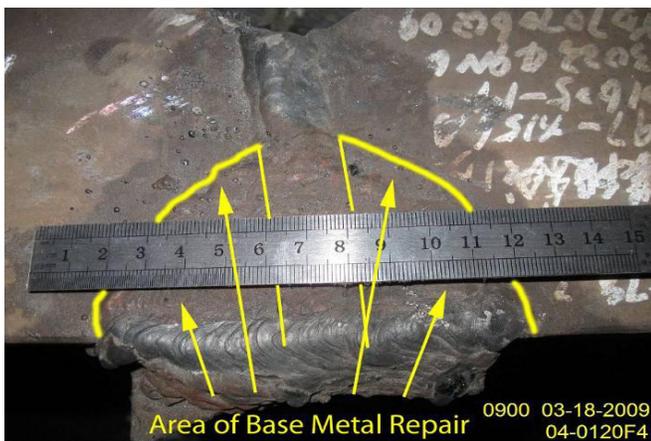
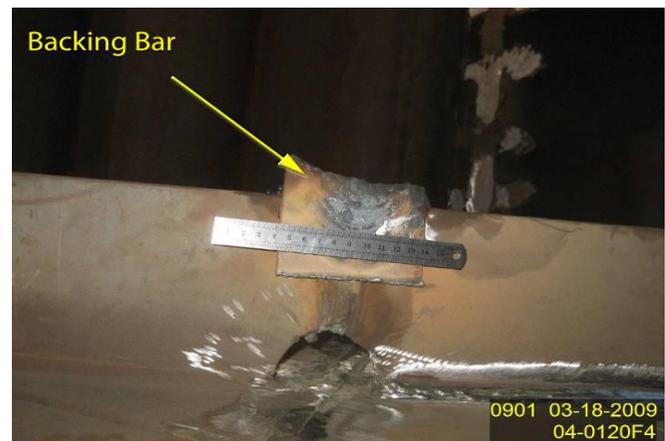
Quality Assurance (QA) Inspector observed that base metal repair was performed on the floor beam top flange plate X156F. The base metal repair was at a portion of a CJP weld splice. This splice is joining the floor beam to the corner assembly diaphragm. The welder deposited approximately 40mm x 70mm of filler material around the weld splice. This base metal repair was performed without an Engineer's approval.

AWS D1.5- 2002 Section 3.7.4 "Prior approval of the Engineer shall be obtained for repairs to base metal, repair of major or delayer cracks..."

The proposed resolution is not acceptable. Section 9.2.1.2 of the Welding Quality Control Plan (WQCP) states that "... prior approval of the Engineer shall be obtained for repairs to base metal ...".

Prior approval of base metal repairs is required on the first time excavation, not at the third-time excavation as stated in this NPR.

The proposed resolution is acceptable. The welding repair report is included, and the repair welds have been accepted by VT and UT as shown in the attached documents. The Department concurs that Non-Conformance ZPMC-0214 is closed.

Submit WRR and perform repair in accordance with accepted procedures.

Contractor submitted WRR, performed repair, and submitted subsequent NDT reports confirming weld is in conformance.
