Contract #: 04-0120F4Cty: SF/ALA Rte: 80 PM: 13.2/13.9File #: 69.25B**QUALITY ASSURANCE -- NON-CONFORMANCE REPORT****Location:** Changxing Island, Shanghai, PRC**Report No:** NCR-000256**Prime Contractor:** American Bridge/Fluor Enterprises, a JV**Date:** 21-Apr-2009**Submitting Contractor:** Zhenhua Port Machinery Company, Ltd (ZPMC), Changxing Island**NCR #:** ZPMC-0230**Type of problem:**

Reference Description: Continuity Plate Retrofit, Doubler Plate Fit-Up**Description of Non-Conformance:**

Job Name: SAS Superstructure

Report No: NCR-000256

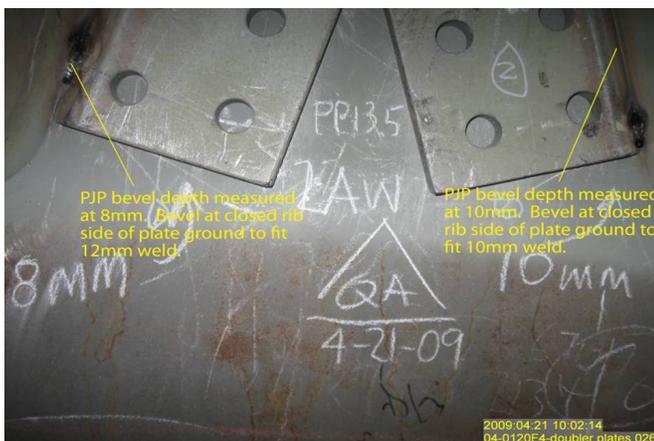
The following issues were found regarding the fit-up of the continuity plate retrofit doubler plates in OBG Segment 2AW:

- 1) The doubler plates were fit up without sufficient depth for the PJP weld.
- 2) Closed rib to diaphragm welds were not ground to 8mm as required for proper fit-up.
- 3) The doubler plates were fit up with excessive gap (3mm) to the diaphragm plate and the closed rib to diaphragm welds.

Perform joint survey of doubler plates, and use shims for bolting fit up issues.

Joint survey was performed with CT and ABF. Welds were ground down, root gap issue was addressed, and shims will be used where gap is out of tolerance for bolting.

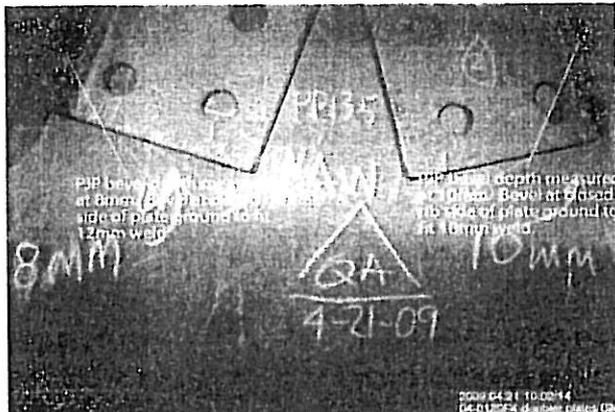
The following issues were found regarding the fit-up of the continuity plate retrofit doubler plates in OBG Segment 2AW:

- 1) The doubler plates were fit up without sufficient depth for the PJP weld.
- 2) Closed rib to diaphragm welds were not ground to 8mm as required for proper fit-up.
- 3) The doubler plates were fit up with excessive gap (3mm) to the diaphragm plate and the closed rib to diaphragm welds.
