Contract #: 04-0120F4
 Cty: SF/ALA Rte: 80 PM: 13.2/13.9
 File #: 69.25B

QUALITY ASSURANCE -- NON-CONFORMANCE REPORT

Location: Changxing Island, Shanghai, PRC **Report No:** NCR-000264
Prime Contractor: American Bridge/Fluor Enterprises, a JV **Date:** 08-May-2009
Submitting Contractor: Zhenhua Port Machinery Company, Ltd (ZPMC), Changxing Island **NCR #:** ZPMC-0238

Reference Description: Inconsistent Bevel and Excessive/Inconsistent Root Opening at Longitudinal Diaphragm-Bottom Panel-Side Panel Joint

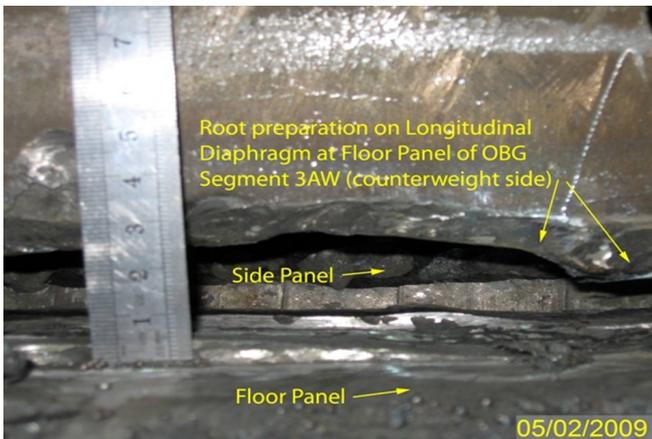
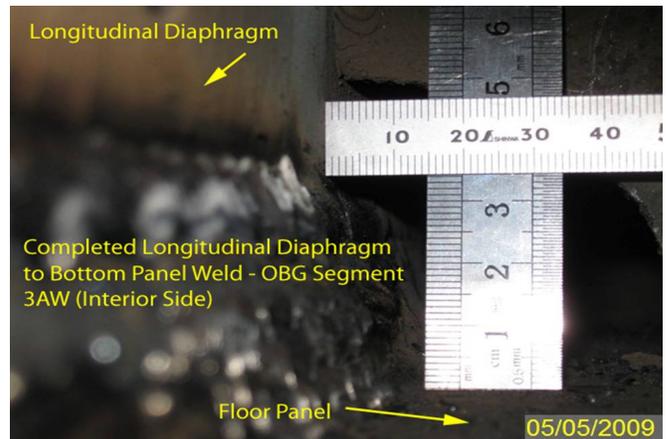
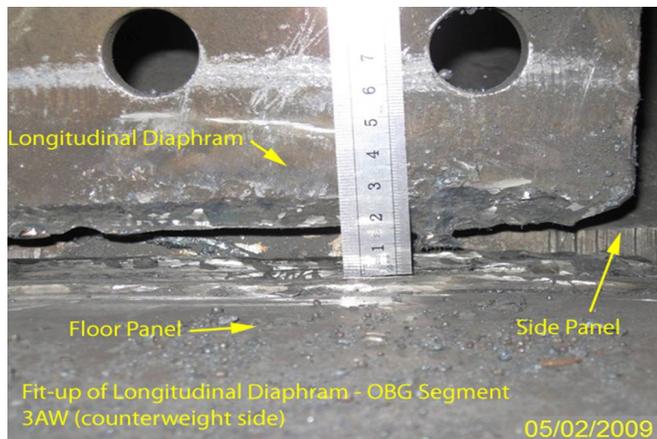
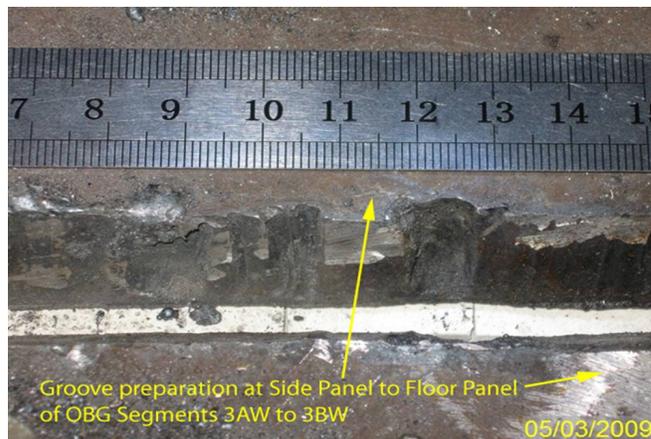
Caltrans Quality Assurance (QA) Inspector observed inconsistent bevel and excessive/inconsistent root opening at segment splice 3AW-3BW. This occurred where the segments were unzipped and adjusted for proper segment alignment at the longitudinal diaphragm - bottom panel - side panel joints. The panels affected are:

- BP101A, SP025A, LD017-003(Working Point W3, Segment 3AW)
- BP103A, SP070B, LD018-003(Working Point W4, Segment 3AW)

3.2.1 "Surfaces and edges to be welded shall be smooth, uniform, and free from fins, tears, cracks, and other discontinuities which would adversely affect the quality or strength of the weld."

3.2.3 "Steel and weld metal may be thermally cut, provided a smooth and regular surface free from cracks and notches is secured, and provided that an accurate profile is secured by the use of a mechanical guide."

ZPMC have finished welded this weld joint. This weld joint is a CJP, therefore weld will be subsequently backgouged and inspected. ZPMC to submit the welding repair report as well as all related inspection documentation at a later date.

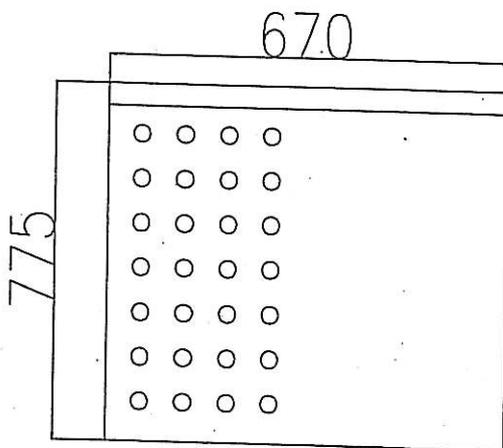
Drawing requirement size

After inspection 3AE inner longitudinal LD18F, the size was shorter than drawing requirement, see the following draft.

The worker operated error caused base metal gouged.

1. Prepare excavation with relevant WPS.
2. VT to verify repair area is free of all defects.
3. Add steel backing at the back of groove according to AWS D1.5.3.13;
4. Preheat and weld according to the relevant WPS.
5. Gouge off the steel backing and grind the weld flush with base metal after welding;
6. Perform NDT inspection of the weld according to the working drawings.
