Contract #: 04-0120F4
 Cty: SF/ALA Rte: 80 PM: 13.2/13.9
 File #: 69.25B

QUALITY ASSURANCE -- NON-CONFORMANCE REPORT

Report No: NCR-000271

Reference Description: Missed MT Indications by QC, Welds SEG2A-033 and 034

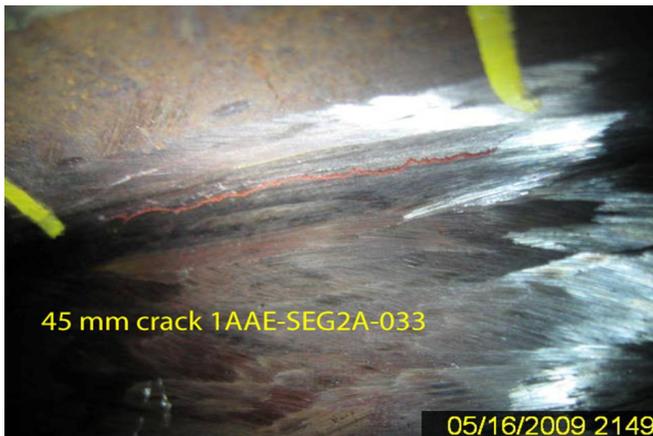
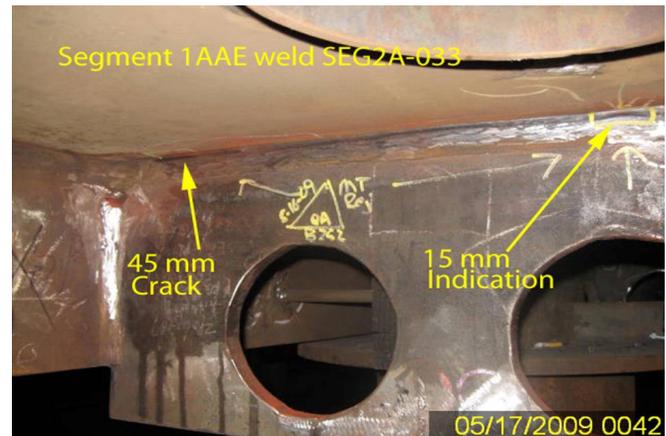
During Final Magnetic Particle Testing (MT) Inspection of OBG Segment 1AAE, Caltrans Quality Assurance (QA) Inspector performed tests on complete joint penetration welds SEG2A-033 and 034. Two linear indications were found on weld 033, a 45 mm crack and a 15 mm indication. One linear indication 15 mm in length was found on weld 034. Prior to QA MT, ZPMC Quality Control (QC) stated that 100% MT and Visual inspection had been performed on the above mentioned welds.

AWS D1.5 (02) Section 6.26.2 – “Welds that are subject to MT in addition to visual inspection shall have no cracks”

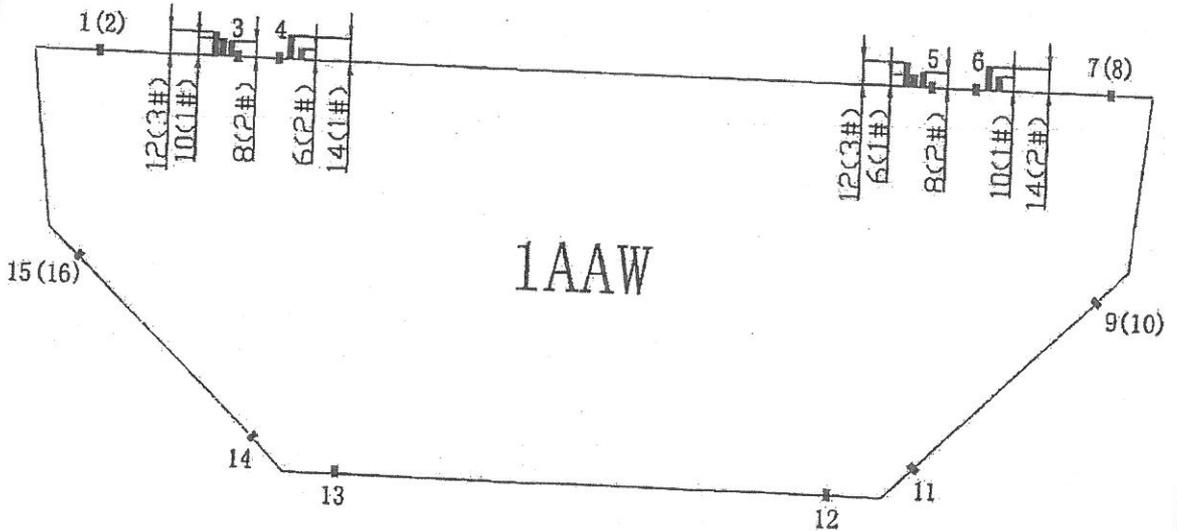
Ten transverse cracks were found by use of MT in material after removing lifting.

1、L=10mm; 2、L=8mm; 3、L=12mm; 4、L=14mm; 5、L=6mm; 6、L=6mm; 7、L=8mm; 8、L=12mm; 9、L=10mm; 10、L=14mm;

- 1. The tack crack was caused during assembly lifting, and cracks extended to base metal after removing lifting.
- 2. Welding contraction stresses and insufficient preheat and post heat control caused the crack.

- 1. 采用打磨的方式去除裂纹;
 - 2. 准备一个正确的接头型式, 具体参照相应的返修WPS;
 - 3. VT和MT检测确认返修区域没有裂纹;
 - 4. 根据批准的返修焊接工艺规程
 - 5. 预热温度应不小于100℃,
 - 6. 预热范围在修补区域周围不应小于150mm;
 - 7. 将修补区域打磨与母材或相邻焊缝平齐;
 - 8. 对修补区域做VT与MT检测.
- 1. Remove the crack by means of grinding.
 - 2. Prepare excavation according to the approved repair WPS.
 - 3. Verify with VT and MT repair areas are crack free.
 - 4. Preheat and weld according to the approved repair WPS.
 - 5. Preheat prior to welding to a minimum temperature of 100°C
 - 6. The preheat area shall be a minimum of 150mm in all directions around the repair area.
 - 7. Grind the repaired area flush with base metal or the adjacent weld.
 - 8. Perform VT and MT of the repair areas.

- 加强装配和焊接时监控和控制, 减少点焊裂纹;
 - 在焊后严格控制其后热程序, 避免裂纹现象发生。
- Enhance supervision and controlling during assembly and welding to reduce tack welding cracks.
 - Enhance supervision during the post heating operation to avoid cracks.

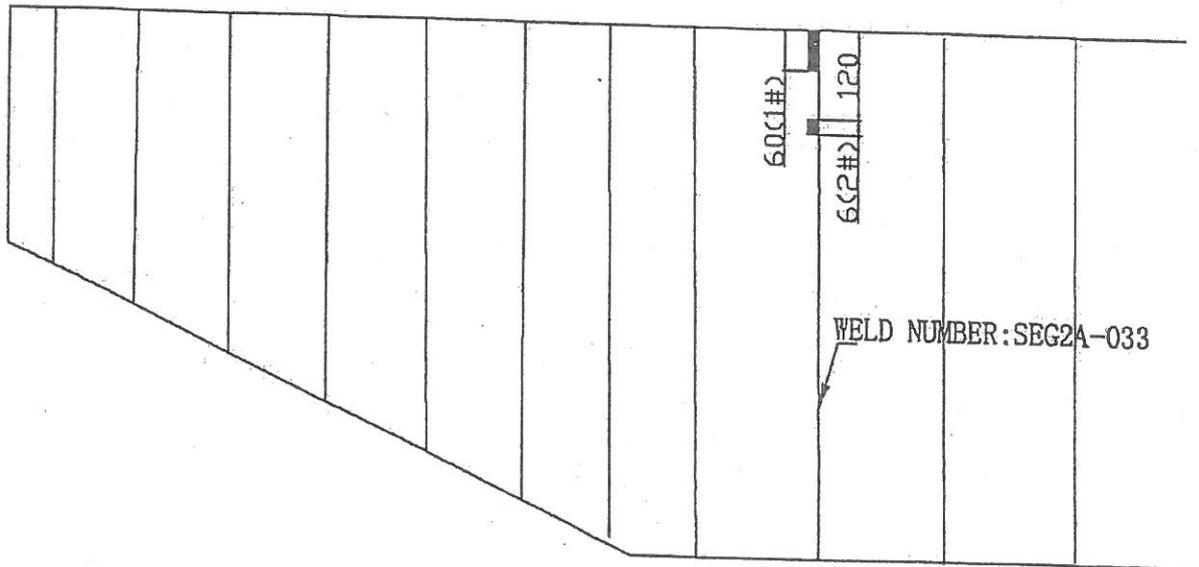
We found two longitudinal cracks in SEG2A-033.

1. 火焰加热时, 水汽没有完全的去掉或者这个区域预热不够;
1. Moisture wasn't completely removed during drying operation (preheating) or the area wasn't preheated sufficiently.

1. 采用打磨的方式去除裂纹;
 2. 准备一个正确的接头型式, 具体参照相应的返修WPS;
 3. VT和MT检测确认返修区域没有裂纹;
 4. 根据批准的返修焊接工艺规程
 5. 预热温度应不小于100℃;
 6. 预热范围在修补区域周围不应小于150mm;
 7. 将修补区域打磨与母材或相邻焊缝平齐;
 8. 对修补区域做VT与MT检测。
1. Remove the crack by means of grinding.
 2. Prepare excavation according to the approved repair WPS.
 3. Verify with VT and MT repair areas are crack free.
 4. Preheat and weld according to the approved repair WPS.
 5. Preheat prior to welding to a minimum temperature of 100°C
 6. The preheat area shall be a minimum of 150mm in all directions around the repair area.
 7. Grind the repaired area flush with base metal or the adjacent weld.
 8. Perform VT and MT of the repair areas.

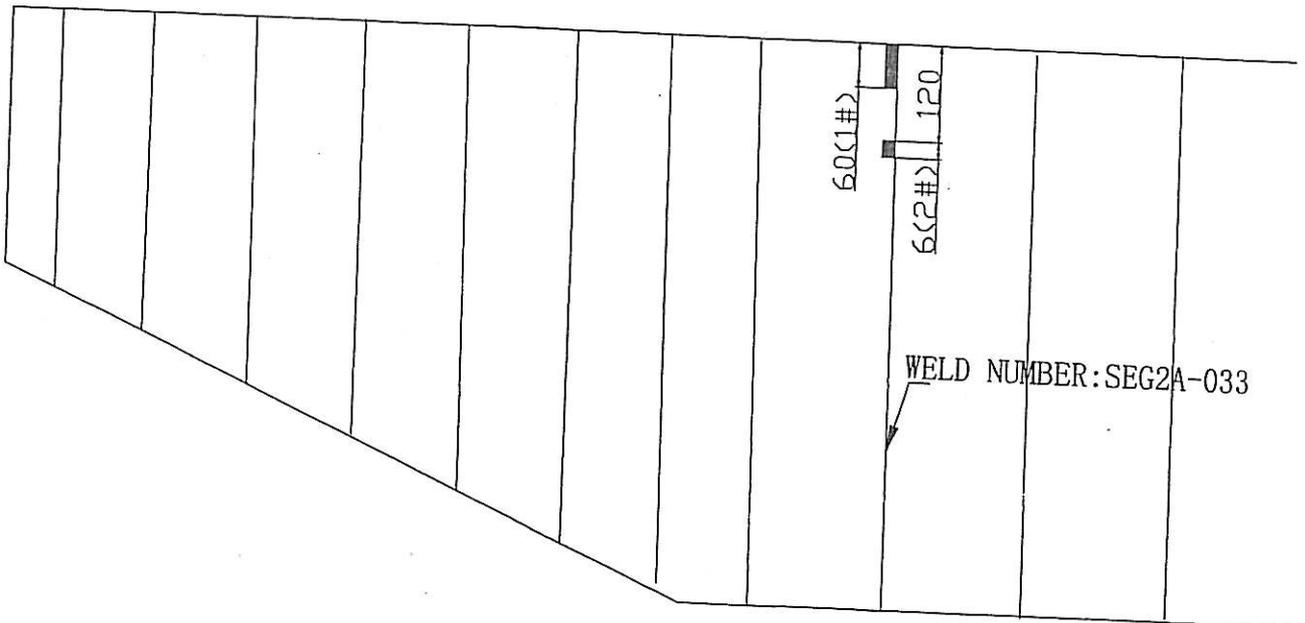
We found two longitudinal cracks in SEG2A-033.

1. 火焰加热时, 水汽没有完全的去掉或者这个区域预热不够;
1. Moisture wasn't completely removed during drying operation (preheating) or the area wasn't preheated sufficiently.

1. 采用打磨的方式去除裂纹;
 2. 准备一个正确的接头型式, 具体参照相应的返修WPS;
 3. VT和MT检测确认返修区域没有裂纹;
 4. 根据批准的返修焊接工艺规程
 5. 预热温度应不小于100℃,
 6. 预热范围在修补区域周围不应小于150mm;
 7. 将修补区域打磨与母材或相邻焊缝平齐;
 8. 对修补区域做VT与MT检测。
1. Remove the crack by means of grinding.
 2. Prepare excavation according to the approved repair WPS.
 3. Verify with VT and MT repair areas are crack free.
 4. Preheat and weld according to the approved repair WPS.
 5. Preheat prior to welding to a minimum temperature of 100°C
 6. The preheat area shall be a minimum of 150mm in all directions around the repair area.
 7. Grind the repaired area flush with base metal or the adjacent weld.
 8. Perform VT and MT of the repair areas.

1. QC shall verify sufficient preheat has been applied, to remove moisture, prior to welding.
