Contract #: 04-0120F4Cty: SF/ALA Rte: 80 PM: 13.2/13.9File #: 69.25B**QUALITY ASSURANCE -- NON-CONFORMANCE REPORT****Location:** Changxing Island, Shanghai, P.R. China**Report No:** NCR-000281**Prime Contractor:** American Bridge/Fluor Enterprises, a JV**Date:** 22-May-2009**Submitting Contractor:** Zhenhua Port Machinery Company, Ltd (ZPMC), Changxing Island**NCR #:** ZPMC-0255**Type of problem:**

**Reference Description:** Unidentifiable Filler Metal, Deck Panel Splice, Segment 8BE**Description of Non-Conformance:**

## NON-CONFORMANCE REPORT TRANSMITTAL

**Job Name:** SAS Superstructure

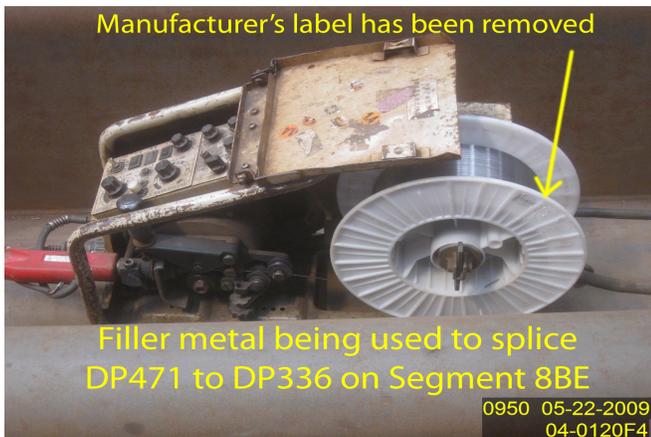
Caltrans Quality Assurance (QA) Inspector observed a spool of flux cored arc welding (FCAW) filler metal that was unidentifiable due to the labels being removed. The filler metal was being used for tack welding of a complete joint penetration (CJP) weld using FCAW Process in the 1G position on deck panel splice weld joint SEG046-008 (DP471 to DP336 on Segment 8BE). The welder was identified as Song Wei Rong #056205. When QA Inspector inquired about the unidentifiable filler metal, the welder removed the spool and walked away with it. QA Inspector observed approximately 50% of the filler metal had already been used.

AWS D1.5, 2002, Section 6, Paragraph 6.5.3: "The Inspector shall make certain that electrodes are used only in the positions and with the type of welding current and polarity for which they are classified."

Unidentifiable materials or materials not accepted to be used shall not be incorporated into production work. A response for the resolution of this issue is expected within 14 days.

Perform repair by removing the weld and re-weld. Confirm the repair with NDT.

ZPMC has completely removed the weld, inspected it and found it acceptable.
