QUALITY ASSURANCE -- NON-CONFORMANCE REPORT

Location: Changxing Island, Shanghai, P.R. China**Report No:** NCR-000284**Prime Contractor:** American Bridge/Fluor Enterprises, a JV**Date:** 19-May-2009**Submitting Contractor:** Zhenhua Port Machinery Company, Ltd (ZPMC), Changxing Island**NCR #:** ZPMC-0258**Type of problem:**

Reference Description: Missed MT/VT by QC, Segment 1AAE**Description of Non-Conformance:**

NON-CONFORMANCE REPORT TRANSMITTAL

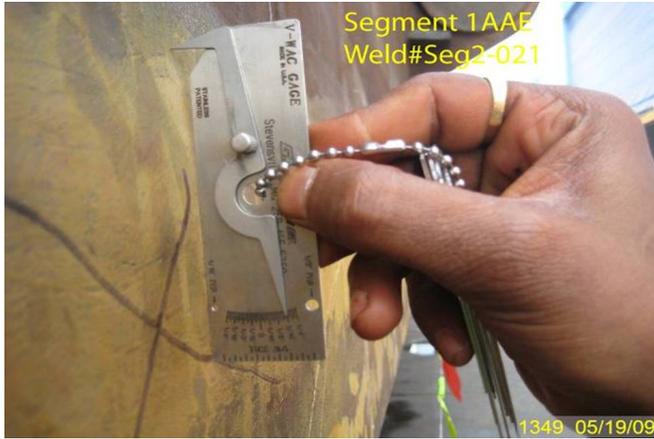
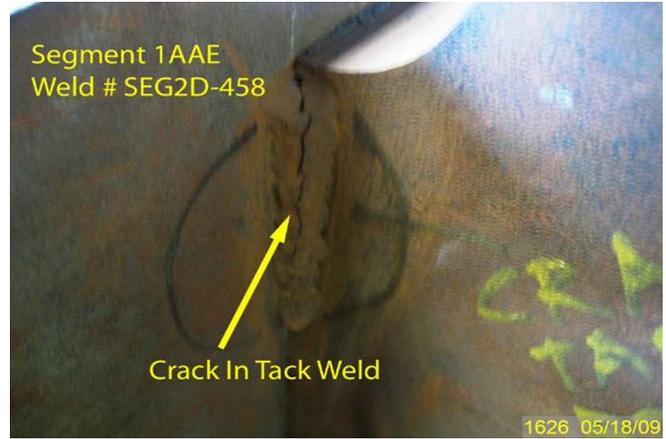
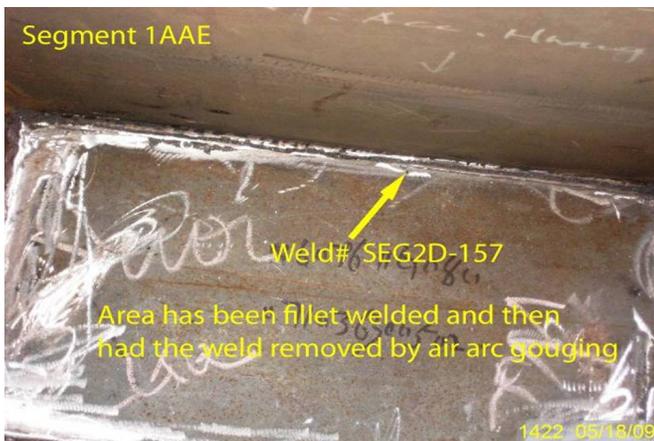
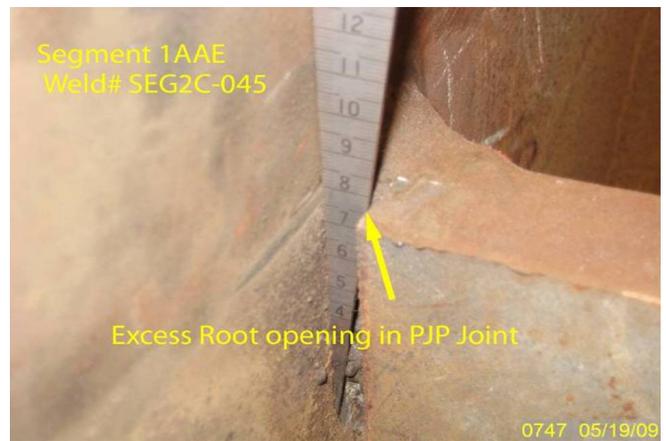
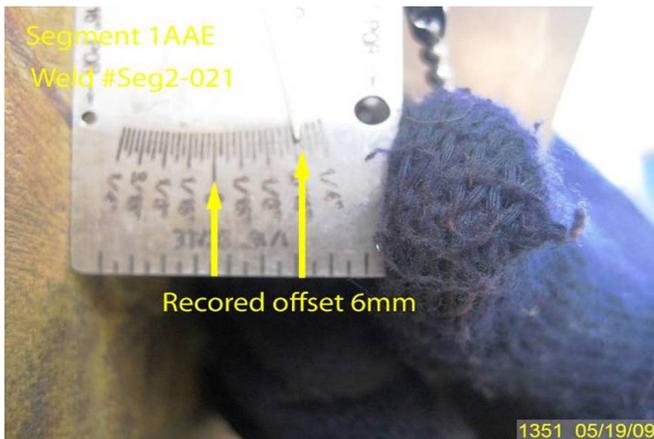
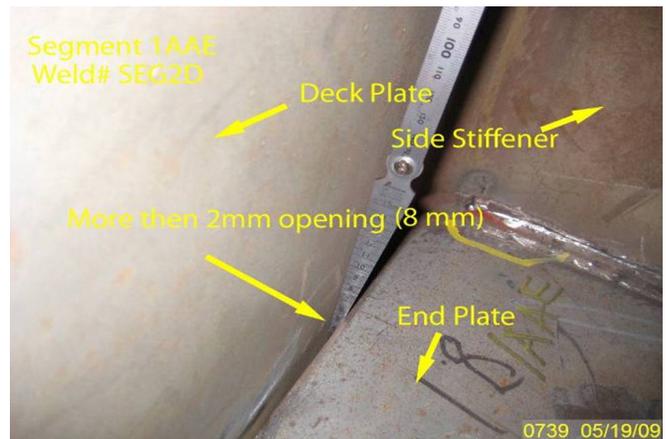
- Four linear indications (transverse) were discovered by MT on weld joint# Seg2-036 (corner assembly joint). After removing the indications by grinding, the resulting weld was accepted by ZPMC-QC and Caltrans-QA.

- Joint offset (misalignment) was found in weld #Seg2-021 and Seg2-019. The measured offset is approximately 5mm.
- SEG2C-045 - PJP weld root opening is approximately 8 mm. SEG2E-137 - PJP weld root opening exceeds allowable tolerances of WPS-B-T-2333-Tc-U4b-F.

- SEG2E-458- Crack in tack weld
- SEG2D-157- Drawings require tight fit. The joint has been fillet welded. The weld has been removed by arc gouging resulting in base metal damage. This area cannot be measured for compliance with the tolerances for tight fit due to melted weld metal and base metal at the joint.

- SEG2D- The fit-up at the end plate and deck plate exceeds the allowable 2mm tolerance. The measured gap is approximately 8mm.

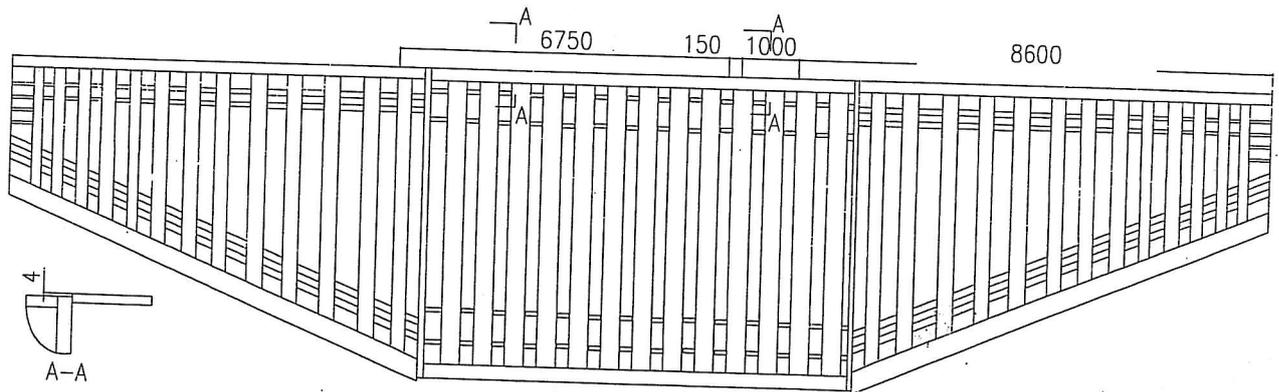
Draft of Welding Discontinuity:

The welder operated error caused welding distortion.

4. 采用外力调整错边量及平整度到公差要求的范围内;
 5. 根据相应的返修WPS准备焊接接头;
 6. 根据相应的WPS预热及焊接;(先焊接端封板及顶板筋板之间焊缝)
 7. 打磨返修区域使与周边母材平滑过渡;
 8. 根据图纸要求对返修区域进行VT及NDT检测。
1. Gouge the misaligned weld between end bulkhead and deck stiffener to the depth of about 20mm(No gouging through), and then divide the weld by heat cutting. (The cutting gap shall be as soon as narrow.) Preheat prior to gouging according to the WPS and note not to damage base metal.

2. Remove the fillet weld between deck stiffener and stiffeners in the repaired area by grinding and gouging. Preheat prior to gouging according to the WPS.

3. Remove the defects by grinding and perform MT.
 4. Adjust the misalignment and flatness to meet the requirement of shop drawing by outer force.
 5. Prepare the excavation according to the WPS.

6. Preheat and weld according to the WPS.(Perform welding between end bulkhead and deck stiffener first.)
 7. Grind the repaired area flush to base metal.

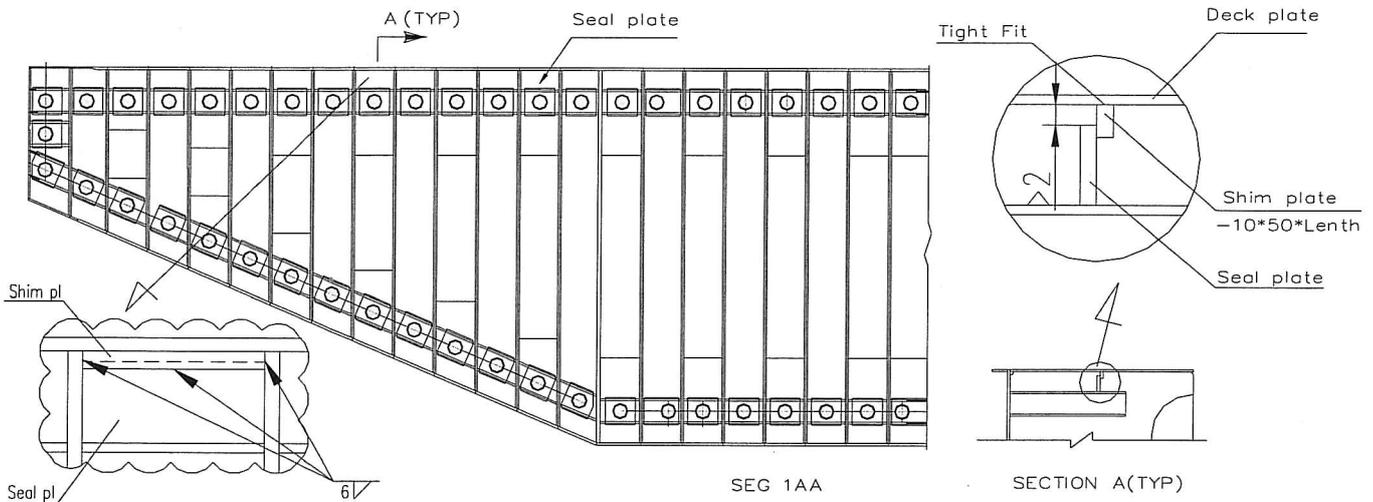
During fabrication of 1AA, in the drawings of SEG1C, SEG1D, SEG2C, SEG2D, it should be tight fit between seal plates and deck plate, but shop workers missed the requirements when fitting. That led to excessive fit-up gap. For the fit-up gap >2mm, we propose to add a shim plate (A709M-345T2) tight fit to deck plates (no weld, sealed with silicone). The shim plates will be 6mm fillet welded with the seal plates and end stiffeners. For details, see the following fig.

The proposed fill plate size and welds are acceptable for the specified repair. The fillet welds on both sides should have a 2 to 5mm holdback to avoid connecting to the deck. Please note pre-approved material should be used for caulking the tight-fit end.
