Contract #: 04-0120F4Cty: SF/ALA Rte: 80 PM: 13.2/13.9File #: 69.25B**QUALITY ASSURANCE -- NON-CONFORMANCE REPORT****Location:** Changxing Island, Shanghai, PRC**Report No:** NCR-000285**Prime Contractor:** American Bridge/Fluor Enterprises, a JV**Date:** 28-May-2009**Submitting Contractor:** Zhenhua Port Machinery Company, Ltd (ZPMC), Changxing Island**NCR #:** ZPMC-0259**Type of problem:**

Reference Description: Inadequate pre-heat on North Tower, Lift 2, Skin A Doubler Plate**Description of Non-Conformance:**

Subject: NCR No. ZPMC-0259

Job Name: SAS Superstructure

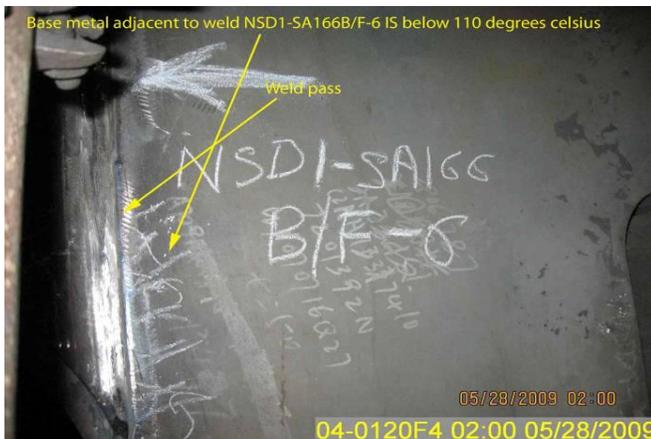
QA observed ZPMC personnel welding North Tower, Lift 2, Skin A doubler plate weld NSD1-SA166B/F-6 without preheating the weld and adjacent base material.

Welding procedure WPS-B-T-4332-TC-P6-F requires a minimum base material preheat temperature of 180 degrees Celsius.

ABF QCM has informed ZPMC QA and QC to first educate the person (s) performing the pre-heat of the WPS requirements to pre-heat based on material thickness and that tack welding has the same requirements as the balance of the welding. ABF QCM has explained the consequences of hydrogen embrittlement and that these thicker materials should be heated from the opposite side to ensure through thickness heat distribution as materials at these thicknesses lend themselves to cooling faster than thinner materials. ZPMC will provide the inspection documentation for this weld at a later date for close out.

The Non-Destructive Testing (NDT) for these welds should be at least 72 hours after welding to ensure that there are no delayed cracks from any possible hydrogen contamination.

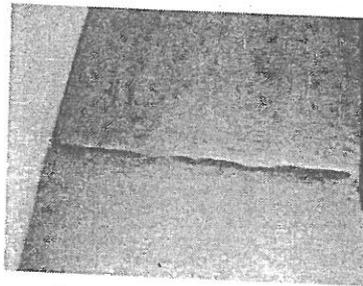
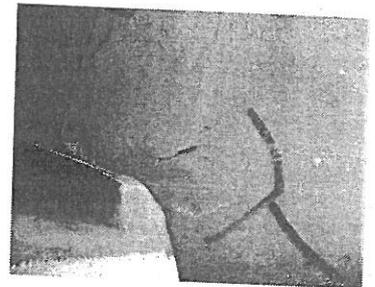
Draft of welding discontinuity:

东塔第一吊装段AE角嵌补块与隔板对接缝背面衬垫由于长度不够、返修等原因造成了焊缝出现了多处不连续，需进行返修(注:18M,23M,33M,28M,43M,47.6M均有不同程度的损伤)，现已涂油漆.如图:
Several discontinuity was found at east tower first lifting corner AE flg plate and diaphragm butt weld, and needed to repair(remark: the base metal was gouged at 18m, 23m, 33m, 28m, 43m, 47.6m), and has finished paint, see the draft.

The backing was shorter than weld length, so it can't weld total weld caused discontinuity defects.

- 1、Grind the building-up area;
- 2、Preheat and weld passes temperature according to the approved WPS, it should be 2-3mm than the theory size;
- 3、Grind the weld area smoothly after repairing;
- 4、Perform 100%MT and 100%UT to the repair area.

Enhance supervision in process of welding, and backing shall cover total weld during welding.

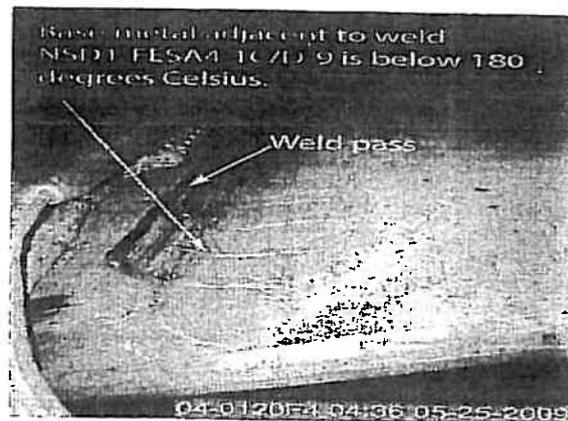
QA observed ZPMC personnel welding North Tower, Skin E, Lift 3 doubler plate welds NSD1-FESA3-1D/D-9, NSD1-FESA3-1DD-18 and NSD1-FESA3-1C/D-9 without the required base metal preheat. The photographs below indicate an unmelted 180 degree Celsius temperature indicating crayon adjacent to welds NSD1-FESA3-1C/D-9 and NSD1-FESA3-1D/D-9.

Welding procedure WPS B-T-4332-TC-P6-F requires a minimum base material preheat temperature of 180 degrees Celsius.

Propose a resolution for the identified non-conformance including documentation that the welds placed are in compliance with the contract requirements. In addition to the material/workmanship non-conformance, propose a resolution that addresses the failure of Quality Control to identify the lack of preheat of the base material. Provide documentation of the steps taken by the Quality Control Manager to prevent future occurrences.

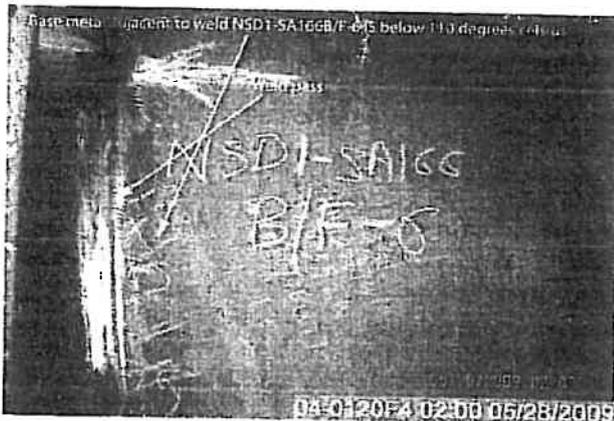
QA observed ZPMC personnel welding North Tower, Lift 2, Skin A doubler plate weld NSD1-SA166B/F-6 without preheating the weld and adjacent base material.

Welding procedure WPS-B-T-4332-TC-P6-F requires a minimum base material preheat temperature of 180 degrees Celsius.
