Contract #: 04-0120F4Cty: SF/ALA Rte: 80 PM: 13.2/13.9File #: 69.25B**QUALITY ASSURANCE -- NON-CONFORMANCE REPORT****Location:** Changxing Island, Shanghai, P.R. China**Report No:** NCR-000287**Prime Contractor:** American Bridge/Fluor Enterprises, a JV**Date:** 27-May-2009**Submitting Contractor:** Zhenhua Port Machinery Company, Ltd (ZPMC), Changxing Island**NCR #:** ZPMC-0261**Type of problem:**

Reference Description: Missed UT by QC, Weld SB003-026-061**Description of Non-Conformance:**

Job Name: SAS Superstructure

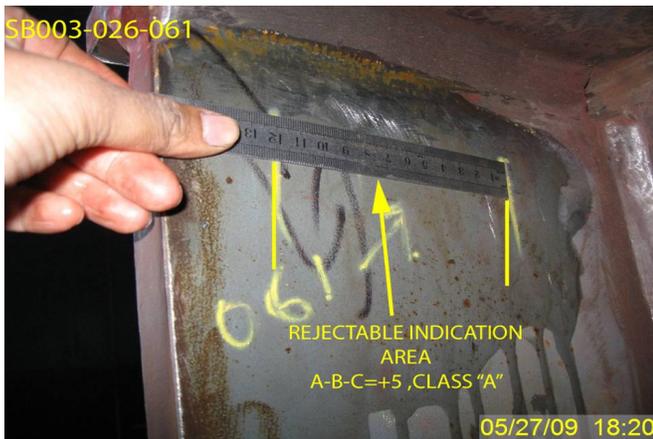
Caltrans Quality Assurance (QA) Inspector performed verification ultrasonic testing (UT) on Weld Joint SB003-026-061 for Suspender Bracket SB003-026. QA Inspector discovered a class "A" rejectable indication measuring approximately 120mm in length. This weld was previously tested and accepted by ZPMC Quality Control UT technicians.

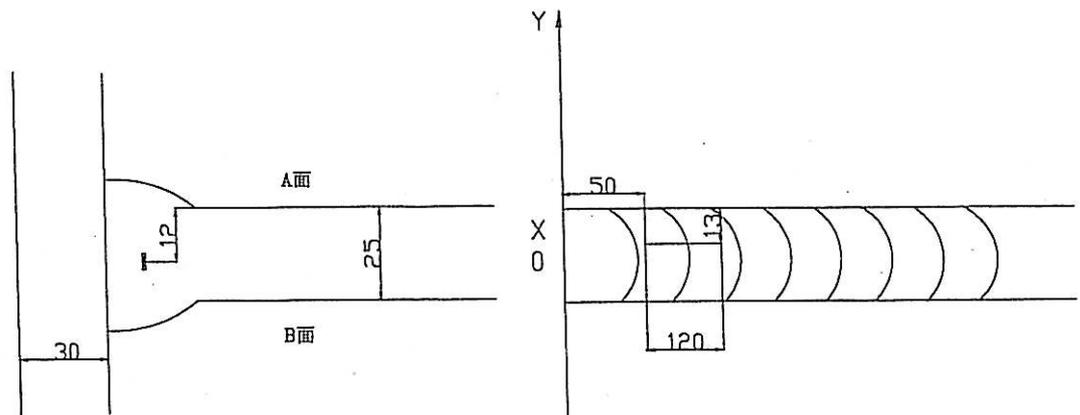
WELD NUMBER: SB003-026-061

Rejected indication found by ultrasonic inspection is less than the maximum allowance aggregate length.

1. Did not clear the weld pass completely in time.

1. Gouge or grind from nearer side from metal edge ($D \leq 0.65T$, "D" is depth of defects, "T" is thickness of metal) to remove all defects;

2. Follow repair WPS for joint preparation, preheat, and weld deposit;

3. Verify with VT no defects remain in the weld joint prior to welding;

4. Grind the repaired area flush with base metal or the adjacent weld;

5. Check the welds according to the working drawings.
