QUALITY ASSURANCE -- NON-CONFORMANCE REPORT

Report No: NCR-000316

Reference Description: Missed MT Indications by QC, Segment 6AE

Job Name: SAS Superstructure

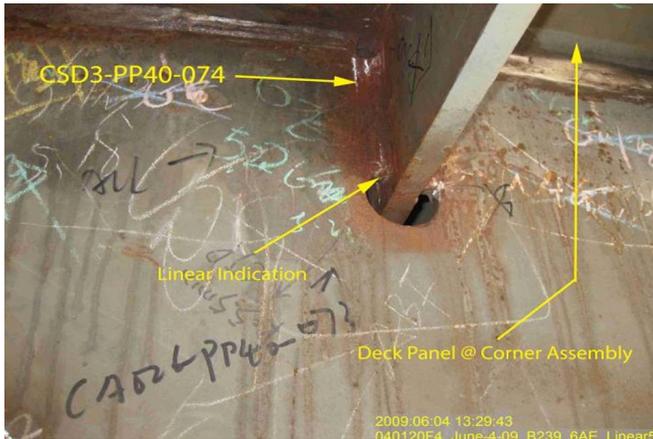
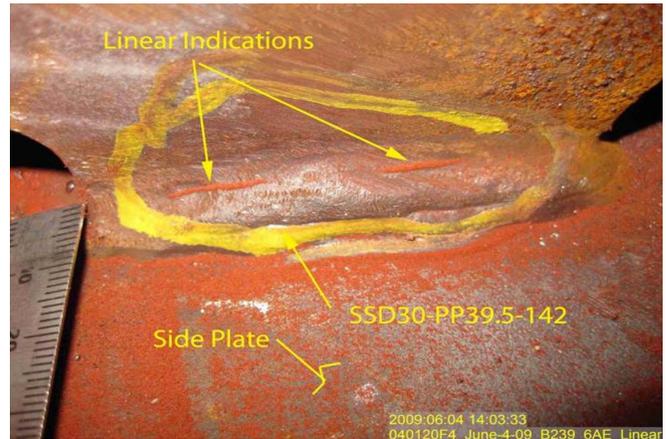
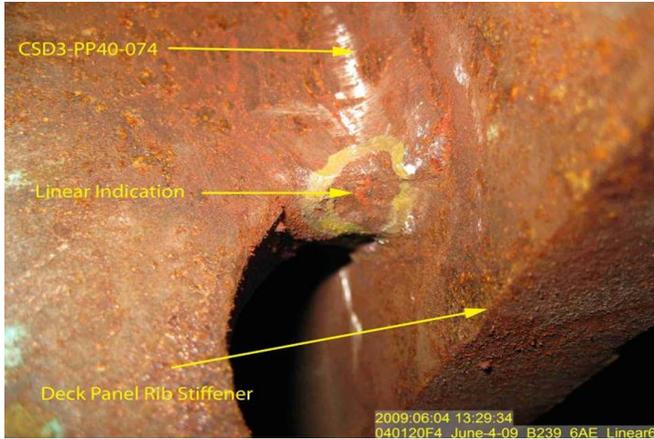
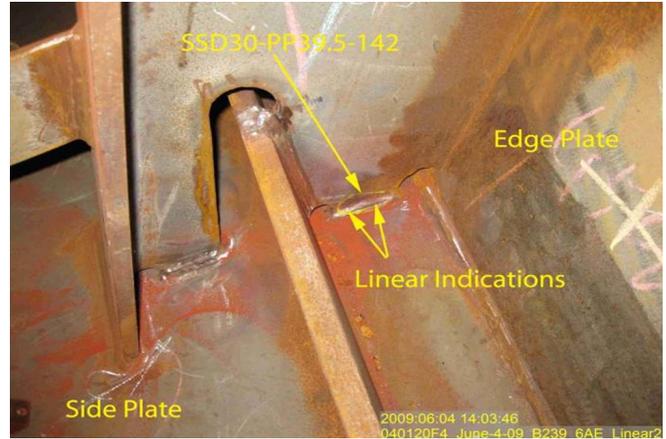
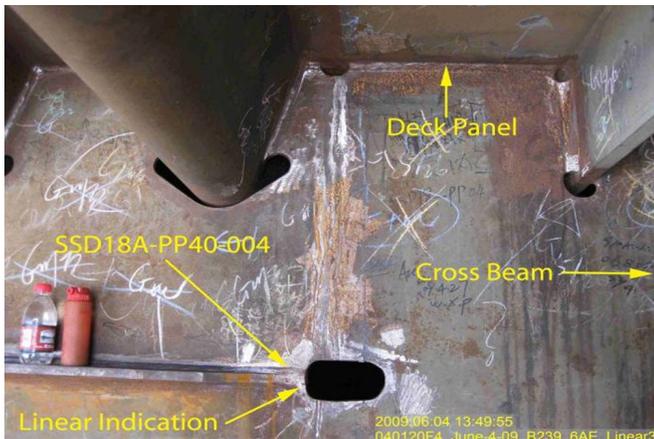
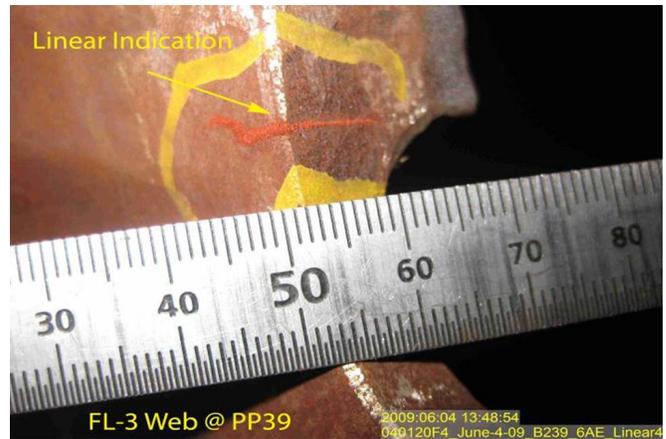
During random verification magnetic particle testing (MT) of the internal components of OBG Segment 6AE, Caltrans Quality Assurance (QA) Inspector discovered a total of five (5) linear indications ranging from 10 to 40mm in length in the following welds: SSD18A-PP40-004, SSD17A-PP39-003, CSD3-PP40-074 and SSD30-PP39.5-142. These welds have been previously tested and accepted by ZPMC Quality Control (QC) MT technicians.

AWS D1.5 (02) Section 6.26.2 – “Welds that are subject to MT in addition to visual inspection shall have no cracks.”

ABF has notified ZPMC of the missed MT indications and ZPMC has completed the necessary repairs. ABF has taken action by hiring several MT technicians to perform overchecks of several types of welds due to the amount of missed indications. ABF is also conducting an investigation of why ZPMC is experiencing cracking of welds. This investigation is being performed by both onsite ABF personnel as well as welding experts hired by ABF for this purpose. Recently CT has brought in their own welding consultant to discuss ABF findings and preventive actions. Preventive actions such as increased preheats have been discussed with ZPMC. When the investigation is completed, ABF will submit the findings to ZPMC and CT. ABF will continue to perform overchecks until we are sure this issue is corrected and preventive actions are implemented. ZPMC will submit the repair documents at a later date to close this NCR.

ZPMC has repaired these indication using grinding and is attaching NDT reports to show that the welds are acceptable. ZPMC has conducted training with its inspectors to decrease occurrences of missed indications. Based on this ZPMC requests closure of this NCR.

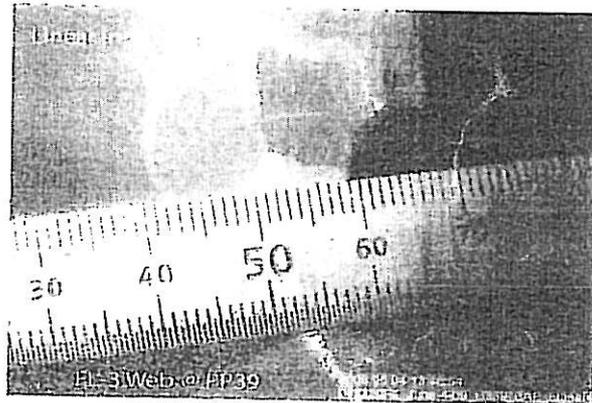
During random verification magnetic particle testing (MT) of the internal components of OBG Segment 6AE, Caltrans Quality Assurance (QA) Inspector discovered a total of five (5) linear indications ranging from 10 to 40mm in length in the following welds: SSD18A-PP40-004, SSD17A-PP39-003, CSD3-PP40-074 and SSD30-PP39.5-142. These welds have been previously tested and accepted by ZPMC Quality Control (QC) MT technicians.

AWS D1.5 (02) Section 6.26.2 – “Welds that are subject to MT in addition to visual inspection shall have no cracks.”

Repair indications and perform NDT required to verify weld quality.

Contractor submitted NDT reports verifying the welds are now in conformance with Contract specifications. An internal NCR was issued by the Contractor and additional training was provided for NDT Technicians in regards to this issue.
