QUALITY ASSURANCE -- NON-CONFORMANCE REPORT

Report No: NCR-000319

Reference Description: Missed MT indications on West Tower, Lift 1 access portal doubler plate

To: AMERICAN BRIDGE/FLUOR, A JV **Date:** 15-Jun-2009
 375 BURMA ROAD
 OAKLAND CA 95607 **Contract No:** 04-0120F4
 04-SF-80-13.2 / 13.9
Dear: Mr. Charles Kanapicki **Job Name:** SAS Superstructure
Attention: Mr. Thomas Nilsson Project/Fabrication Manager **Document No:** 05.03.06-000282
Subject: NCR No. ZPMC-0293

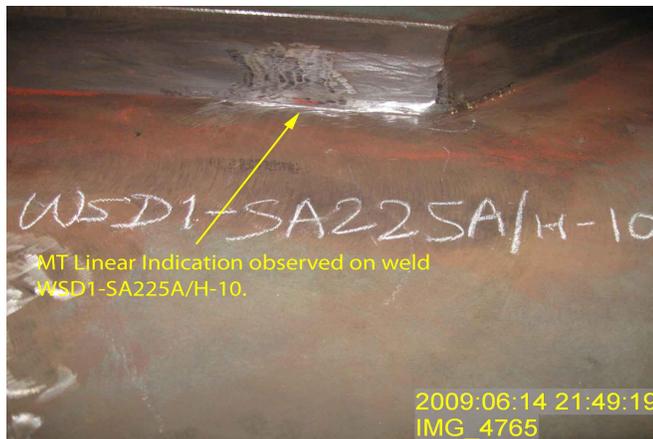
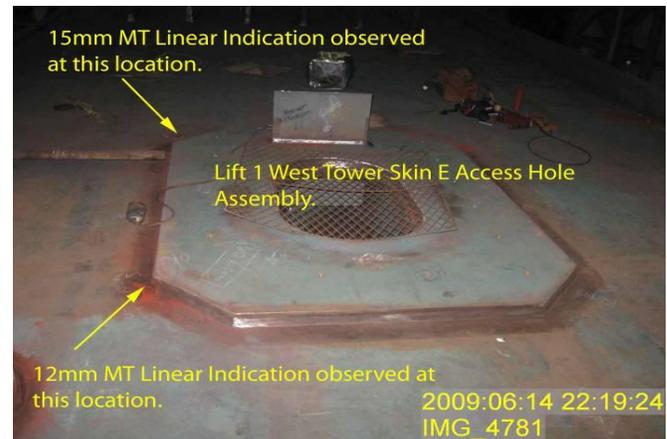
QA discovered two linear indications, 15mm and 12mm in length, during random Magnetic Particle Testing (MT) of Lift 1, West Tower, Skin E, access portal doubler plate weld WSD1-SA225A/H-10. This weld was previously tested and accepted by ZPMC QC MT Technicians.

AWS D1.5-2002 Section 6.26.2 – “Welds that are subject to MT in addition to visual inspection shall have no cracks.”

Propose a resolution for this systematic non-conformance that addresses the failure of Quality Control to identify the linear indication (MT). Provide documentation of the steps taken by the Quality Control Manager to prevent future occurrences.

In addition to the Quality Control failure, propose a resolution for the identified material/workmanship non-conformance, documenting that the repaired weld is in compliance with the contract requirements.

Repair affected weld.

The affected weld has been repaired and a NDT report indicating a sound weld has been submitted. The weld has been verified by QA and green tagged.
