Contract #: 04-0120F4
 Cty: SF/ALA Rte: 80 PM: 13.2/13.9
 File #: 69.25B

QUALITY ASSURANCE -- NON-CONFORMANCE REPORT

Report No: NCR-000325

Reference Description: Missed MT Indication by QC, Base Metal of Deck Panel DP009A, Segment 3AW

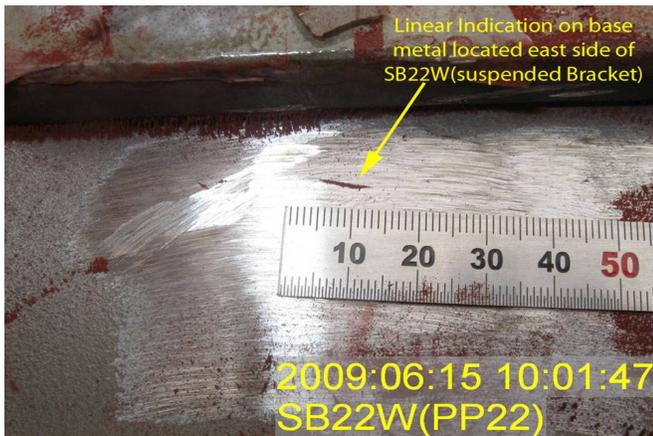
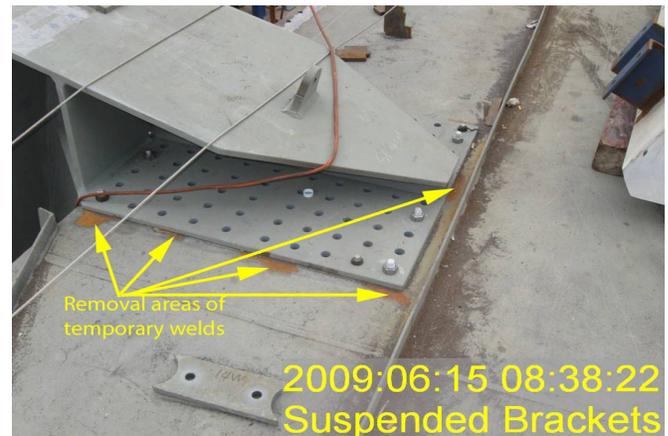
During random verification magnetic particle testing (MT) of temporary weld removal areas between suspender bracket SB22W and OBG Deck Panel DP009A, Caltrans Quality Assurance (QA) Inspector discovered a linear indication measuring 10mm in length located in the deck panel. One hundred percent (100%) of the temporary weld removal areas were MT tested and accepted by ZPMC Quality Control technicians.

AWS D1.5 (02) Section 3.3.7.4: "The removal of tack welds may expose unacceptably hard or cracked HAZs. Such areas on members subject to tension or reversal-of-stress shall be tested by MT (preferably by the yoke method) to assure that no cracks are present."

Grind and perform MT to make sure that the defect is removed.
