Contract #: 04-0120F4Cty: SF/ALA Rte: 80 PM: 13.2/13.9File #: 69.25B**QUALITY ASSURANCE -- NON-CONFORMANCE REPORT****Location:** Changxing Island, Shanghai, P.R. China**Report No:** NCR-000338**Prime Contractor:** American Bridge/Fluor Enterprises, a JV**Date:** 22-Jun-2009**Submitting Contractor:** Zhenhua Port Machinery Company, Ltd (ZPMC), Changxing Island**NCR #:** ZPMC-0312**Type of problem:****Welding****Concrete****Other****Welding****Curing****Procedural****Bridge No:** 34-0006**Joint fit-up****Coating****Other****Component:** OBG Segment 2AE**Procedural****Procedural****Description:****Reference Description:** T-Stiffener Misalignment, Side Panel, Segment 2AE**Description of Non-Conformance:**

Job Name: SAS Superstructure

Reference Description: T-Stiffener Misalignment, Side Panel, Segment 2AE

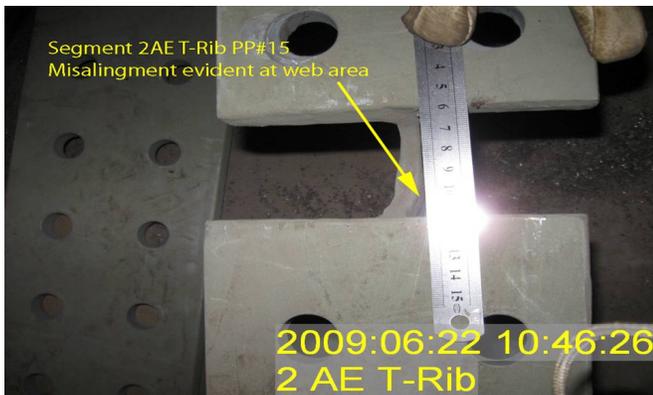
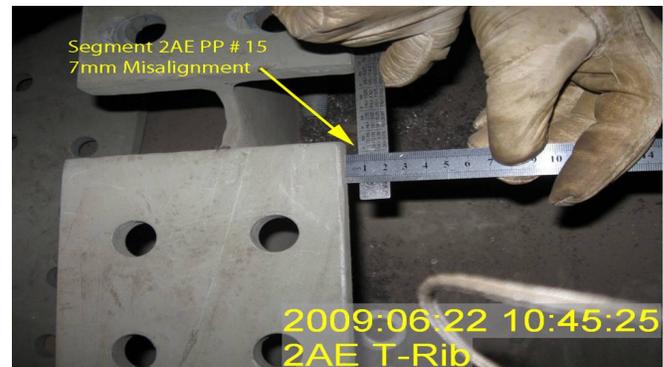
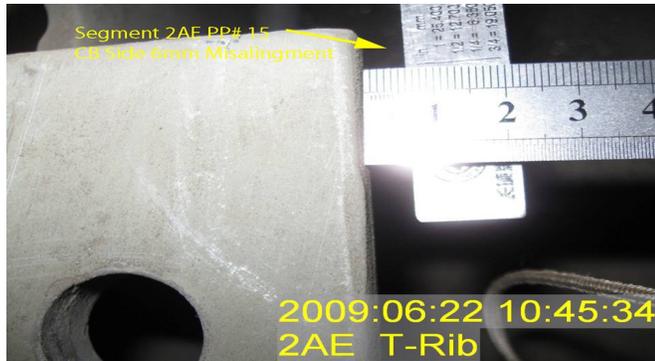
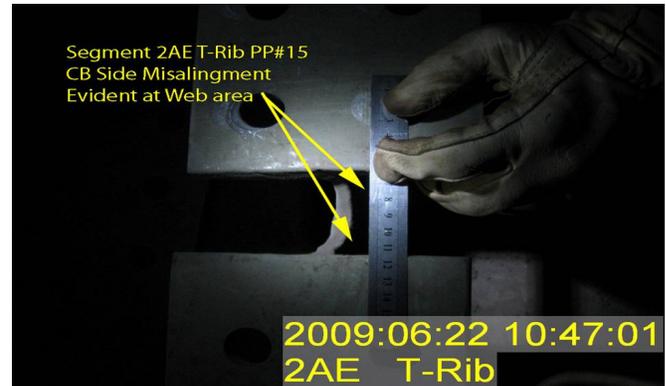
Caltrans Quality Assurance (QA) Inspector observed misalignment between T-stiffeners on the side panel of OBG Segment 2AE (crossbeam side) at Panel Point 15. The misalignment between T-stiffeners was measured to be 7mm.

AWS D1.5-2002, Section 3.3.3: "Parts to be joined by groove welds shall be carefully aligned. Theoretical alignment shall not exceed 10% of the thickness of the thinner part joined, but in no case shall be more than 3mm."

Caltrans Special Provisions, Section 10-1.59: "Steel Structure- Design Details-G.2- Misalignment between discontinuous members shall not exceed 10% of the thickness of the thinner member or 3mm, whichever is less."
"

The proposed resolution is acceptable. The stiffeners in question have subsequently been brought into alignment, and green tagged as shown in the attached documents. The Department concurs that Non-Conformance ZPMC-0312 is closed.

With this letter of response, ZPMC requests closure for Caltrans NCR-000338 (ZPMC-312). We agree what describe in the non-conformance report, and we have removed the complete weld of the T-rib and side plate, after adjusting the misalign we fix the right location and re-weld for the fillet joint. Meanwhile we have completed the final tight for the splice plate and got the green tag with the three parties.
