Contract #: 04-0120F4Cty: SF/ALA Rte: 80 PM: 13.2/13.9File #: 69.25B**QUALITY ASSURANCE -- NON-CONFORMANCE REPORT****Location:** Changxing Island, Shanghai, PRC**Report No:** NCR-000349**Prime Contractor:** American Bridge/Fluor Enterprises, a JV**Date:** 06-Jul-2009**Submitting Contractor:** Zhenhua Port Machinery Company, Ltd (ZPMC), Changxing Island**NCR #:** ZPMC-0323**Type of problem:****Welding****Concrete****Other****Welding****Curing****Procedural****Bridge No:** 34-0006**Joint fit-up****Coating****Other****Component:** OBG Segment 4BE**Procedural****Procedural****Description:****Reference Description:** Missed MT 4BE**Description of Non-Conformance:**

Job Name: SAS Superstructure

Subject: NCR No. ZPMC-0323

Reference Description: Missed MT 4BE

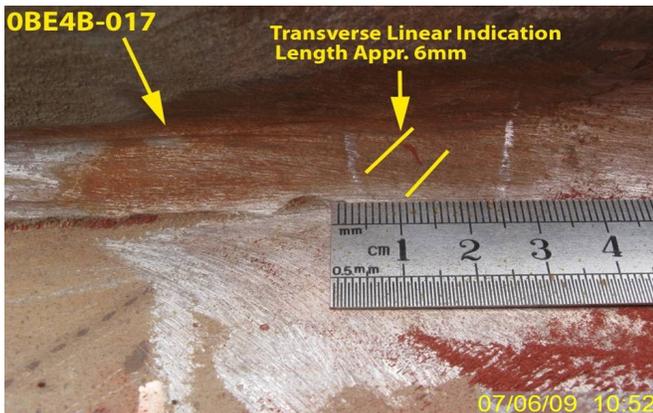
Caltrans Quality Assurance (QA) Inspector performed 15% verification Magnetic Particle Testing (MT) on weld joint identified as OBE4B-017 on Segments 4BE. QA Inspector discovered one rejectable transverse linear indication measuring approximately 6 mm in length. This weld was previously tested and accepted by ZPMC QC MT technicians. See MT report for this date.

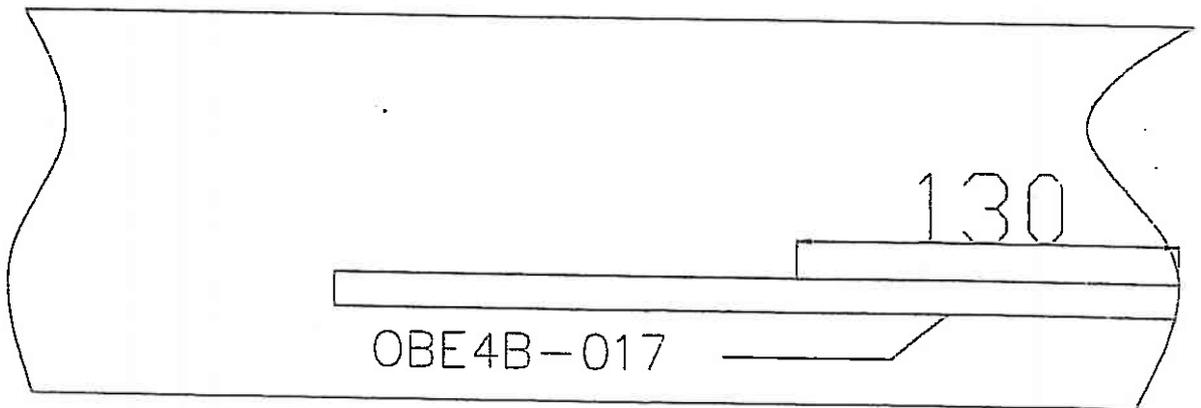
Draft of Welding Discontinuity:

One transverse crack was found by use of MT on OBE4B-017.

1. 火焰加热时, 水汽没有完全的去掉或者这个区域预热不够;
1. Moisture wasn't completely removed during drying operation (preheating) or the area wasn't preheated sufficiently.

1. QC and a Lead CWI shall have an approved copy of the CWR in hand prior to the repair.
2. Remove paint ≥ 25 mm in all direction of HAZ prior to MT.
3. Remove cracks by grinding, if gap > 5 mm is found while grinding, seek approval from engineer before next operation.
4. Prepare excavation in accordance with an approved repair WPS prior to welding.
5. Preheat and weld according to the approved repair WPS.
6. Grind the repaired area flush with base metal or the adjacent weld.
7. Perform relevant NDT inspection to all repaired welds as well as the welds which are in the opposite position of the repaired welds according to shop drawing and additional NDT requirement stated in special provision 10-1.59 "inspection testing" note 3 after repair.

PERFORM MT IN AREA SURROUNDING CRACK TO ENSURE CRACK
DID NOT PROPAGATE INTO BASE METAL.
