Contract #: 04-0120F4Cty: SF/ALA Rte: 80 PM: 13.2/13.9File #: 69.25B**QUALITY ASSURANCE -- NON-CONFORMANCE REPORT****Location:** Changxing Island, Shanghai, PRC**Report No:** NCR-000351**Prime Contractor:** American Bridge/Fluor Enterprises, a JV**Date:** 06-Jul-2009**Submitting Contractor:** Zhenhua Port Machinery Company, Ltd (ZPMC), Changxing Island**NCR #:** ZPMC-0325**Type of problem:****Welding****Concrete****Other****Welding****Curing****Procedural****Bridge No:** 34-0006**Joint fit-up****Coating****Other****Component:** OBG Segment 4BE**Procedural****Procedural****Description:****Reference Description:** Missed UT 4BE**Description of Non-Conformance:**

Job Name: SAS Superstructure

Subject: NCR No. ZPMC-0325

Reference Description: Missed UT 4BE

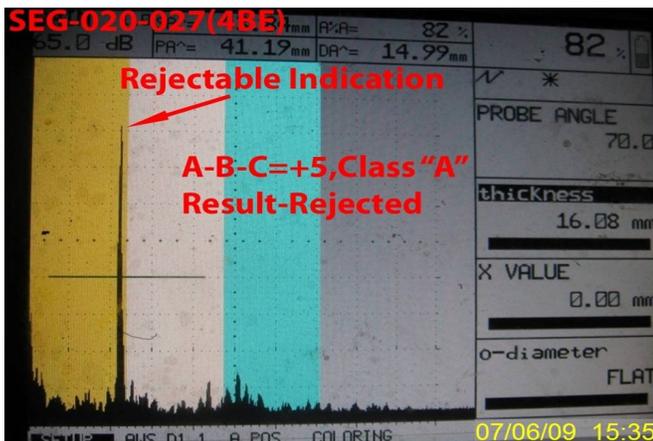
Caltrans Quality Insurance (QA) Inspector performed 10% verification Ultrasonic Testing (UT) after Heat Straightening area on weld joint SEG-020-027 of OBG Segment 4BE. QA Inspector discovered One class "A" rejectable indication measuring approximately 35 mm in length. This weld was previously tested and accepted by ZPMC QC UT technicians. See UT report for this date.

This work has already repaired according to the approved procedure.

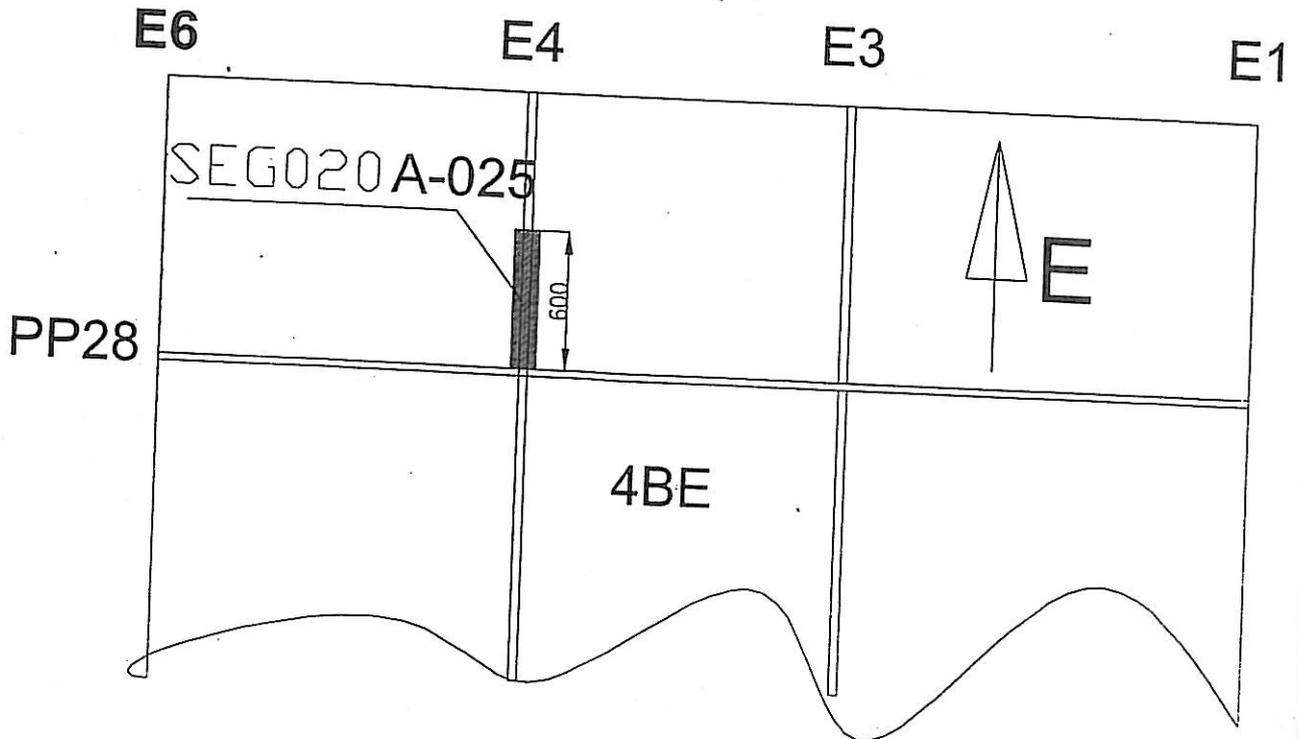
Draft of Welding Discontinuity:

The flatness was 4-14mm at 4BE bottom plate and side plate, 600mm in length, weld No: SEG020A-025.

Weld distortion and fabricate error.

4. 对焊接修补区域进行VT检测确认无缺陷存在;
 5. 根据批准的返修WPS焊接底板与斜底板焊缝, 并随时检测底板与斜底板平整度, 其次焊接纵桁与箱梁底板焊缝;
 6. 将返修处焊缝打磨与周边焊缝或母材平齐;
 7. 根据图纸要求进行检测。
1. Remove L weld between longitudinal diaphragm and bottom plate by use of gouging or cutting, remove L' weld between bottom plate and side plate, (Remark: the length(L、L') was according to flatness condition on site), preheat according to approved WPS before gouging;

2. Prepare a right joint and make the groove of bottom plate(side plate) and longitudinal diaphragm;
 3. Fix bottom plate and side plate by use of force(such as technology strut, fixture) to ensure flatness;

4. Perform VT to ensure the repair area free of defects before repair;
 5. Weld bottom plate and side plate weld according to approved WPS, inspect bottom plate and side plate weld flatness, then weld between longitudinal diaphragm and box side plate;

6. Grind repair area flush with adjacent weld or base metal;
 7. Perform inspection according to drawing requirement.
