Contract #: 04-0120F4Cty: SF/ALA Rte: 80 PM: 13.2/13.9File #: 69.25B**QUALITY ASSURANCE -- NON-CONFORMANCE REPORT****Location:** Changxing Island, Shanghai, PRC**Report No:** NCR-000353**Prime Contractor:** American Bridge/Fluor Enterprises, a JV**Date:** 16-Jul-2009**Submitting Contractor:** Zhenhua Port Machinery Company, Ltd (ZPMC), Changxing Island**NCR #:** ZPMC-0327**Type of problem:**

Bridge No: 34-0006**Component:** Side Panels SP623B, SP626A & SP626B**Reference Description:** Cope Holes**Description of Non-Conformance:**

NON-CONFORMANCE REPORT TRANSMITTAL

Subject: NCR No. ZPMC-0327

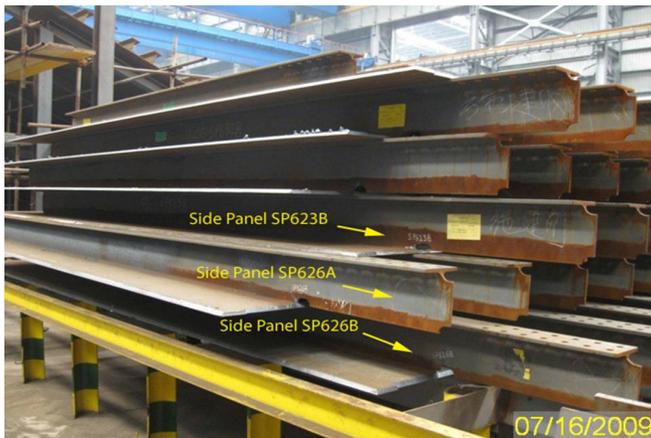
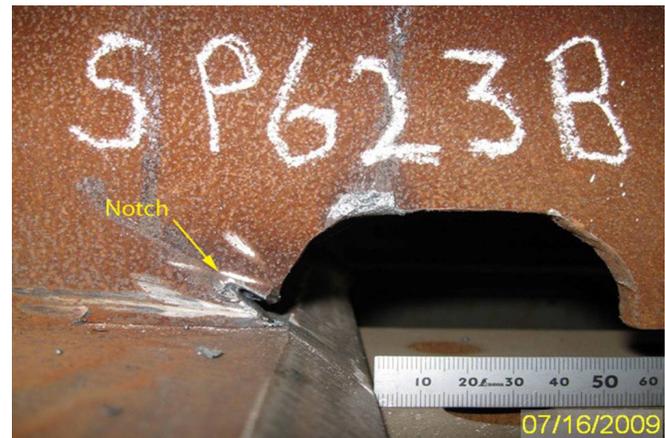
During random visual inspection, Caltrans Quality Assurance (QA) Inspector observed Weld Access Holes, which were removed via thermal cutting, were not finished in accordance with Section 3.2.5 of AWS D1.5. The components observed were located on Side Panels SP623B, SP626A, and SP 626B (currently located in Bay 14). These components were previously inspected and accepted by ZPMC personnel.

AWS D1.5 / 2002 – Section 3.2.5: “Radii of beam copes and weld access holes shall provide a smooth transition, free of notches or cutting past the points of tangency between adjacent surfaces.”

Finish in accordance with AWS D1.5.

Perform cope hole inspection / repair during segment assembly stage.
