Contract #: 04-0120F4
 Cty: SF/ALA Rte: 80 PM: 13.2/13.9
 File #: 69.25B

QUALITY ASSURANCE -- NON-CONFORMANCE REPORT

Location: Changxing Island, Shanghai, PRC **Report No:** NCR-000356
Prime Contractor: American Bridge/Fluor Enterprises, a JV **Date:** 12-Jul-2009
Submitting Contractor: Zhenhua Port Machinery Company, Ltd (ZPMC), Changxing Island **NCR #:** ZPMC-0330

Reference Description: CA Open Rib Stiffeners on OBG Segment 8AE

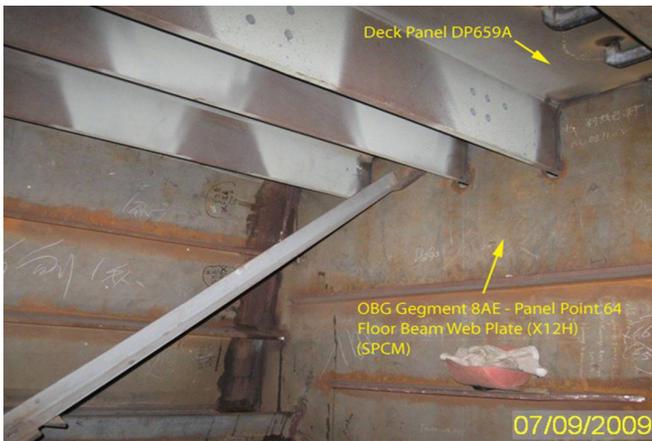
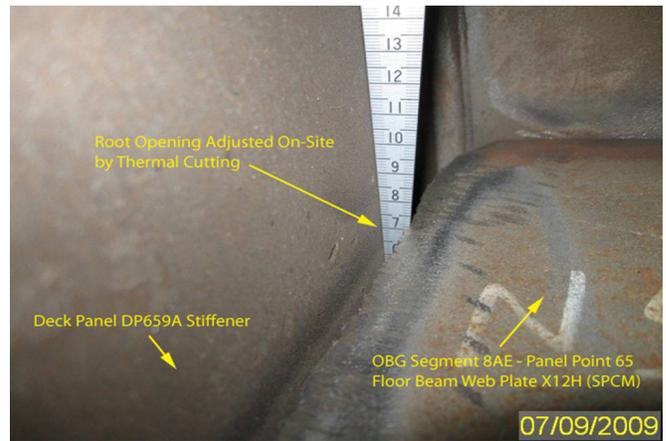
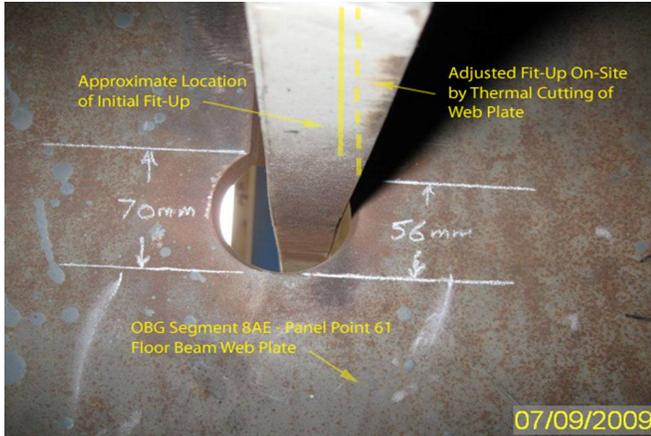
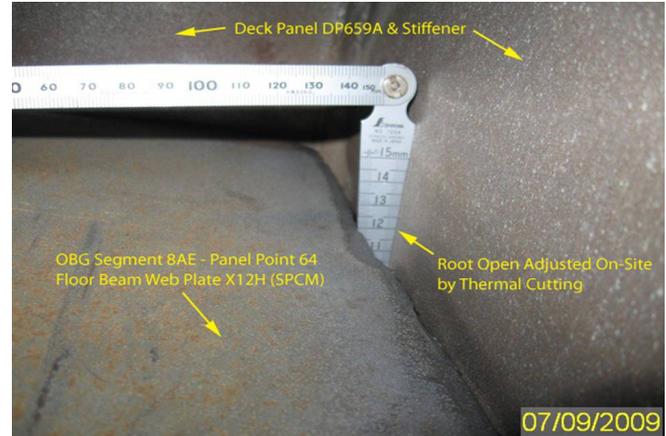
Caltrans Quality Assurance (QA) Inspector observed Thermal Cutting of Floor Beam Web Plates to allow fit-up of Panel Stiffeners in OBG Segment designated as 8AE on the Crossbeam side between Panel Points 61 and 64. This process created excessive root openings which will apparently prohibit ZPMC from completing the welding process with the specified fillet welds.

3.3.1: “The parts to be joined by fillet welds shall be brought into as close contact as practicable. The root opening shall not exceed 5mm (3/16”).”

Submit repair procedure for approval.

Gaps greater than 5mm require build up by buttering the plate edge to an acceptable gap or changing the joint configuration to a CJP to a pre-approved procedure. Prior to performing CJP welding ZPMC/ABF is required to notify the engineer. ZPMC will submit repair reports at a later date to close this NCR.

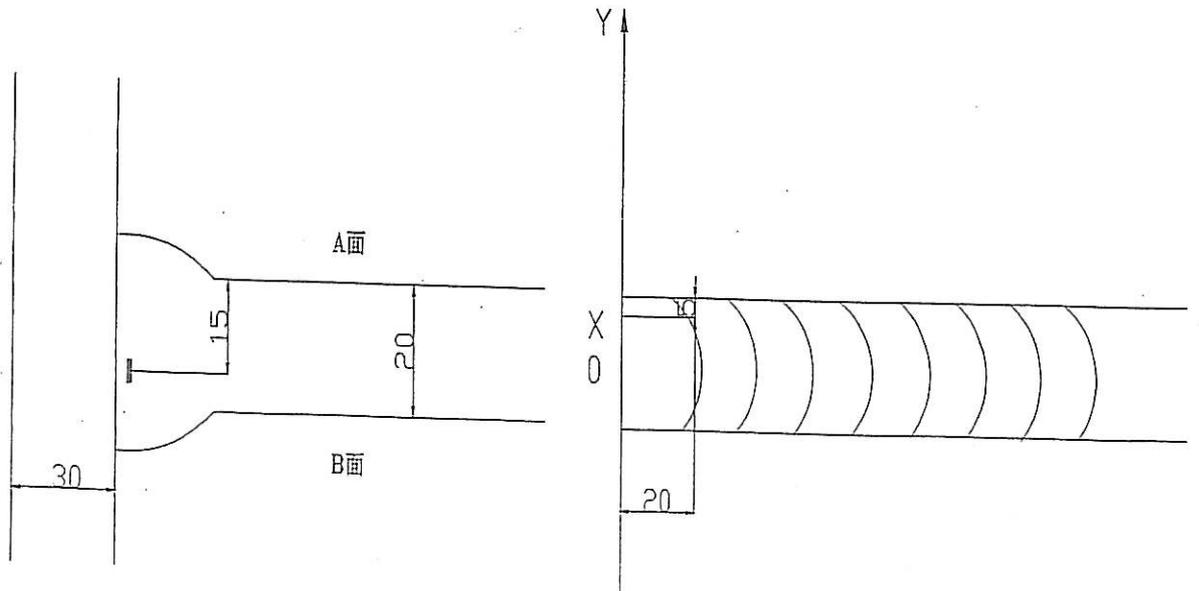
WELD NUMBER: SSD18-PP064-140

Rejected indication found by ultrasonic inspection is less than the maximum allowance aggregate length.

1. 焊道未及时处理干净。
1. Did not clear the weld pass completely in time.

1. 从缺陷距离端面较近一侧 ($D \leq 0.65T$, D 为缺陷深度, T 为板厚) 采用碳刨或打磨的方法去除焊缝缺陷;
 2. 参照返修焊接工艺规程 (WPS) 准备正确的接头型式, 预热和焊接;
 3. 焊前对修补区域进行VT检测保证缺陷完全被清除;
 4. 将修补区域打磨到与母材或邻近焊缝平齐;
 5. 根据批准的车间图纸检查焊缝.
-
1. Gouge or grind from nearer side from metal edge ($D \leq 0.65T$, "D" is depth of defects, "T" is thickness of metal) to remove all defects;
 2. Follow repair WPS for joint preparation, preheat, and weld deposit;
 3. Verify with VT no defects remain in the weld joint prior to welding;
 4. Grind the repaired area flush with base metal or the adjacent weld;
 5. Check the welds according to the working drawings.

1. Improve monitoring of welding and interpass cleaning.

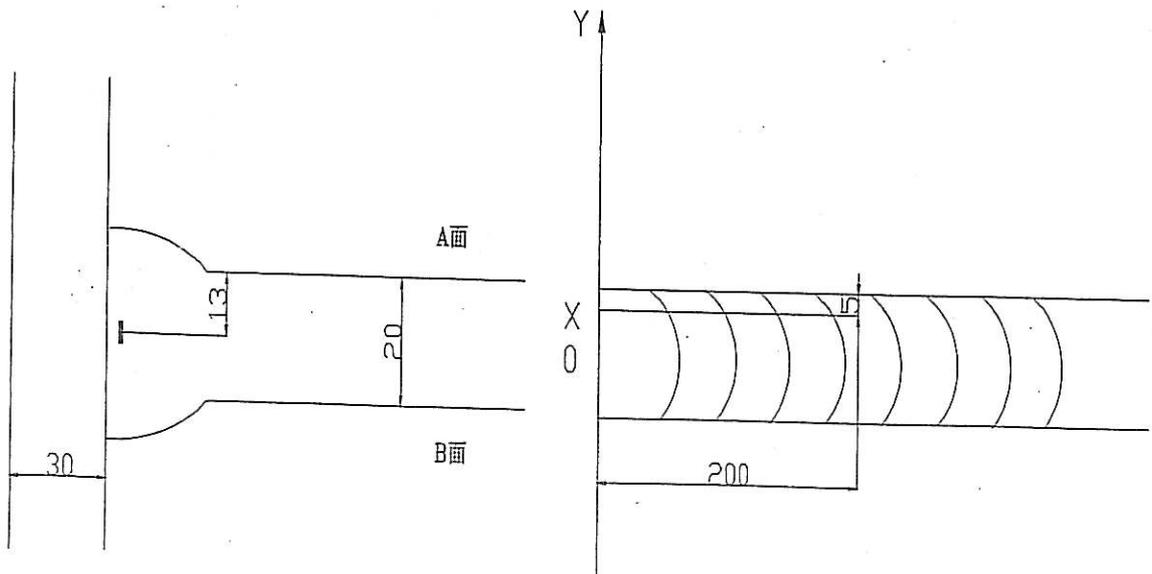
WELD NUMBER: SSD18-PP064-146

Rejected indication found by ultrasonic inspection is less than the maximum allowance aggregate length.

1. 焊道未及时处理干净。
1. Did not clear the weld pass completely in time.

1. 从缺陷距离端面较近一侧 ($D \leq 0.65T$, D为缺陷深度, T为板厚) 采用碳刨或打磨的方法去除焊缝缺陷;
 2. 参照返修焊接工艺规程 (WPS) 准备正确的接头型式, 预热和焊接;
 3. 焊前对修补区域进行VT检测保证缺陷完全被消除;
 4. 将修补区域打磨到与母材或邻近焊缝平齐;
 5. 根据批准的车间图纸检查焊缝.
1. Gouge or grind from nearer side from metal edge ($D \leq 0.65T$, "D" is depth of defects, "T" is thickness of metal) to remove all defects;
 2. Follow repair WPS for joint preparation, preheat, and weld deposit;
 3. Verify with VT no defects remain in the weld joint prior to welding;
 4. Grind the repaired area flush with base metal or the adjacent weld;
 5. Check the welds according to the working drawings.

1. Improve monitoring of welding and interpass cleaning.

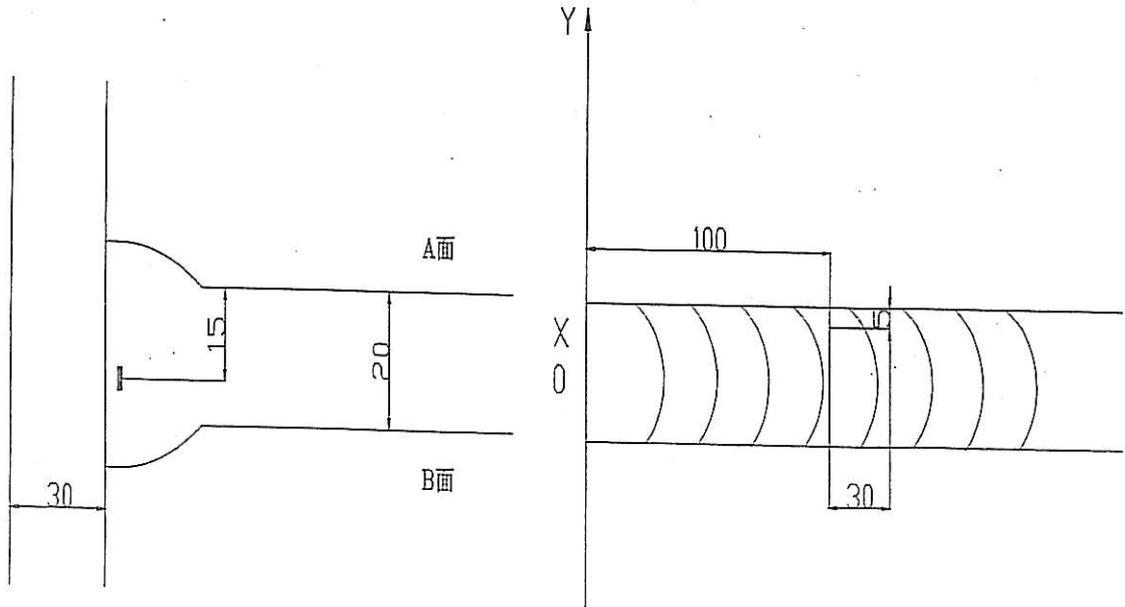
WELD NUMBER: SSD18-PP064-150

Rejected indication found by ultrasonic inspection is less than the maximum allowance aggregate length.

1. Gouge or grind from nearer side from metal edge ($D \leq 0.65T$, "D" is depth of defects, "T" is thickness of metal) to remove all defects;
2. Follow repair WPS for joint preparation, preheat, and weld deposit;
3. Verify with VT no defects remain in the weld joint prior to welding;
4. Grind the repaired area flush with base metal or the adjacent weld;
5. Check the welds according to the working drawings.

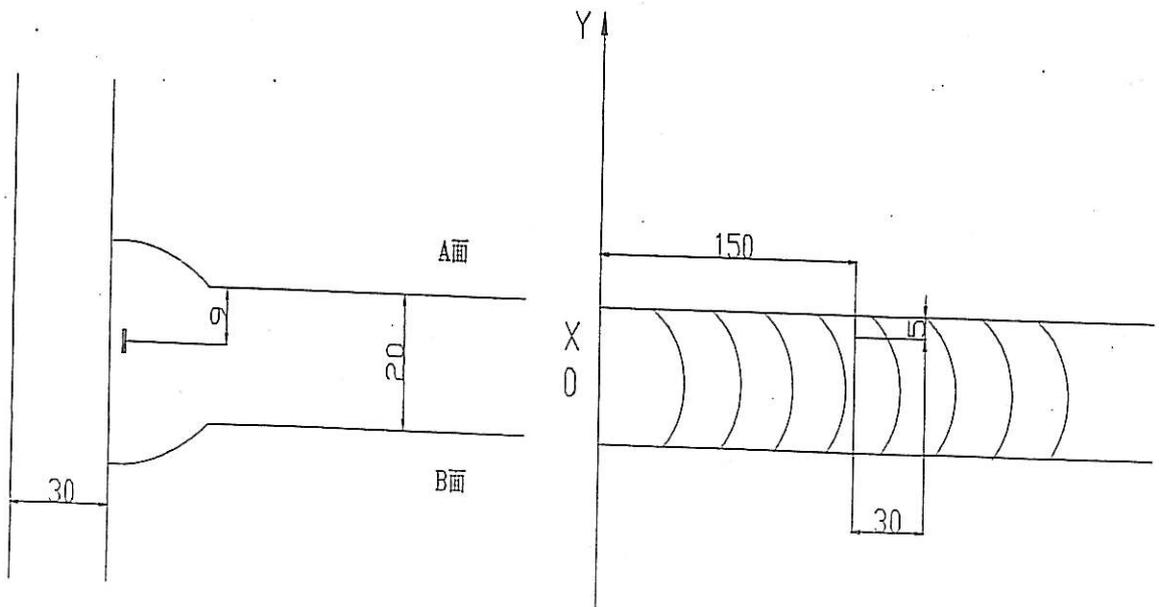
WELD NUMBER: SSD17-PP063-137

Rejected indication found by ultrasonic inspection is less than the maximum allowance aggregate length.

1. Gouge or grind from nearer side from metal edge ($D \leq 0.65T$, "D" is depth of defects, "T" is thickness of metal) to remove all defects;

2. Follow repair WPS for joint preparation, preheat, and weld deposit;

3. Verify with VT no defects remain in the weld joint prior to welding;

4. Grind the repaired area flush with base metal or the adjacent weld;

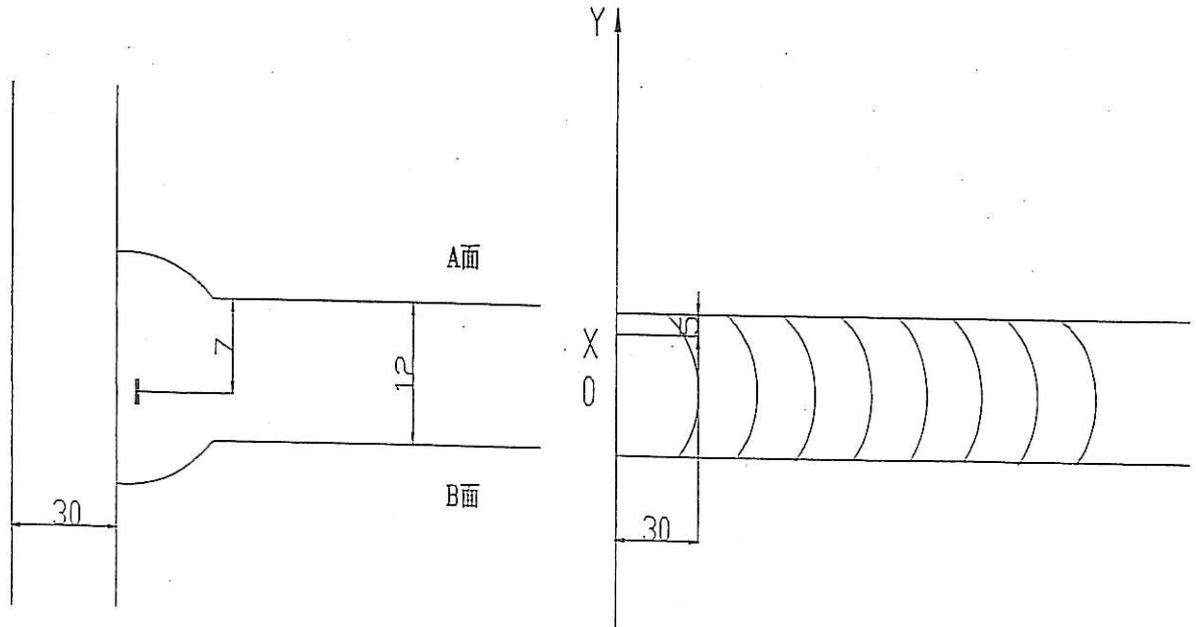
WELD NUMBER: SSD24-PP061.5-135

Rejected indication found by ultrasonic inspection is less than the maximum allowance aggregate length.

1. 从缺陷距离端面较近一侧 ($D \leq 0.65T$, D 为缺陷深度, T 为板厚) 采用碳刨或打磨的方法去除焊缝缺陷;
 2. 参照返修焊接工艺规程 (WPS) 准备正确的接头型式, 预热和焊接;
 3. 焊前对修补区域进行VT检测保证缺陷完全被清除;
 4. 将修补区域打磨到与母材或邻近焊缝平齐;
 5. 根据批准的车间图纸检查焊缝.
-
1. Gouge or grind from nearer side from metal edge ($D \leq 0.65T$, "D" is depth of defects, "T" is thickness of metal) to remove all defects;
 2. Follow repair WPS for joint preparation, preheat, and weld deposit;
 3. Verify with VT no defects remain in the weld joint prior to welding;
 4. Grind the repaired area flush with base metal or the adjacent weld;
 5. Check the welds according to the working drawings.

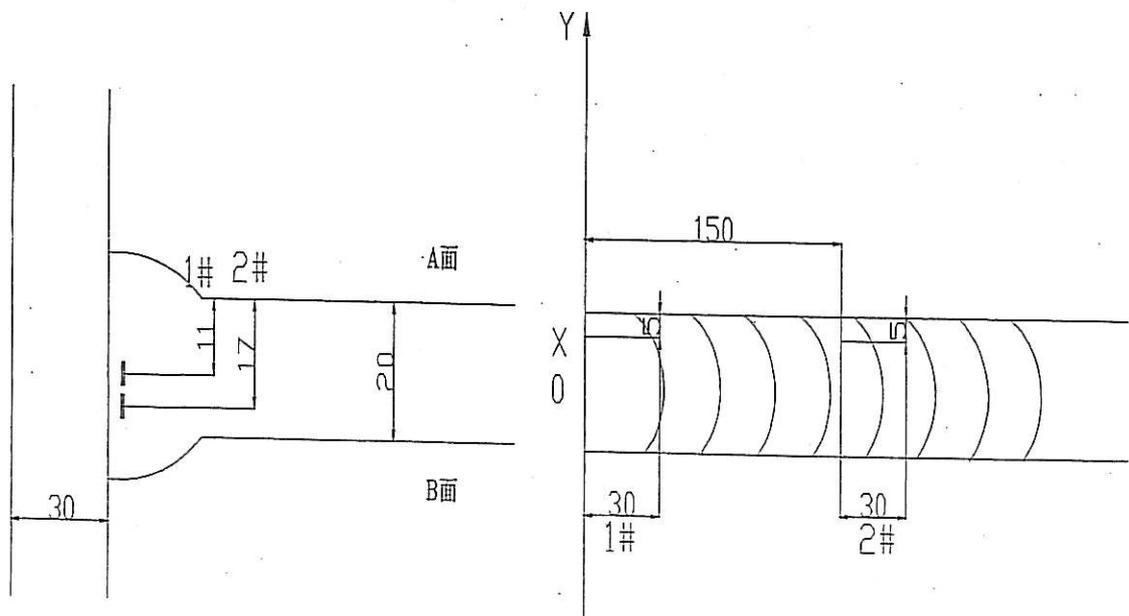
WELD NUMBER: SSD15-PP061-143

Rejected indication found by ultrasonic inspection is less than the maximum allowance aggregate length.

1. Gouge or grind from nearer side from metal edge ($D \leq 0.65T$, "D" is depth of defects, "T" is thickness of metal) to remove all defects;

2. Follow repair WPS for joint preparation, preheat, and weld deposit;

3. Verify with VT no defects remain in the weld joint prior to welding;

4. Grind the repaired area flush with base metal or the adjacent weld;

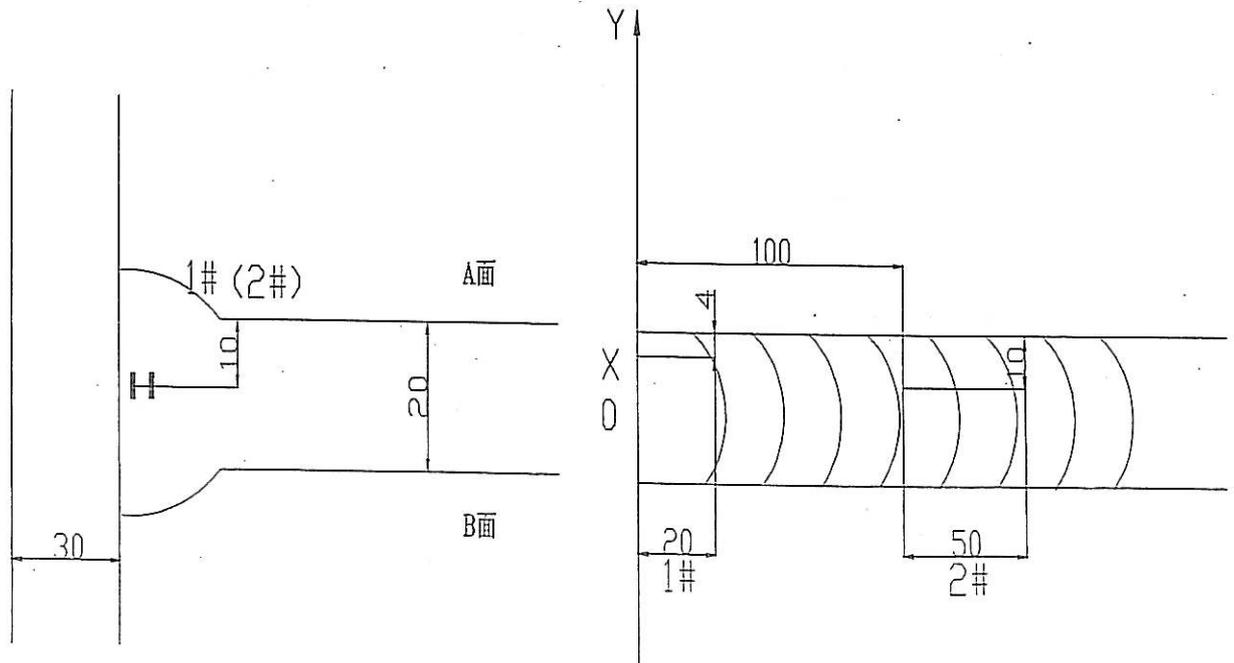
WELD NUMBER: SSD15-PP061-135

Rejected indication found by ultrasonic inspection is less than the maximum allowance aggregate length.

1. Gouge or grind from nearer side from metal edge ($D \leq 0.65T$, "D" is depth of defects, "T" is thickness of metal) to remove all defects;

2. Follow repair WPS for joint preparation, preheat, and weld deposit;

3. Verify with VT no defects remain in the weld joint prior to welding;

4. Grind the repaired area flush with base metal or the adjacent weld;
