Contract #: 04-0120F4Cty: SF/ALA Rte: 80 PM: 13.2/13.9File #: 69.25B**QUALITY ASSURANCE -- NON-CONFORMANCE REPORT****Location:** Changxing Island, Shanghai, PRC**Report No:** NCR-000367**Prime Contractor:** American Bridge/Fluor Enterprises, a JV**Date:** 27-Jul-2009**Submitting Contractor:** Zhenhua Port Machinery Company, Ltd (ZPMC), Changxing Island**NCR #:** ZPMC-0341**Type of problem:**

Reference Description: Base Metal Distortion OBG Segment 7BW**Description of Non-Conformance:**

Job Name: SAS Superstructure

Subject: NCR No. ZPMC-0341

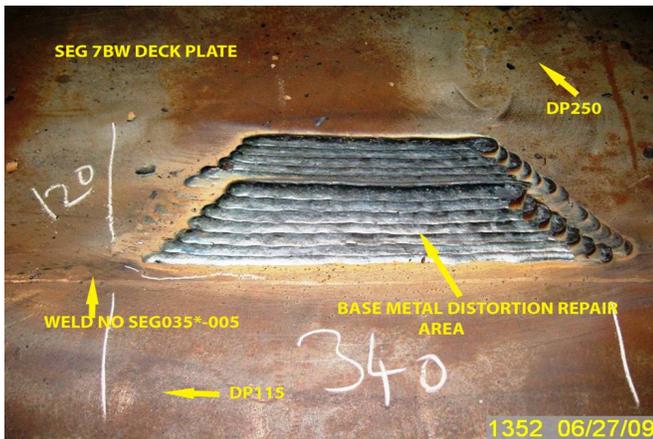
Caltrans Quality Assurance (QA) Inspector observed that a base metal distortion repair was performed on Deck plate 250 in way of deck panel splice weld No. SEG035*-005. Approximately 340mm x 120mm of FCAW filler material was deposited around the splice weld. This base metal distortion repair was performed without the approval of the Engineer.
