Contract #: 04-0120F4Cty: SF/ALA Rte: 80 PM: 13.2/13.9File #: 69.25B**QUALITY ASSURANCE -- NON-CONFORMANCE REPORT****Location:** Changxing Island, Shanghai, P.R. China**Report No:** NCR-000375**Prime Contractor:** American Bridge/Fluor Enterprises, a JV**Date:** 30-Jul-2009**Submitting Contractor:** Zhenhua Port Machinery Company, Ltd (ZPMC), Changxing Island**NCR #:** ZPMC-0349**Type of problem:**

Reference Description: Missed MT Transverse Indication by QC on Side Panel 3022 (Seg 12CE)**Description of Non-Conformance:**

Job Name: SAS Superstructure

Subject: NCR No. ZPMC-0349

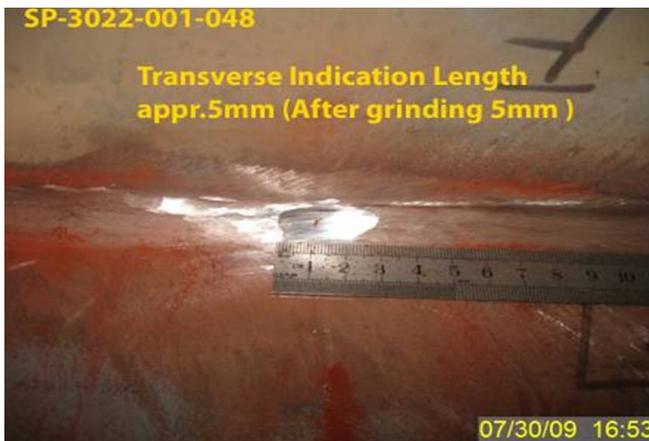
This Quality Assurance Inspector (QA) performed random verification of Magnetic Particle Testing (MT) on weld joint identified as SP-3022-001-048 between T-Stiffener to Side Plate for OBG Segment 12CE. This QA Inspector discovered one (1) rejectable Transverse Indication measuring approximately 5 mm in length. This weld was previously tested and accepted by ZPMC QC MT technicians.

AWS D1.5 (02) Section 6.26.2 - "Welds that are subject to MT in addition to visual inspection shall have no cracks."

Submit repair procedure to engineer for review.

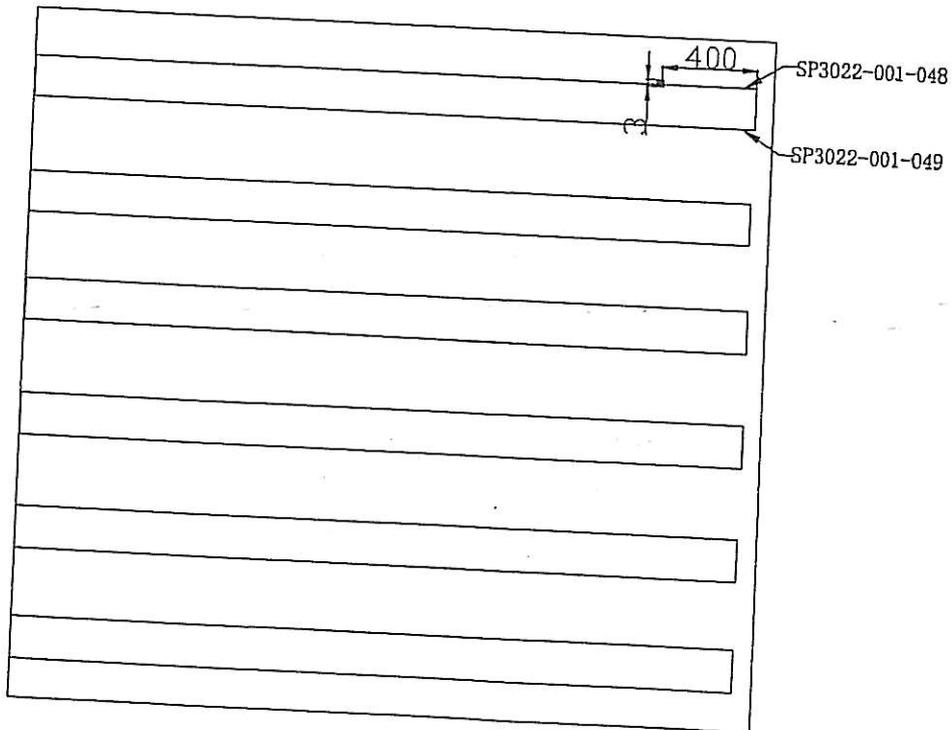
One pore was found by use of MT on SP3022-001-048.
(MT探伤发现1处气孔。)

1. 焊道未及时处理干净。
1. Did not clear the weld pass completely in time.

1. 采用打磨的方法去除气孔;
 2. 焊接前按照焊接返修工艺规程(WPS)准备焊缝接头形式;
 3. 作100%VT与MT检查, 确保缺陷完全去除;
 4. 按照批准的焊缝返修工艺规程(WPS)进行预热和焊接;
 5. 打磨焊缝区域使其与母材平齐;
 6. 对修补区域作100%VT与MT检测;
1. Remove the defects by means of grinding cleanly.
 2. Prepare excavation in accordance with an approved repair WPS prior to welding.
 3. Perform VT 100% of the repair area to insure removal of the defects.
 4. Preheat and weld according to the relevant repair WPS.
 5. Following welding grind the weld flush with base metal.
 6. Perform 100% VT and MT of repair area.

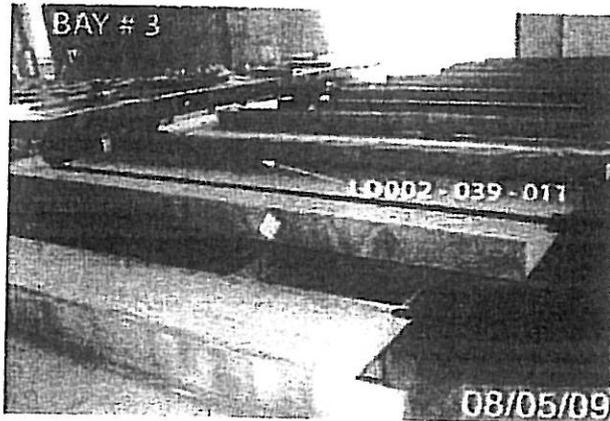
During random verification Magnetic Particle Testing (MT) for the OBG Longitudinal Diaphragms at Bay # 3. The Caltrans Quality Assurance Inspector (QA) observed one (1) longitudinal linear indication approximately 11mm in length in the weld metal on LD002-039-011. Linear Indication was discovered after ZPMC QC MT acceptance.

AWS D1.5 (02) Section 6.26.2 – “Welds that are subject to MT in addition to visual inspection shall have no cracks.

Submit repair procedure to engineer for approval.

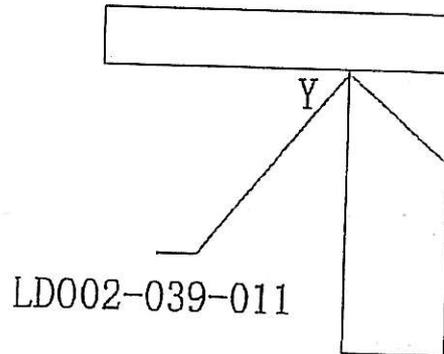
We found one longitudinal crack on the LD002-039-011

1. Moisture wasn't completely removed during drying operation (preheating) or the area wasn't preheated sufficiently.

1. QC and a Lead CWI shall be present, direct and supervise all grinding and welding operations during this repair to ensure the repair is per the disposition requirements

2. QC and a Lead CWI shall have an approved copy of the CWR in hand prior to the repair.
3. Remove paint $\geq 25\text{mm}$ in all direction of HAZ prior to MT.

4. Remove cracks by grinding, repair area shall extend a minimum of 50mm beyond each end of single crack repairs;
5. If base metal is damaged by grinding, the damaged area shall be ground clean prior to performing weld repair. If gap $> 5\text{mm}$ is found during or after grinding, a separate CWR to make the weld joint a CJP is required in that location, and perform MT after performing grinding the defects away.

6. Prepare excavation in accordance with an approved repair WPS prior to welding.
7. Before this repair, Verify with VT and MT repair areas are defects free;

8. Perform MT on the weld metal adjacent to the repair area to ensure that crack did not propagate into base metal. If crack is discovered in base metal, approval of a separate CWR is required before continuing with repair work.

9. Preheat and weld according to the approved repair WPS.
10. Grind the repaired area flush with base metal or the adjacent weld.
11. Perform 100%VT and MT inspection to all repaired welds (along with an additional 50mm at each end of the weld repair) which include the near side and far side on the upper Perform UT and MT inspection to CJP weld.
