QUALITY ASSURANCE -- NON-CONFORMANCE REPORT

Report No: NCR-000415

Reference Description: Missed MT indication on 135 meter Diaphragm

To: AMERICAN BRIDGE/FLUOR, A JV **Date:** 21-Sep-2009
 375 BURMA ROAD
 OAKLAND CA 95607 **Contract No:** 04-0120F4
 04-SF-80-13.2 / 13.9
Dear: Mr. Charles Kanapicki **Job Name:** SAS Superstructure
Attention: Mr. Thomas Nilsson Project/Fabrication Manager **Document No:** 05.03.06-000377
Subject: NCR No. ZPMC-0389
Reference Description: Missed Indication (MT) / West Shaft Lift 4 / 135m Diaphragm

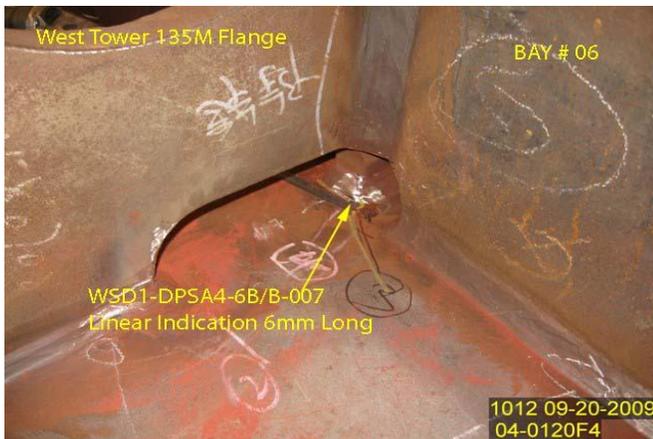
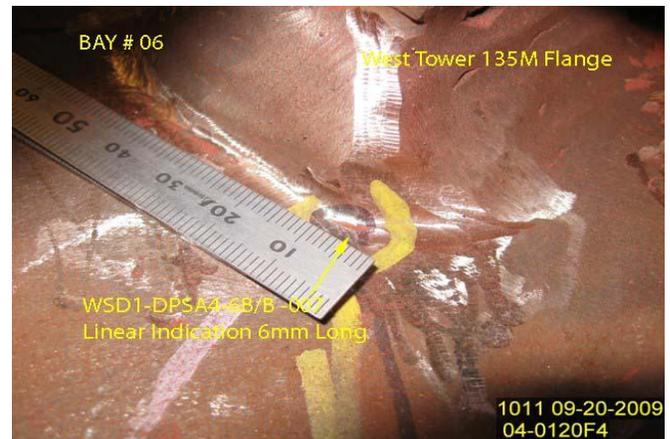
During Magnetic Particle Testing (MT) of West Tower, 135 m Diaphragm weld WSD1-DPSA4-6B/B-007, QA discovered a 6mm long linear indication. This weld had been previously tested and accepted by ZPMC Quality Control MT Technicians.

AWS D1.5-2002, Section 6.26.2 – “Welds that are subject to MT in addition to visual inspection shall have no cracks.”

Propose a resolution for this systematic non-conformance that addresses the failure of Quality Control to identify the linear indication during magnetic particle testing of the welds. Provide documentation of the steps/actions taken by the Quality Control Manager to prevent future occurrences.

In addition to the Quality Control non-conformance, address the material/workmanship for the identified non-conformance including documentation that the deficiency has been brought into compliance with the contract requirements. Additionally address the probable cause for the indication and the actions that will be taken to limit future occurrences.

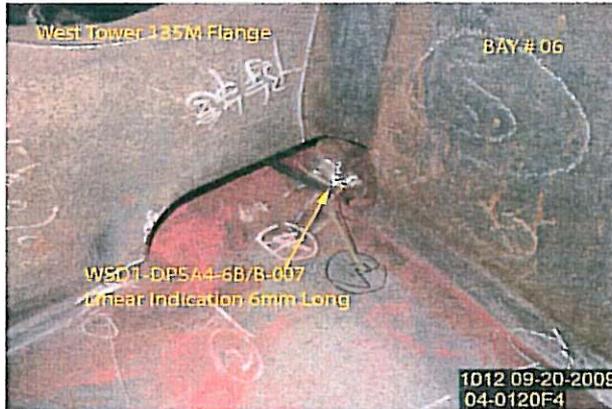
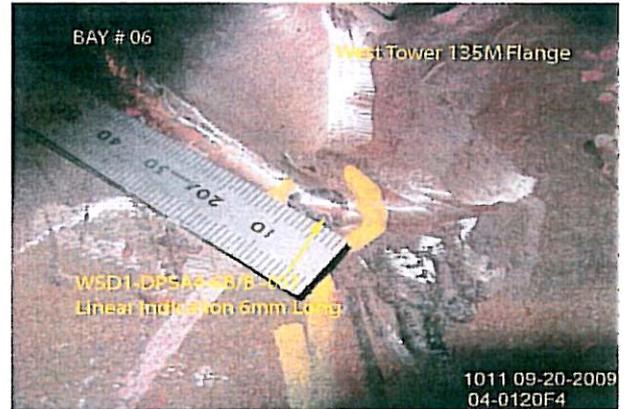
During Magnetic Particle Testing (MT) of West Tower, 135 m Diaphragm weld WSD1-DPSA4-6B/B-007, QA discovered a 6mm long linear indication. This weld had been previously tested and accepted by ZPMC Quality Control MT Technicians.

AWS D1.5-2002, Section 6.26.2 – “Welds that are subject to MT in addition to visual inspection shall have no cracks.”

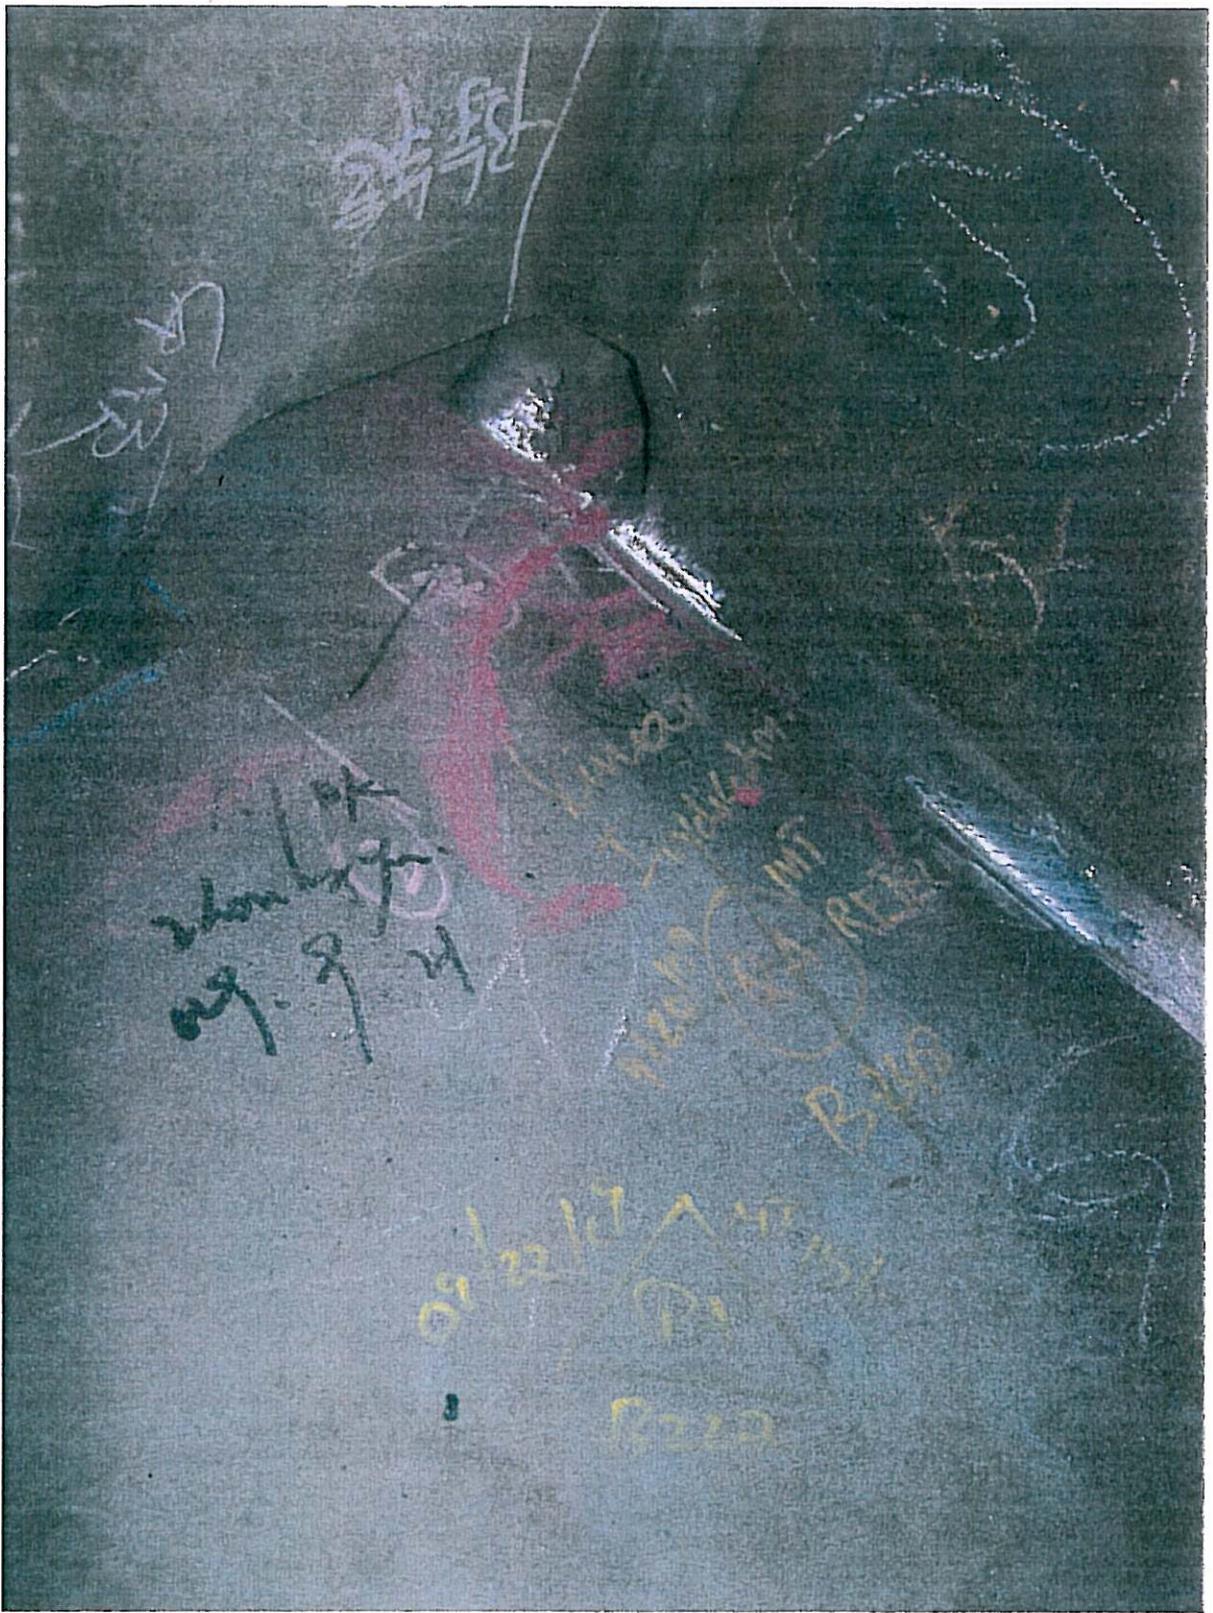
Picture 1 of CT verification

ZPMC acknowledged this. When ZPMC received this information, the grinder was arranged and the indication was removed from the weld surface. ZPMC MT technician retested the weld subsequently. And the double diaphragm was green tagged after CT's verification.
