Contract #: 04-0120F4Cty: SF/ALA Rte: 80 PM: 13.2/13.9File #: 69.25B**QUALITY ASSURANCE -- NON-CONFORMANCE REPORT****Location:** Changxing Island, Shanghai, P.R. China**Report No:** NCR-000422**Prime Contractor:** American Bridge/Fluor Enterprises, a JV**Date:** 05-Sep-2009**Submitting Contractor:** Zhenhua Port Machinery Company, Ltd (ZPMC), Changxing Island**NCR #:** ZPMC-0396**Type of problem:**

<b>Welding</b>	<b>Concrete</b>	<b>Other</b>	
<b>Welding</b>	<b>Curing</b>	<b>Procedural</b>	<b>Bridge No:</b> 34-0006
<b>Joint fit-up</b>	<b>Coating</b>	<b>Other</b>	<b>Component:</b> OBG Segment 6AE Side Panel to WT Weld
<b>Procedural</b>	<b>Procedural</b>	<b>Description:</b> WT Stiffener to Side Panel Fillet Weld Joint

## QUALITY ASSURANCE -- NON-CONFORMANCE REPORT

**NON-CONFORMANCE REPORT TRANSMITTAL**

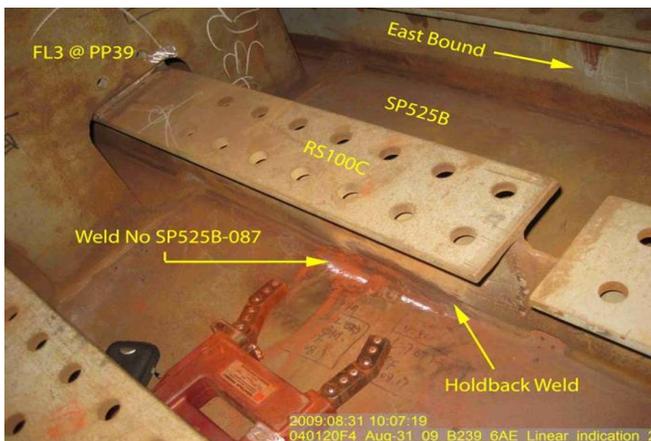
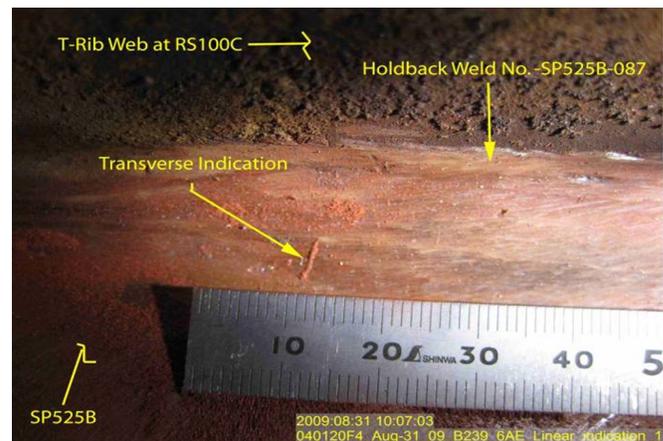
During random verification Magnetic Particle Testing of side panel SP525B holdback welds at panel point 39, weld number SP525B-087, Caltrans Quality Assurance (QA) Inspector discovered a total of one (1) transverse linear indication that measured a total of 8mm in length. This weld was previously tested, rejected and the repairs accepted by ZPMC (MT) technicians.

AWS D1.5 (02) Section 6.26.2 – “Welds that are subject to MT in addition to visual inspection shall have no cracks.”

Submit a repair plan to the engineer for approval.

Remove indication by means of grinding.

Indication was removed by grinding, Contractor submitted NDT documentation verifying the weld is in conformance with Contract specifications.

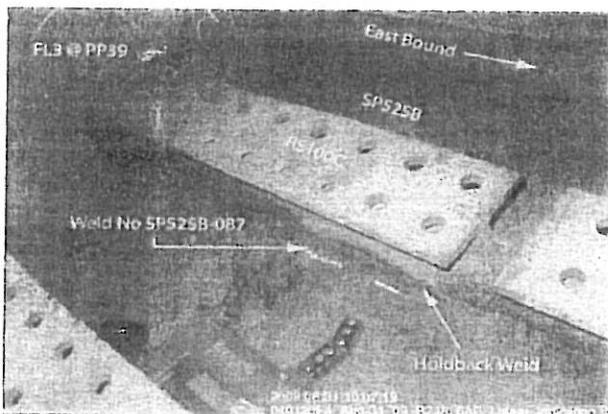
During random verification Magnetic Particle Testing of side panel SP525B holdback welds at panel point 39, weld number SP525B-087, Caltrans Quality Assurance (QA) Inspector discovered a total of one (1) transverse linear indication that measured a total of 8mm in length. This weld was previously tested, rejected and the repairs accepted by ZPMC (MT) technicians.

AWS D1.5 (02) Section 6.26.2 – “Welds that are subject to MT in addition to visual inspection shall have no cracks.”

Submit a repair plan to the engineer for approval.
