Contract #: 04-0120F4Cty: SF/ALA Rte: 80 PM: 13.2/13.9File #: 69.25B**QUALITY ASSURANCE -- NON-CONFORMANCE REPORT****Location:** Changxing Island, Shanghai, P.R. China**Report No:** NCR-000424**Prime Contractor:** American Bridge/Fluor Enterprises, a JV**Date:** 02-Sep-2009**Submitting Contractor:** Zhenhua Port Machinery Company, Ltd (ZPMC), Changxing Island**NCR #:** ZPMC-0398**Type of problem:**

Reference Description: Missed UT indications by QC on SEG060A-011**Description of Non-Conformance:**

Job Name: SAS Superstructure

Subject: NCR No. ZPMC-0398

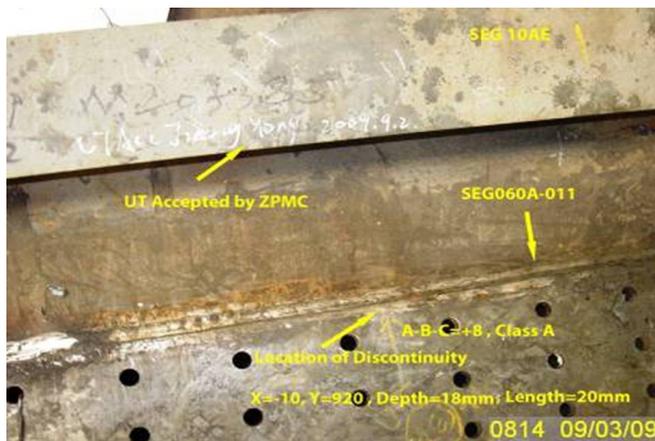
During random verification Ultrasonic Testing (UT) of the Bottom to Side Plate weld identified as SEG060A-011 in OBG segment 10AE. Caltrans Quality Assurance (QA) Inspector discovered a total of (1) one linear rejectable indication that measured 20mm in length.

This weld has been previously tested and accepted by ZPMC Quality Control (UT) Technicians.

Repair indication, perform the required NDT, and provide training for the NDT Technician.

Contractor submitted WRR along with NDT reports verifying the repairs are in conformance with Contract specifications. NDT Technician also received additional training.

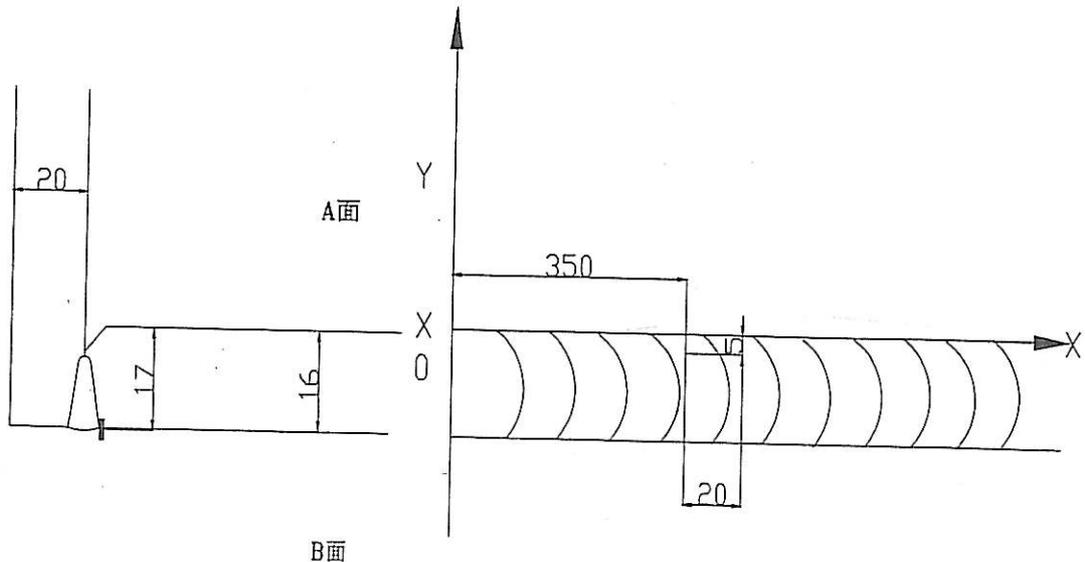
WELD NUMBER: SEG060A-011

Rejected indication found by ultrasonic inspection is less than the maximum allowance aggregate length.

1. Did not clear the weld pass completely in-time.

1. Gouge or grind from nearer side from metal edge ($D \leq 0.65T$, "D" is depth of defects, "T" is thickness of metal) to remove all defects;
2. Follow repair WPS for joint preparation, preheat, and weld deposit;
3. Verify with VT no defects remain in the weld joint prior to welding;
4. Grind the repaired area flush with base metal or the adjacent weld;
5. Check the welds according to the working drawings.

1. 加强焊接监控和道间清理。
1. Improve monitoring of welding and interpass cleaning.
