Contract #: 04-0120F4
 Cty: SF/ALA Rte: 80 PM: 13.2/13.9
 File #: 69.25B

QUALITY ASSURANCE -- NON-CONFORMANCE REPORT

Report No: NCR-000431

Reference Description: Missed UT transverse indications by QC on 1AAW/1AW Segment Transverse Splice

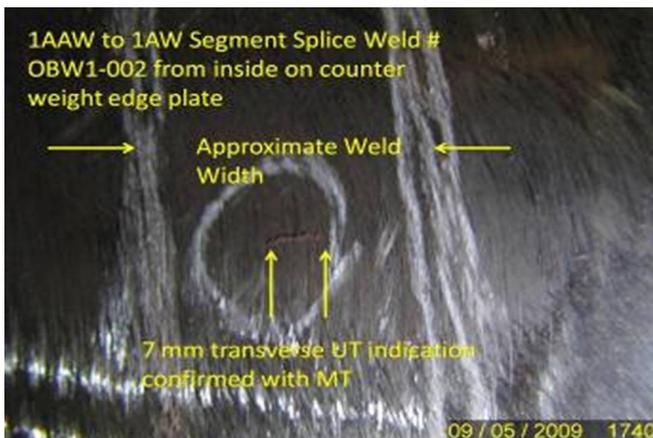
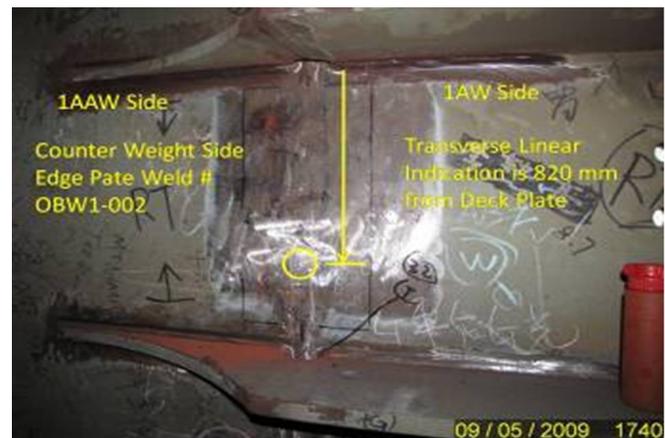
Caltrans Quality Assurance Inspector (QA) discovered rejectable linear transverse indications during ultrasonic testing verification of OBG segment splice weld (1AAW/1AW) designated as OBW1-002 (Edge Panel CW side) utilizing scanning pattern "D". The indications exhibited planar characteristics with significant flaw height dimension as the search unit was moved toward and away from the indications and were not detectable during scanning patterns parallel to the weld axis. In addition, the search unit was rotated 360° around the indications in order to ascertain if they were spherical, cylindrical or linear in nature. No significant ultrasonic response was noted as the search unit was rotated around the indications with the exception of both transverse directions with the search unit located directly on top of the weld (scanning pattern "D"). In evidence of this information the indications were determined to be indicative of transverse indications. Due to the depth of one (1) indication being 21 mm which is near the inside surface, magnetic particle (MT) testing was performed and the transverse linear indication at Y=820mm was confirmed, see digital photos below.

NOTE: The Y locations were taken from the Deck Plate down on the Counter Weight side. (Y=820, 1170 and 1790mm)

Propose a resolution for the identified recurring non-conformance which constitutes a systematic problem on both materials/workmanship and quality control issues with revised procedures to remedy the defected work and to prevent future occurrences. A response for the resolution of this issue is expected within 14 days.

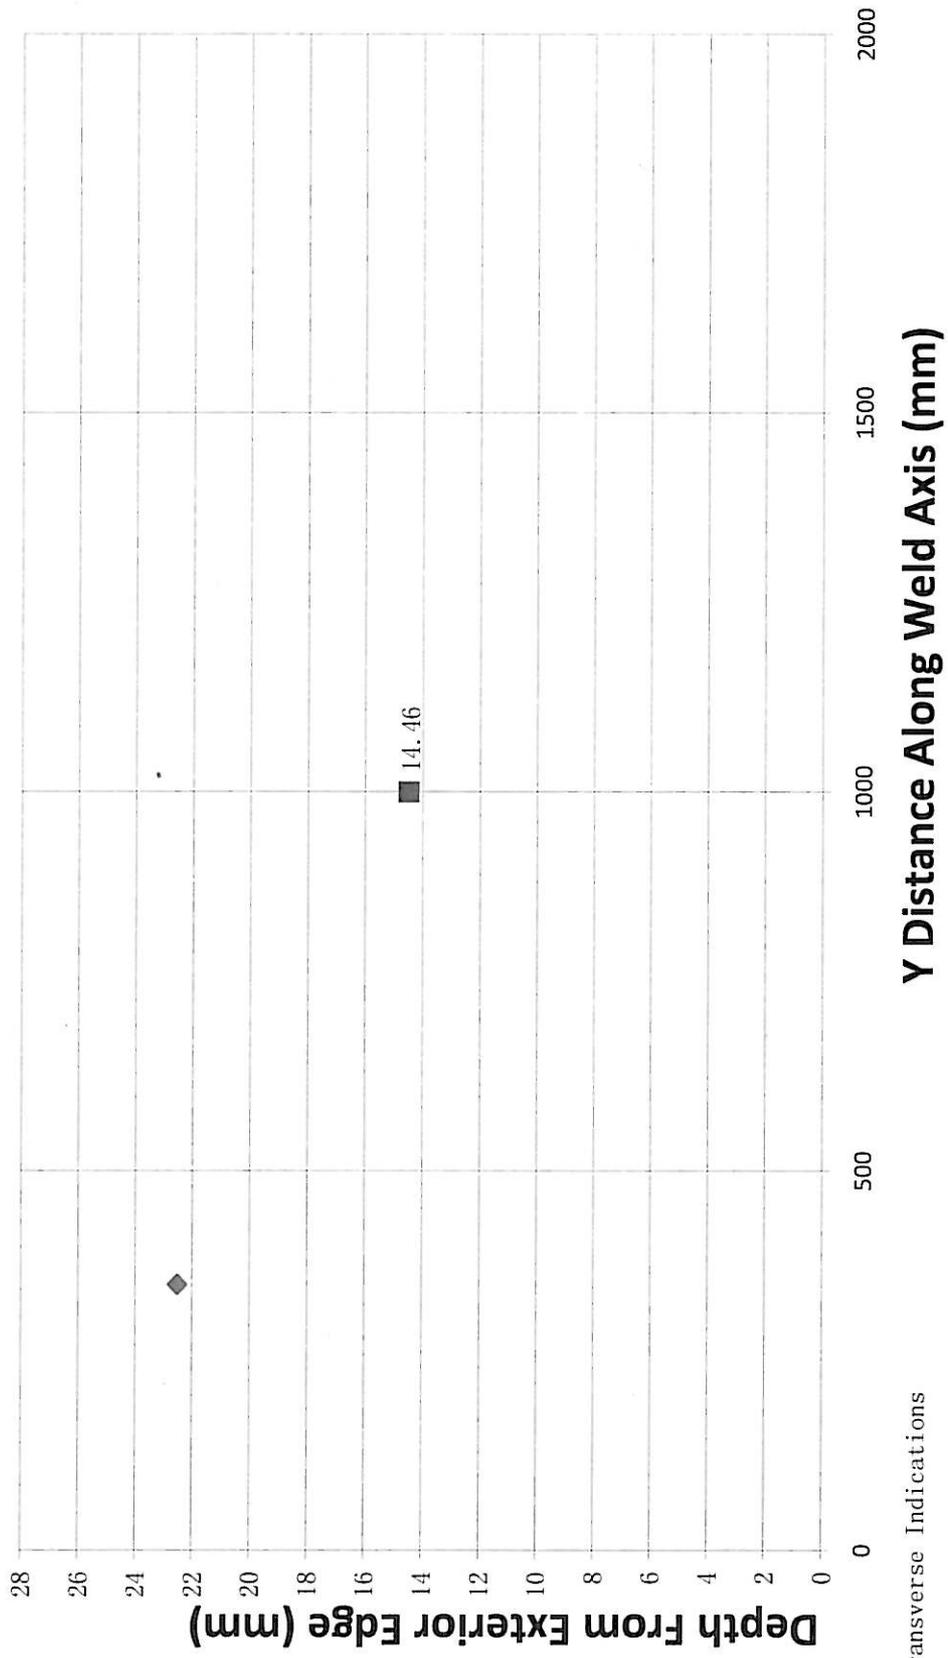
1AAW- 1AW Edge Panel CB Side

Ind. No.	Date	Lot #	Scanning Pattern	Angle in Deg.	Sound Path(mm)	Depth (mm)	A	B	C	D	Class	Thickenss (mm)	Length (mm)	REJ.	Distance From X (mm)	Distance From Y (mm)	Indication Orientation
1	21-Oct-09	B288	D	70	65.79	22.5	77.5	58.8	3	16		28	39		0	350	T
2	21-Oct-09	B288	B	70	42.3	14.46	81.9	58.8	1	22		28	25		0	1000	L

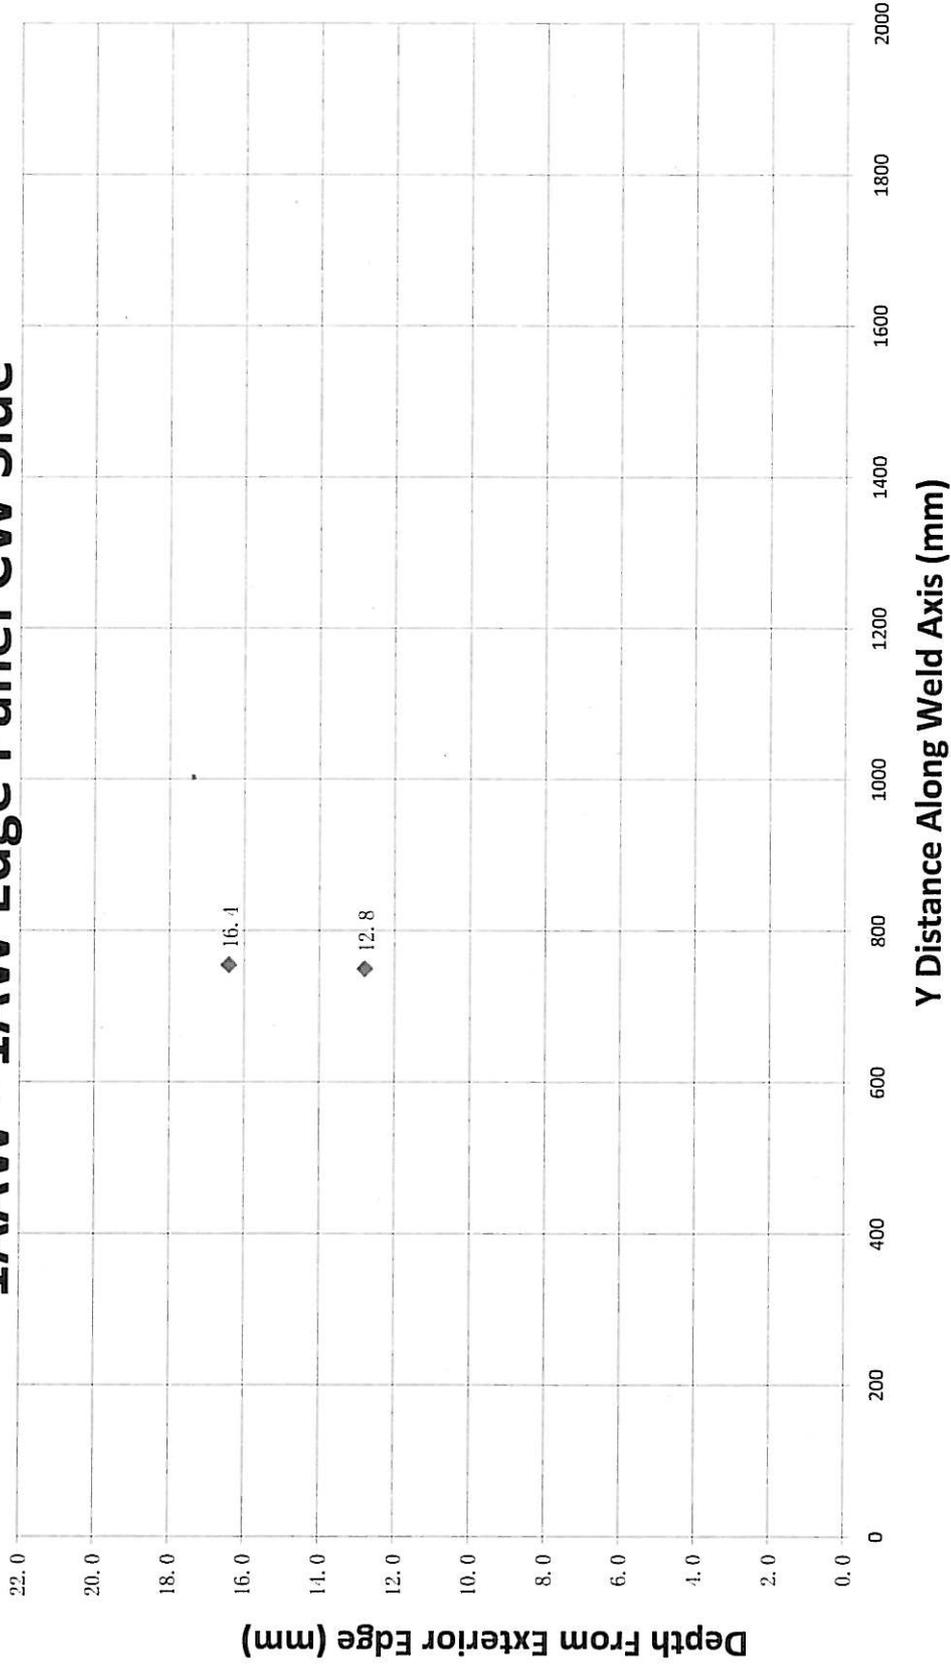
1AAW - 1AW Edge Panel CW Side

Ind. No.	Date	Lot #	Scanning Pattern	Angle	Sound Path	Depth	A	B	C	D	Class	Thk. (mm)	Length	REJ.	Distance From X	Distance From Y	Indication Orientation	Comments (Surface and Ecl.)	
1	19-Oct-09	B277	D	70	37.4	12.8	64	53	1	10	D	22	8		0	750			
2	19-Oct-09	B277	D	70	47.93	16.4	69	53	1.8	14	D	22	6		0	755

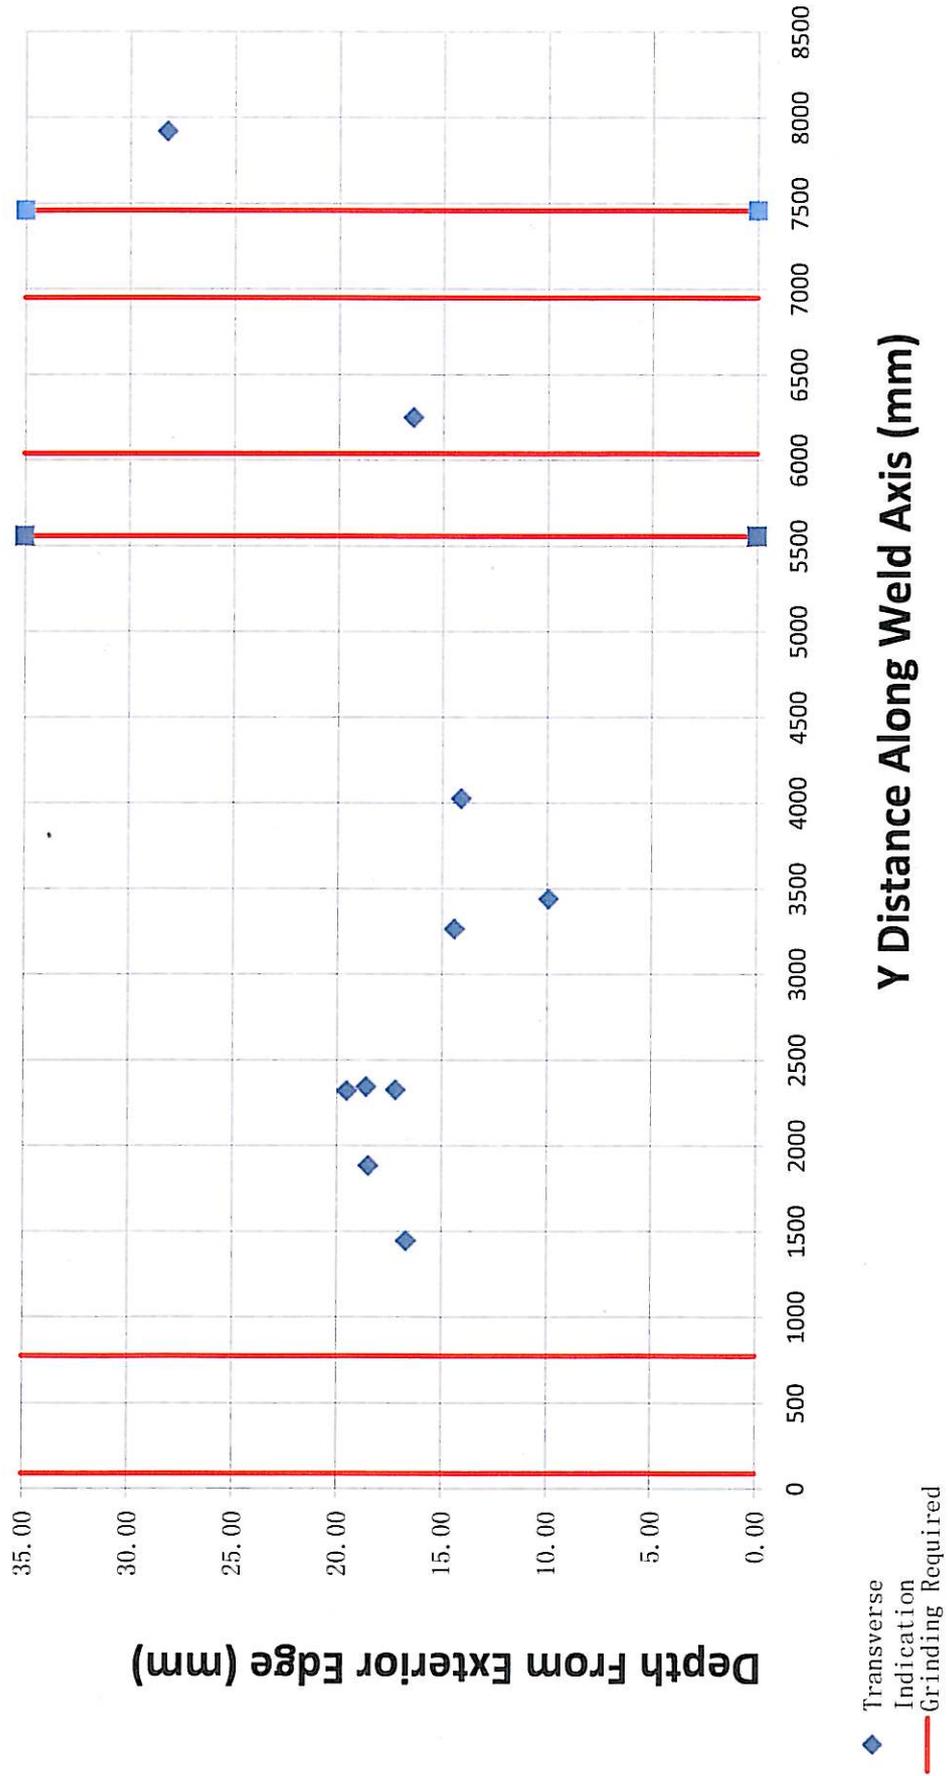
1AAW - 1AW Bottom Plate

Ind. No.	Date	Lot #	Scanning Pattern	Angle in Deg.	Sound Path (mm)	Depth (mm)	A	B	C	D	Class	Thickenss (mm)	Length (mm)	REF.	Distance From X (mm)	Distance From Y (mm)	Indication Orientation	Comments (Surface Condition and Ect.)
1	23-Oct-09	B264	D	70	48.8	16.69	76.00	51	1.90	23		35	10			1446	T	
2	23-Oct-09	B205	D	70	54.1	18.50	76.00	51	2.33	23		35	8			1885	T	
3	23-Oct-09	B205	D	70	57.1	19.53	77.00	51	2.57	23		35	10			2320	T	
4	23-Oct-09	B205	D	70	50.3	17.20	77.00	51	2.02	24		35	10			2325	T	
5	23-Oct-09	B205	D	70	54.4	18.60	76.00	51	2.35	23		35	8			2345	T	
6	23-Oct-09	B264	D	70	42.1	14.40	76.00	51	1.37	24		35	10			3265	T	
7	23-Oct-09	B205	D	70	28.97	9.91	74.00	51	0.32	23		35	8			3440	T	
8	23-Oct-09	B205	D	70	41.2	14.09	73.00	51	1.30	21		35	10			4025	T	
9	23-Oct-09	B264	D	70	48.1	16.45	75.00	51	1.85	22		35	10			6250	T	
10	23-Oct-09	B205	D	70	82.5	28.22	76.00	51	4.60	20		35	8			7920	T

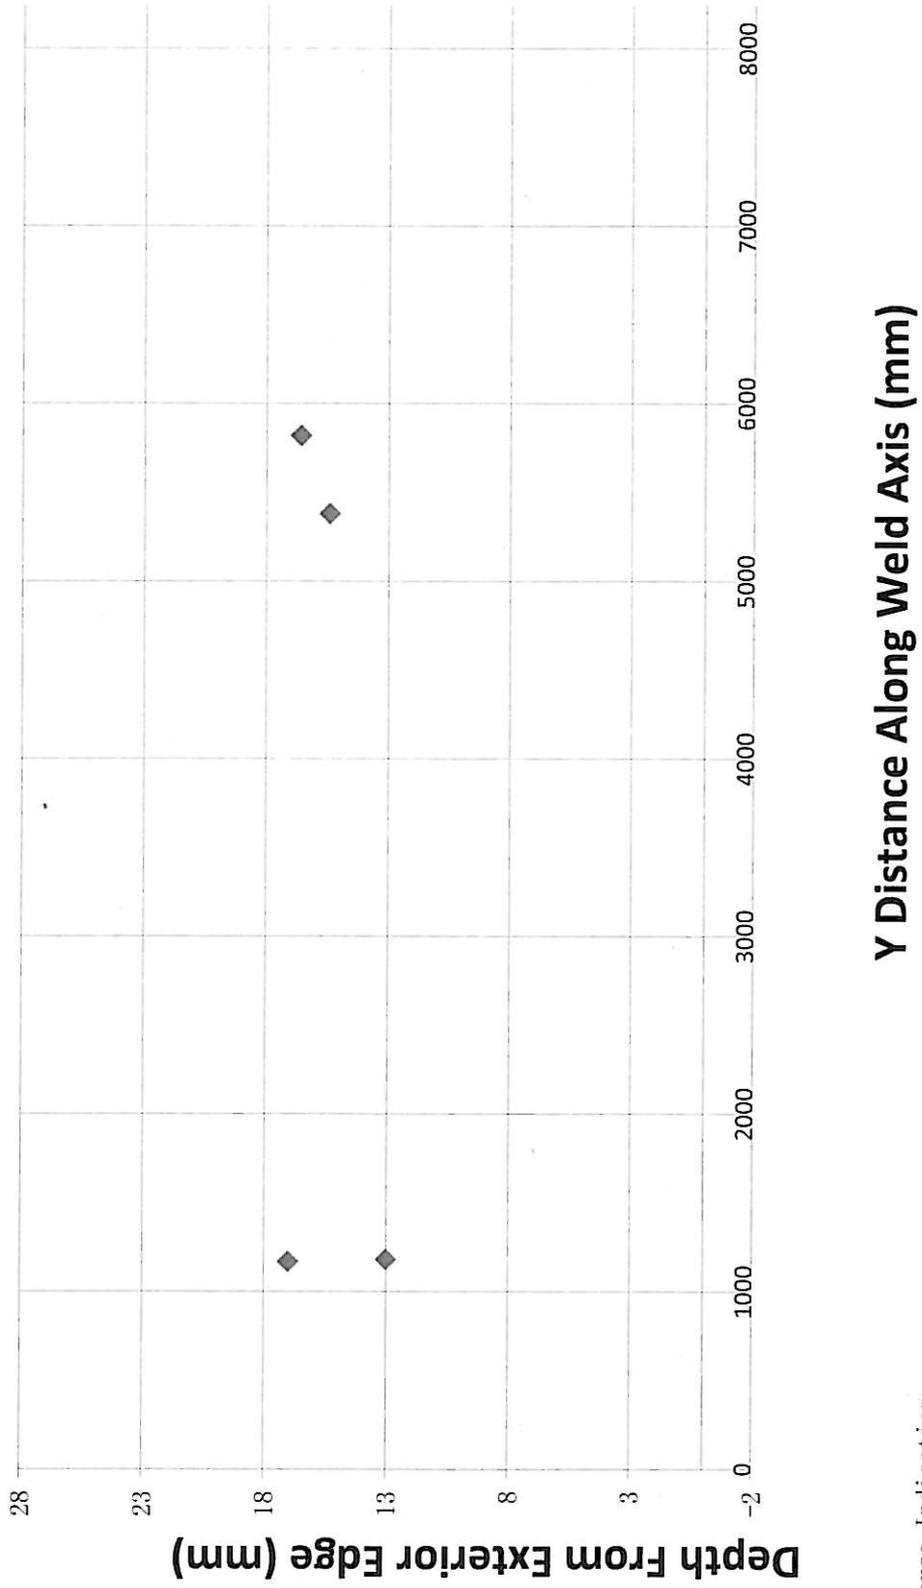
1AAW - 1AW Side Panel CW Side

Ind. No.	Weld ID	Date	Lot #	Scanning Pattern	Angle in Deg.	Sound Path (mm)	Depth (mm)	A	B	C	D	Class	Thickenss (mm)	Length (mm)	REJ.	Distance From X (mm)	Distance From Y (mm)	Indication Orientation	Comments (Surface Condition and Ecl.)
1	OBWIA-001	19-Oct-09	B277	D	70	-	-	-	-	-	-	-	22						ACC
4	OBWIA-002	19-Oct-09	S004	D	70	51.3	17	68	50	2	16	D	28	5			1168	Trans.	-
5	OBWIA-002	19-Oct-09	S004	D	70	39.8	13	61.6	50	1	11	D	28	6			1182	Trans.	-
2	OBWIA-002	19-Oct-09	S003	D	70	41	15	74.8	54	1	20	D	28	4			5380	Trans.	-
3	OBWIA-002	19-Oct-09	S003	D	70	44	17	74.7	54	2	19	D	28	5			5820	Trans.	-
