Contract #: 04-0120F4  
 Cty: SF/ALA Rte: 80 PM: 13.2/13.9  
 File #: 69.25B

**QUALITY ASSURANCE -- NON-CONFORMANCE REPORT**

**Location:** Changxing Island, Shanghai, PRC **Report No:** NCR-000434  
**Prime Contractor:** American Bridge/Fluor Enterprises, a JV **Date:** 28-Sep-2009  
**Submitting Contractor:** Zhenhua Port Machinery Company, Ltd (ZPMC), Changxing Island **NCR #:** ZPMC-0408

**Reference Description:** Missed MT Indications on East Tower, Lift 1 Padeyes

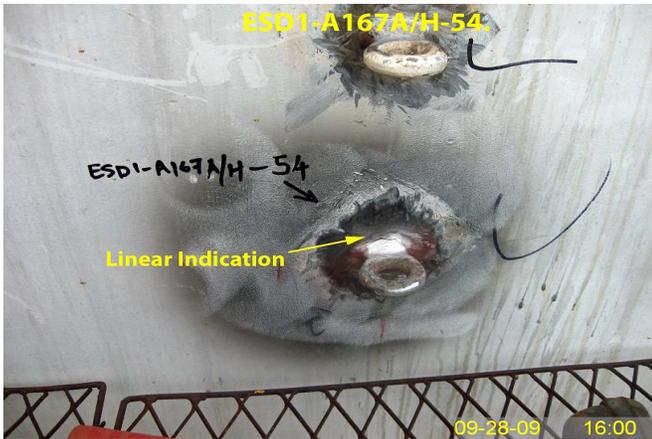
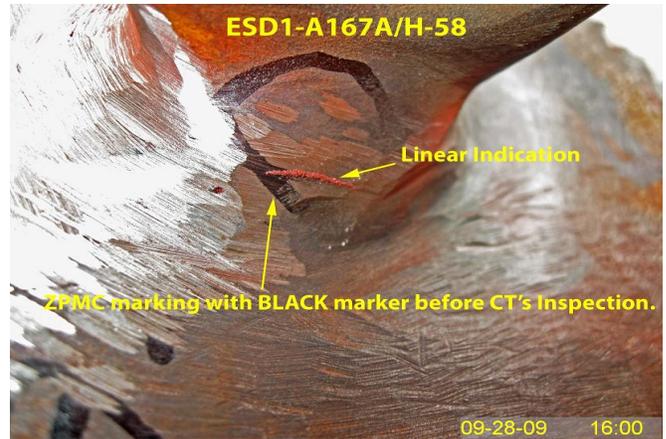
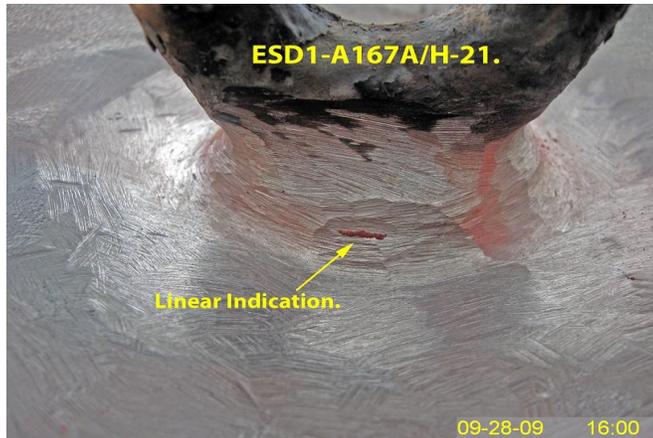
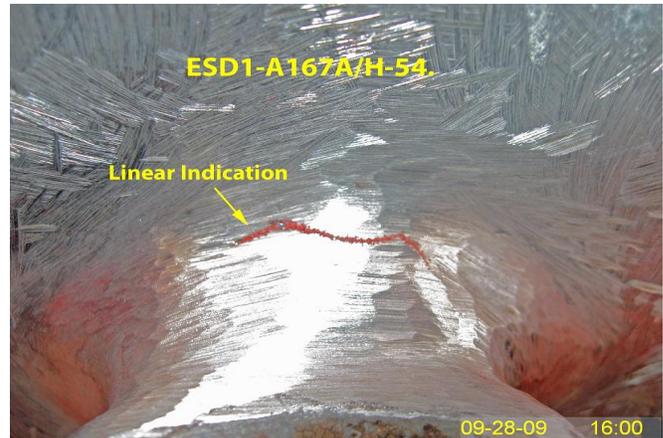
During Magnetic Particle Testing (MT) of East Tower, Lift 1, padeyes; QA observed linear indications at weld joints NSD1-A167A/H-21, 54, 58. ZPMC QC provided the NDT Notification Sheet # 004309 informing Caltrans QA that they have completed their 10% NDT requirements.

AWS D1.5-2002, Section 6.26.2 – “Welds that are subject to MT in addition to visual inspection shall have no cracks.”

Propose a resolution for this systematic non-conformance that addresses the failure of Quality Control to identify the linear indications during magnetic particle testing of the welds. Provide documentation of the steps/actions taken by the Quality Control Manager to prevent future occurrences.

In addition to the Quality Control non-conformance, address the material/workmanship for the identified non-conformance including documentation that the deficiencies have been brought into compliance with the contract requirements. Additionally address the probable causes for the indications and the actions that will be taken to limit future occurrences.

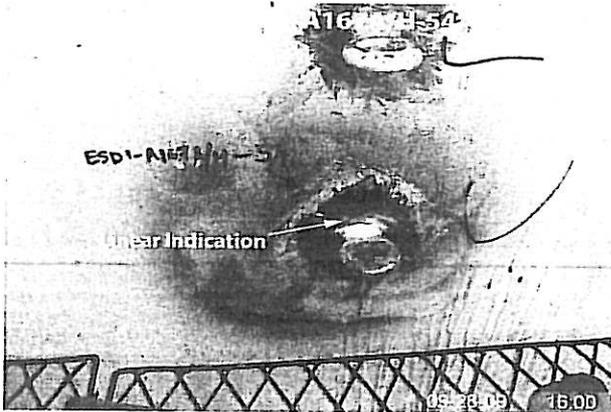
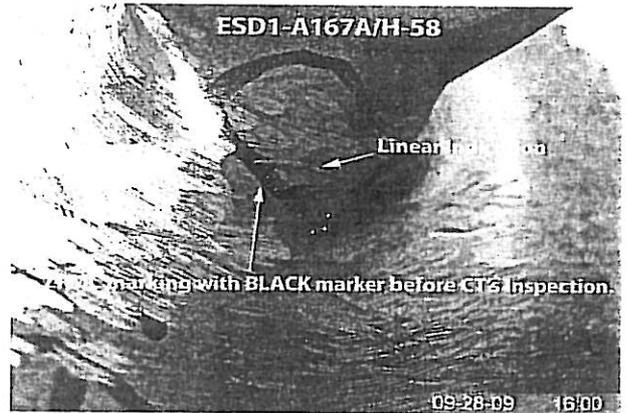
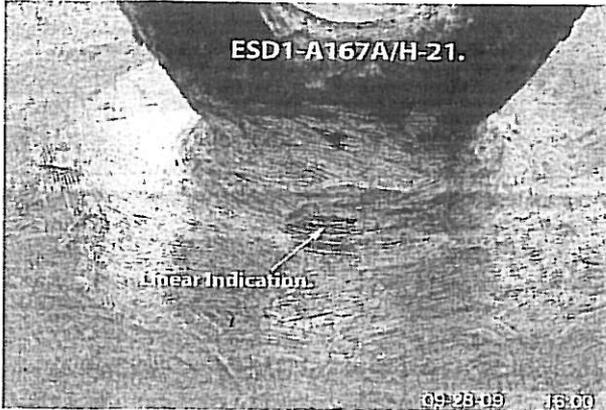
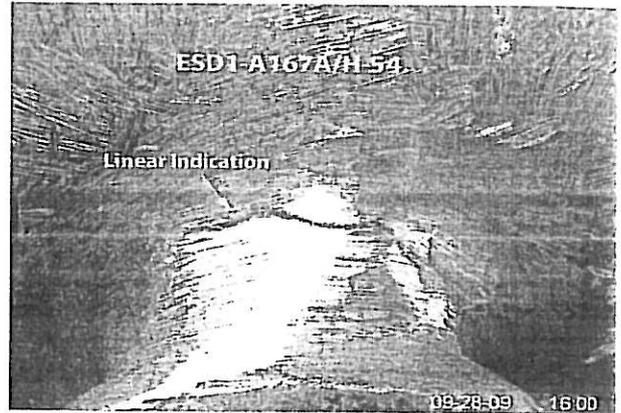
During Magnetic Particle Testing (MT) of East Tower, Lift 1, padeyes; QA observed linear indications at weld joints NSD1-A167A/H-21, 54, 58. ZPMC QC provided the NDT Notification Sheet # 004309 informing Caltrans QA that they have completed their 10% NDT requirements.

AWS D1.5-2002, Section 6.26.2 – “Welds that are subject to MT in addition to visual inspection shall have no cracks.”

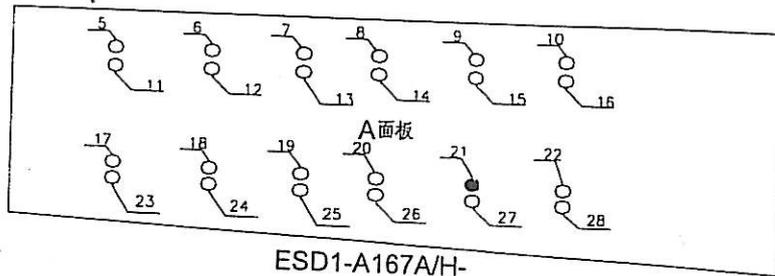
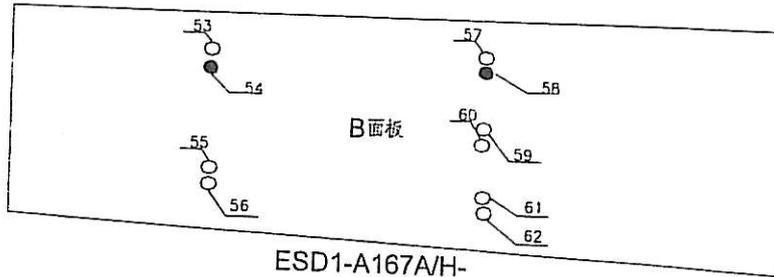
东塔一吊A面1个吊环B面2个吊环MT后发现裂纹:

Cracks were found at first lifting Skin A and Skin B, relevant weld No.:

Skin A: ESD1-A167A/H-21;

Skin B: ESD1-A167A/H-58 54

注: 阴影部位为返修区域。Remark: repair area in shadow.

1. Moisture wasn't completely removed during drying operation (preheating) or the area wasn't preheated sufficiently.

1. QC shall monitor and direct the welder and the grinder doing the repair operation.
2. Preheat before gouging; the temperature shall be at least 65°C.
3. Gouge the weld to remove identified defects.
4. Joint details shall refer to the approved WPS repair.
5. Grind the gouged areas to a smooth and shiny surface.
6. Verify with VT and MT to ensure no defects remain in the weld joint prior to welding.
7. QC shall monitor all welding passes being deposited.
8. QC shall ensure all slag has been removed prior the deposition of next pass.
9. Preheat and maintain interpass temperature control in accordance with the WPS.
10. Blend the weld repaired areas into the adjacent weld or base metal by grinding.
11. Perform VT, MT and other NDT inspection to the repaired areas.

1. QC shall verify sufficient preheat has been applied, to remove moisture, prior to welding.
