Contract #: 04-0120F4Cty: SF/ALA Rte: 80 PM: 13.2/13.9File #: 69.25B**QUALITY ASSURANCE -- NON-CONFORMANCE REPORT****Location:** Changxing Island, Shanghai, PRC**Report No:** NCR-000450**Prime Contractor:** American Bridge/Fluor Enterprises, a JV**Date:** 19-Oct-2009**Submitting Contractor:** Zhenhua Port Machinery Company, Ltd (ZPMC), Changxing Island**NCR #:** ZPMC-0423**Type of problem:**

**Reference Description:** Weld repair performed without CWR on North Tower, Interior Splice Plate**Description of Non-Conformance:**

**Subject:** NCR No. ZPMC-0423

**Reference Description:** Weld repair performed without CWR on North Tower, Interior Splice Plate

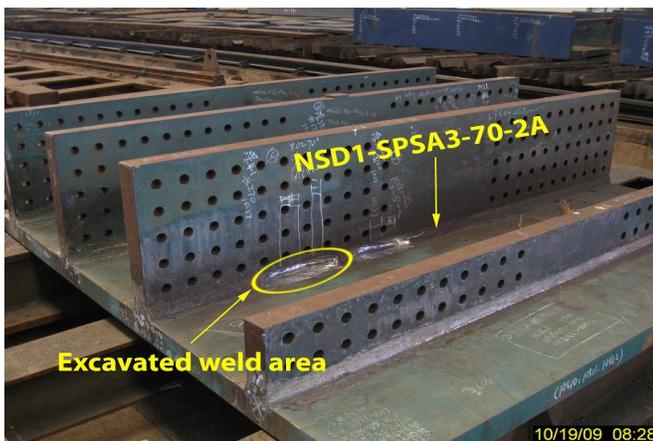
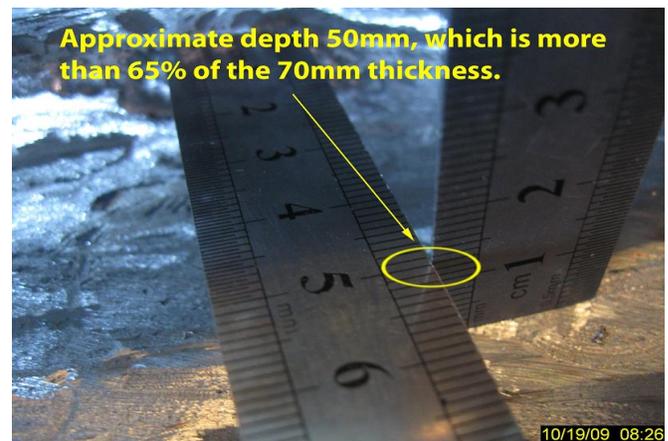
During in-process Visual Testing (VT) of North Tower, Interior Splice Plate Skin to Stiffener weld NSD1-SPSA3-70-2A, QA observed that the CJP weld repair excavation depth exceeded 65% of the weld size. The 70mm thick plate was excavated approximately 50mm deep. A Critical Weld Repair (CWR) was not submitted for approval.

AWS D1.5-2002, Section 12.17.2 Noncritical Repair Welds, (4) - "First-time excavation and repair from one side of groove welds and fillet welds which contain unacceptable porosity, slag and fusion discontinuities, provided the excavations do not exceed the following limits:

The depth of groove weld excavation shall not exceed 65 percent of the weld size shown on the drawings."

AWS D1.5-2002, Section 12.17.3 Critical Weld Repairs - "Except as provided in 12.17.2, all welded repairs shall be considered critical."

Propose a resolution for the identified non-conformance with revised procedures to ensure critical weld repair that requires the Engineer's approval does not occur prior to the submission to and approval by the Engineer of the procedures to be utilized. In addition, provide documentation of the steps taken by the welding Quality Control Manager to prevent future occurrences

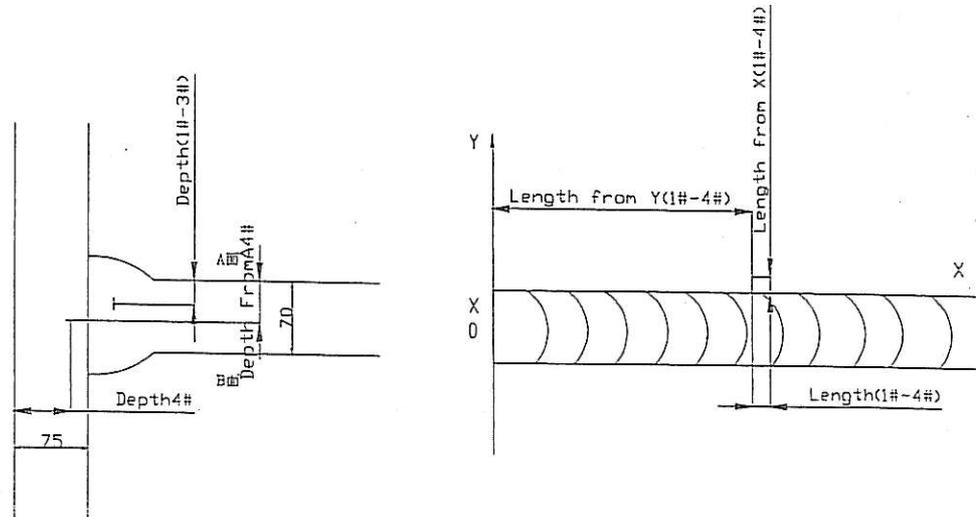
WELD NUMBER: NSD1-SPSA3-70-2A/B

Rejected indication found by ultrasonic inspection is less than the maximum allowance aggregate length.

- 1、 碳刨后,焊接接头没有有效打磨;
  - 2、 起弧和收弧没有交错布置,以将焊渣减少到最少;
  - 3、 焊道间没有有效的清理.
- 1.The weld joint was not ground sufficiently after arc-gouging.
  2. The arc starts and stops were not staggered to minimize slag entrapment.
  3. Interpass cleaning was not performed properly.

- 1、 Gouge off the defect weld;
  - 2、 Grind smoothly the gouged surface;
  - 3、 If User's request ,check with MT or other NDT method to make sure the defect remove compelety;
  - 4、 Preheat and the interpass temperature control according to the relative WPS-repair;
  - 5、 Check the welding according to the approved shop drawing.
- 1、 请将有缺陷的焊缝碳刨去除;
  - 2、 将碳刨处打磨光滑;
  - 3、 如用户要求,用 MT 或其它的无损检测方法证实缺陷被完全清除;
  - 4、 按批准后返修焊接工艺规程 WPS 要求进行预热和控制道间温度;
  - 5、 按图纸要求检测焊缝

- 1、碳刨后的接头位置打磨圆滑过渡，保证每道焊缝的接头可以交错布置；
  - 2、认真仔细检查每道焊缝和加强焊道的清理；
  3. 焊缝中所有的焊渣全部去除后，表面的缺陷全部打磨干净。
1. The joint shall be ground to a smooth transition to ensure that arc starts and stops are in a staggered Arrangement.
  2. QC shall inspect the weld passes more carefully and enforcing interpass cleaning.
  3. All weld slag shall be removed and surface defects ground during interpass cleaning.
