QUALITY ASSURANCE -- NON-CONFORMANCE REPORT

Report No: NCR-000458

Component: OBG Segment 5BW Floor Beam

Reference Description: Removal of a Floorbeam section and introducing additional weld splice at Floorbeam FB5A at PP33

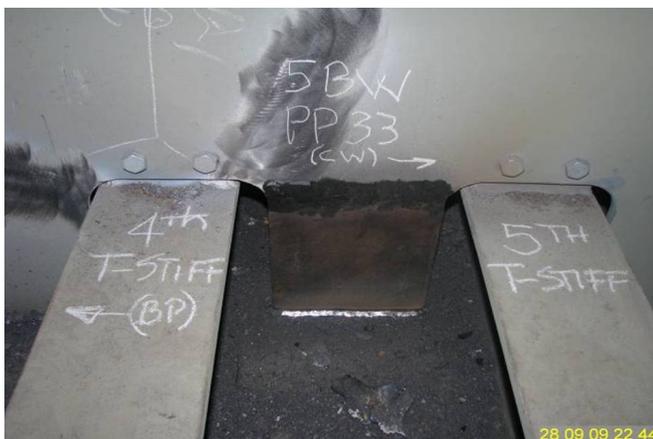
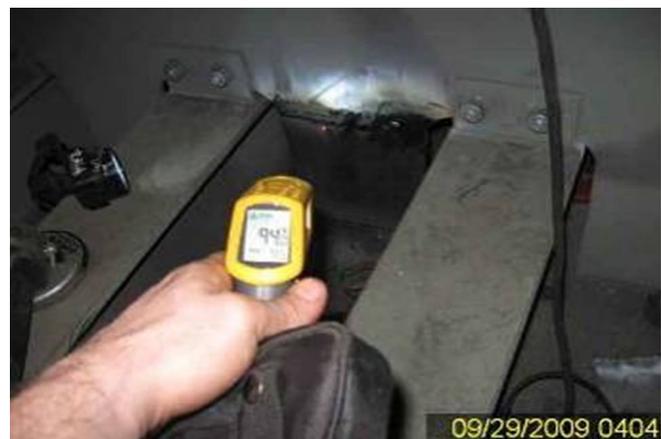
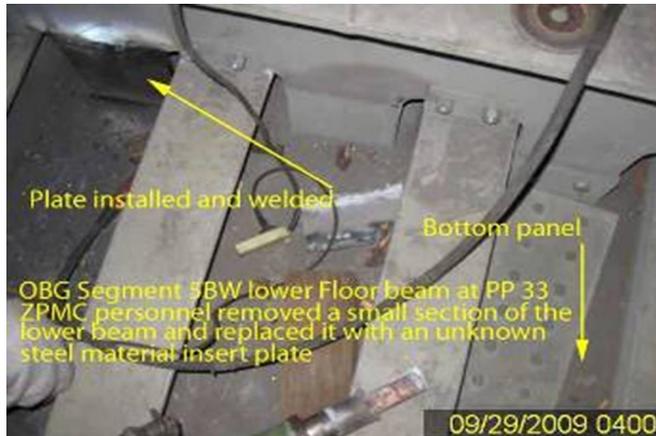
The Caltrans Quality Assurance (QA) Inspector observed that ZPMC personnel have removed a small section of plate from the lower Floor Beam and replaced this section with an unknown steel plate. During this process the contractor has removed the double-sided fillet welds and added a new un-approved complete joint penetration (CJP) weld without the Engineer's approval. Subsequently, the double-sided fillet weld joint between the new plate and the bottom panel was welded. This un-approved repair was performed at OBG Segment 5BW lower Floor Beam (FB5A) to Bottom Panel at panel point 33 between the 4th and 5th WT stiffeners from the Bikepath side.

AWS D1.5-2002 Section 1.2.1; The contract documents shall designate the specification and classification of base metals to be used.

AWS D1.5-2002 Section 3.7.4; Prior approval of the Engineer shall be obtained for repairs to base metal or for revised design to compensate for deficiencies.

AWS D1.5-2002 Section 6.5.1; "The Inspector shall make certain that the size, length, and location of all welds conform to the requirements of this code and to the detail drawings and that no unspecified welds have been added without approval".

Submit repair procedure to the engineer for approval that includes repair using contract steel in place of the unknown steel.
