Contract #: 04-0120F4Cty: SF/ALA Rte: 80 PM: 13.2/13.9File #: 69.25B**QUALITY ASSURANCE -- NON-CONFORMANCE REPORT****Location:** Changxing Island, Shanghai, PRC**Report No:** NCR-000464**Prime Contractor:** American Bridge/Fluor Enterprises, a JV**Date:** 29-Oct-2009**Submitting Contractor:** Zhenhua Port Machinery Company, Ltd (ZPMC), Changxing Island**NCR #:** ZPMC-0437**Type of problem:**

Reference Description: Missed MT indications on East Tower, Lift 3 Fit Lug weld**Description of Non-Conformance:**

Job Name: SAS Superstructure
Document No: 05.03.06-000423

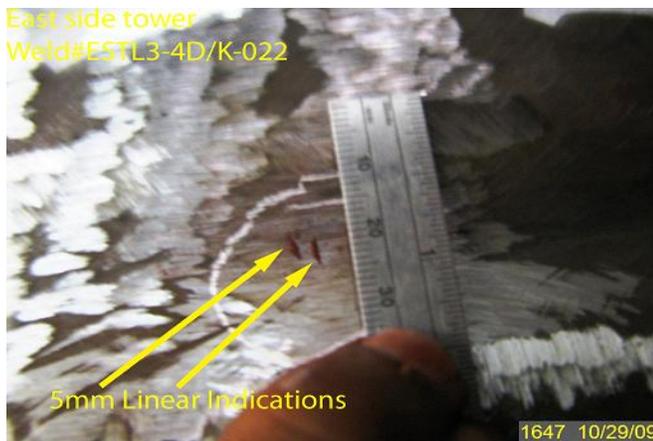
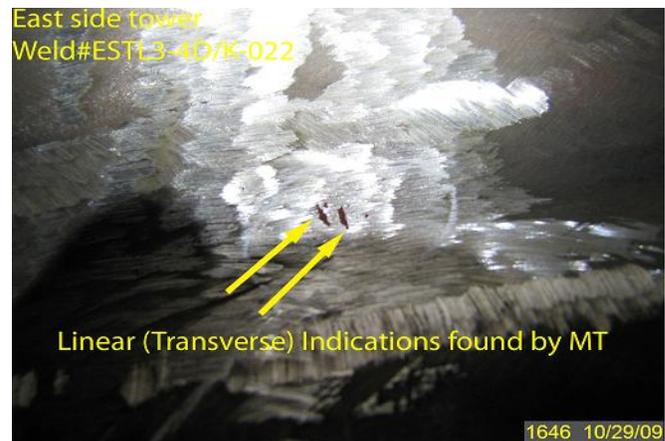
During Magnetic Particle Testing (MT) of East Tower, Lift 3, 89m diaphragm fit lug weld ESTL3-4D/K-022, QA discovered two transverse linear indications of approximately 5mm in length. This weld has been previously tested and accepted by ZPMC NDT personnel.

AWS D1.5-2002, Section 6.26.2 – “Welds that are subject to MT in addition to visual inspection shall have no cracks.”

We ZPMC acknowledge this problem ,About this situation our people at the first time removed the linear indication which is on the surface ,we used the method just by grinding not welding repair. Then did the MT work to make sure no problem on this weld which confirmed by the CT inspector Hiranch Patel, and the CT people accepted this weld and did the green tag on the weld.

Affected weld has been repaired, verified by QA, and green tagged. To resolve the recurring failure for QC to detect MT indications, ABFJV QCM has implemented training with ZPMC to improve quality of inspectors. Topics include: inspection of equipment prior to use, proper conditions for inspection, proper technique for MT & UT.
