QUALITY ASSURANCE -- NON-CONFORMANCE REPORT

Report No: NCR-000472

Reference Description: Improper storage of fabricated Floor Beam components in Lift 12

Job Name: SAS Superstructure

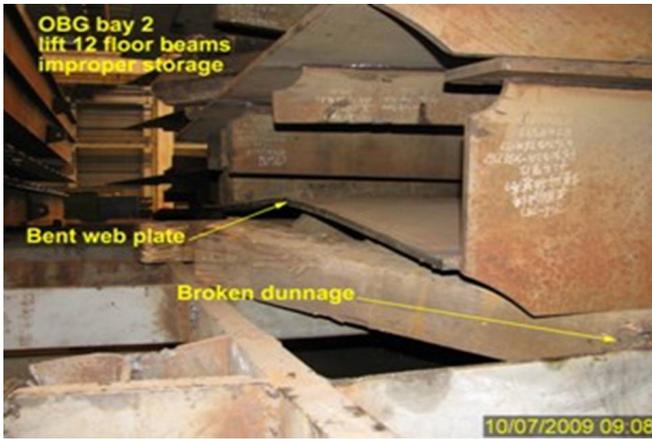
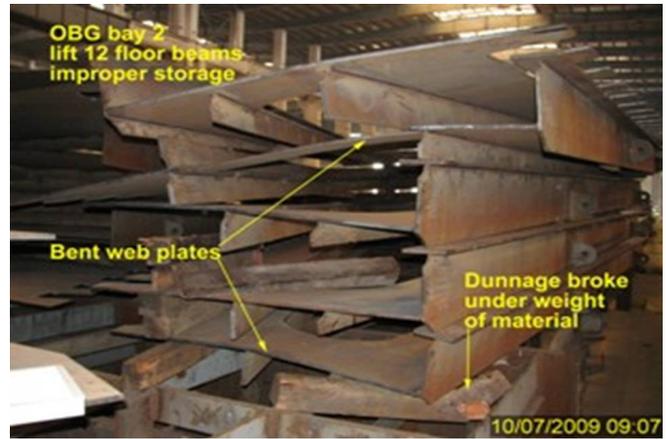
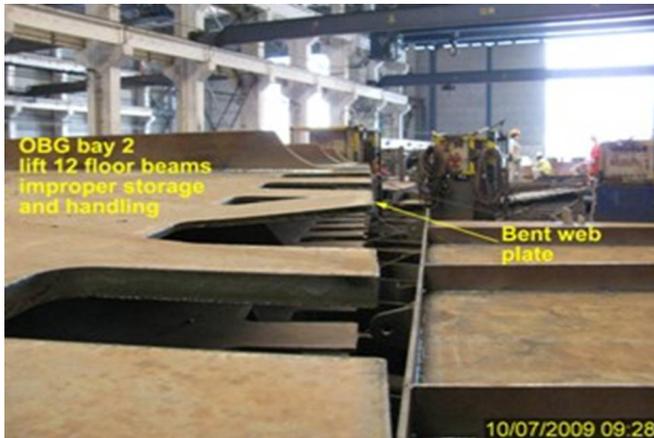
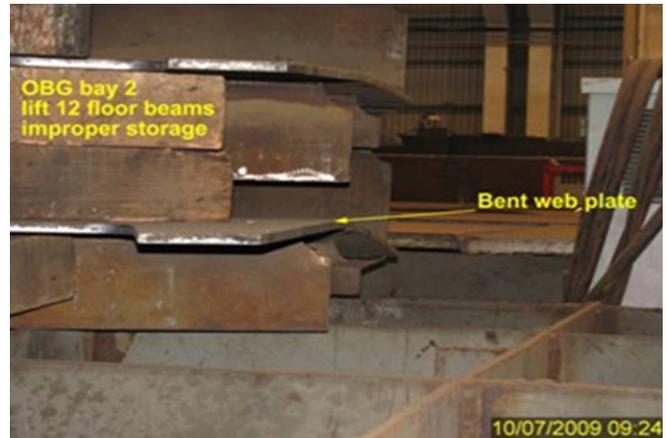
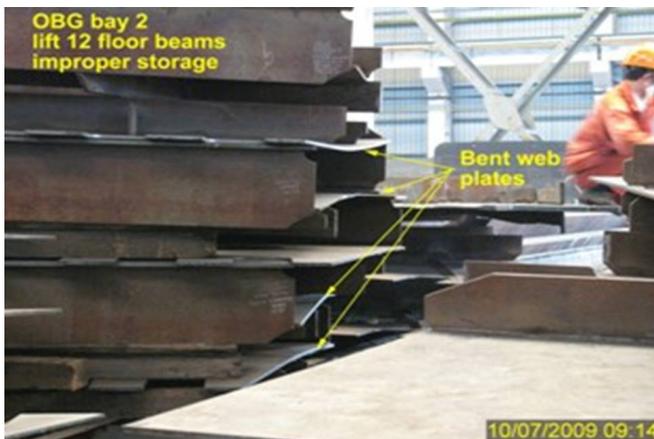
This Quality Assurance Inspector (QA) observed Lift 12 Floor Beam components were bent and warped due to improper handling and/or storage. These Floor Beam components are fabricated and stored in OBG sub-assembly Bay 2.

- 1) Section 6-1.3; Articles or materials to be incorporated in the work shall be stored in such a manner as to ensure the preservation of their quality and fitness for the work, and to facilitate inspection.
- 2) Section 55-1.04; In handling and shipping of the steel work, every care shall be taken to avoid bending, scraping or overstressing the pieces. All pieces bent or otherwise injured will be rejected.
- 3) Section 55-3.09; Finish members shall be true to line and free from twists, bends and open joints.

Submit a repair procedure to the engineer for approval prior to installing these bent and warped components into the work. Correct the storage procedure that lead to the bent and warped components.

All Lift 12 Floor Beam sub-assemblies have been moved to Bays 13 and 14. The Contractor submitted a training session roster as verification of ABF addressing storage and handling issues internally with ZPMC. No documentation was submitted in regards to the current condition of the Floor Beam sub-assemblies as no piece marks were listed in the NCR. Dimensional inspections will continue throughout the Segment Assembly phase.
