Contract #: 04-0120F4Cty: SF/ALA Rte: 80 PM: 13.2/13.9File #: 69.25B**QUALITY ASSURANCE -- NON-CONFORMANCE REPORT****Location:** Changxing Island, Shanghai, P.R. China**Report No:** NCR-000477**Prime Contractor:** American Bridge/Fluor Enterprises, a JV**Date:** 14-Oct-2009**Submitting Contractor:** Zhenhua Port Machinery Company, Ltd (ZPMC), Changxing Island**NCR #:** ZPMC-0450**Type of problem:****Welding****Concrete****Other****Welding****Curing****Procedural****Bridge No:** 34-0006**Joint fit-up****Coating****Other****Component:** OBG Segment 6CE Deck Plate Stiffener Weld Joint**Procedural****Procedural****Description:** Missed MT indication by QC and Repair without CWR**Reference Description:** Missed MT Indications by QC on Segment 6CE and weld repair without CWR**Description of Non-Conformance:**

Job Name: SAS Superstructure

Subject: NCR No. ZPMC-0450

Reference Description: Missed MT Indications by QC on Segment 6CE and weld repair without CWR

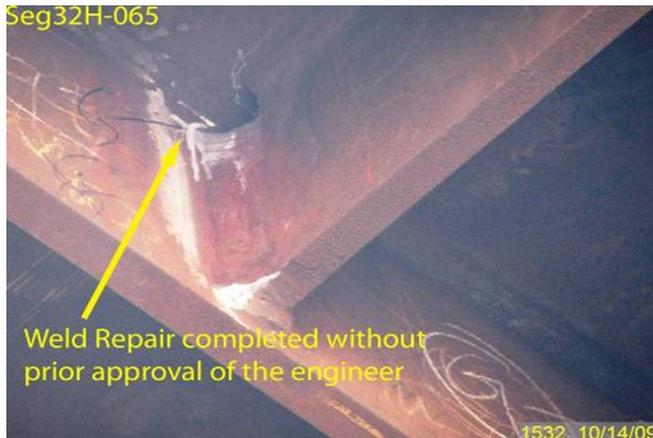
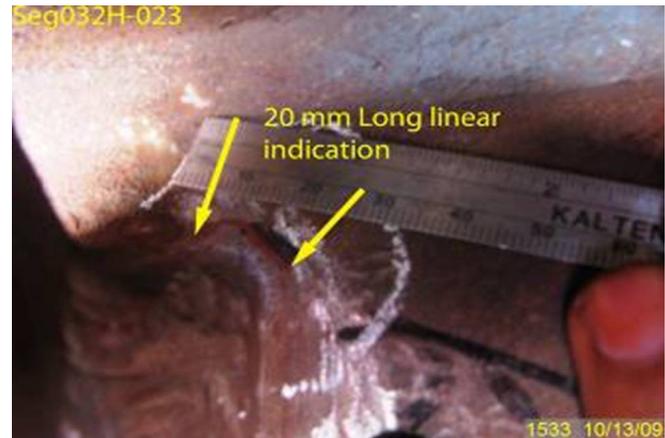
During a random verification of Magnetic Particle (MT) Testing of the OBG Segment 6CE welds, Caltrans Quality Assurance (QA) inspector discovered a total three (3) linear indications approximately 12mm to 20mm in length located at welds SEG32H-065, 123 and 023. These welds have been previously tested and accepted by ZPMC Quality Control MT technicians. Also, ZPMC personnel completed these weld repairs without prior Engineer approval or utilizing an approved critical weld repair procedure (CWR).

Submit a repair procedure to the engineer for approval. Provide training and certification verification to the engineer. Use the correct CWR.

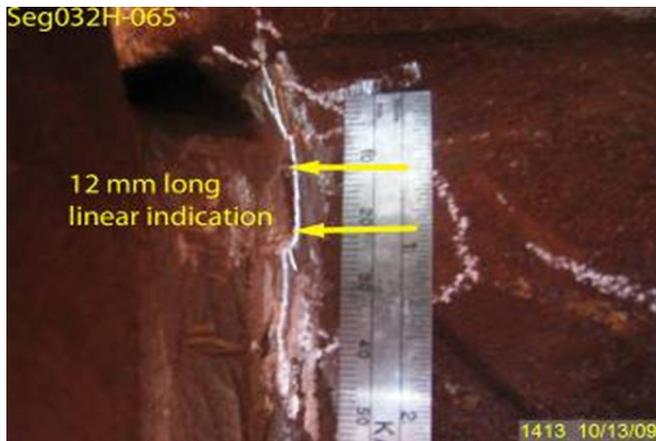
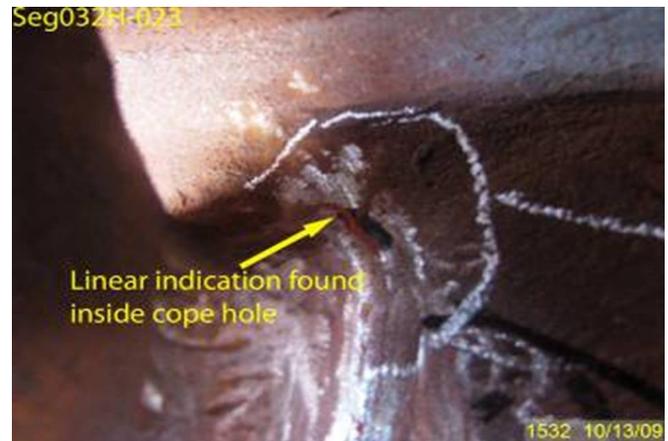
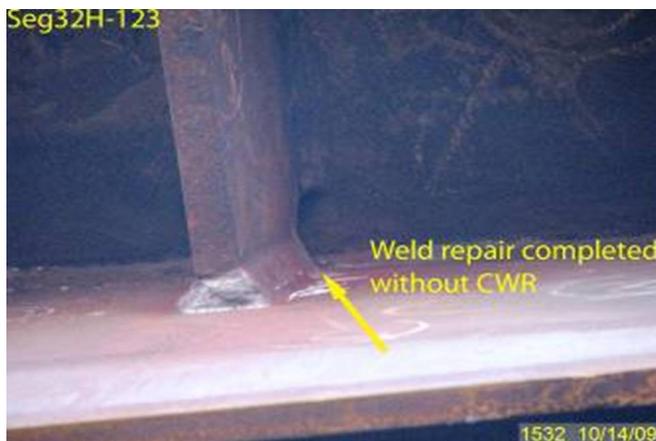
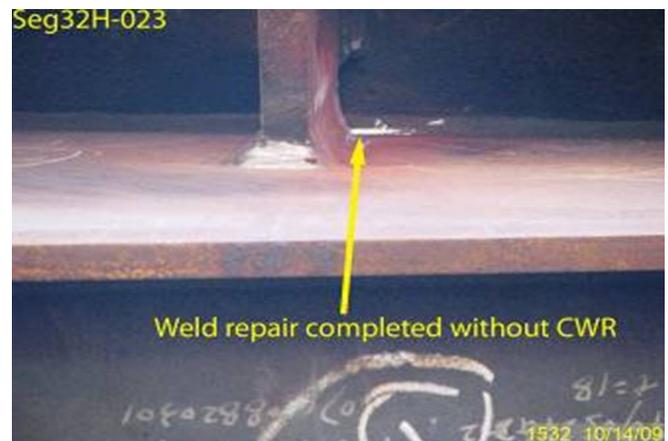
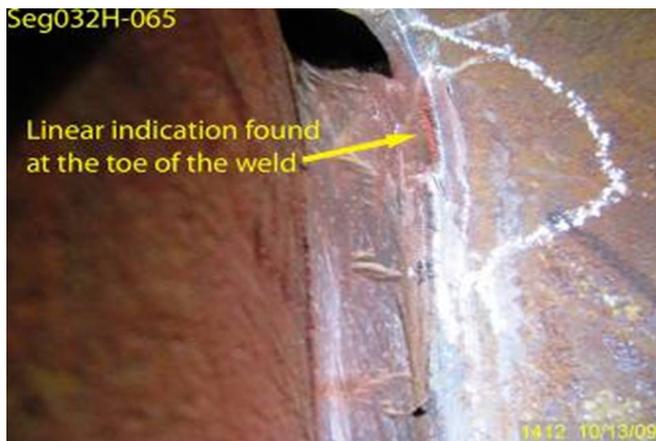
AWS D1.5 (02) Section 6.26.1.1; “Welds shall have no Cracks”.

AWS D1.5 (02) Section 6.26.2; “Welds that are subject to MT in addition to visual inspection shall have no Cracks”

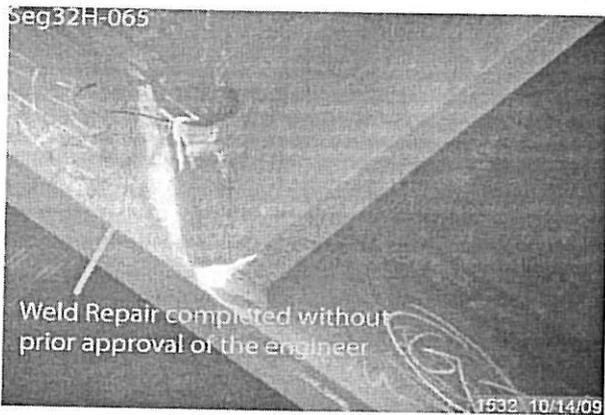
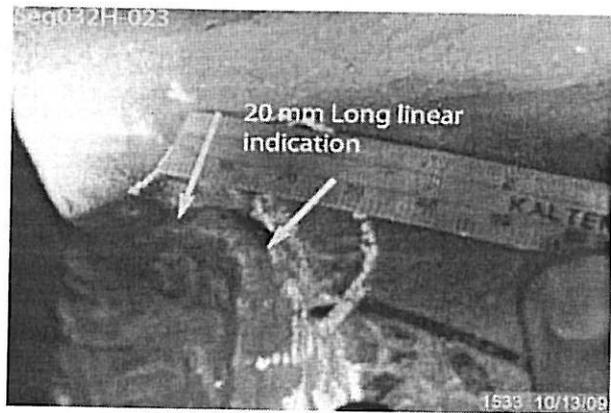
During a random verification of Magnetic Particle (MT) Testing of the OBG Segment 6CE welds, Caltrans Quality Assurance (QA) inspector discovered a total three (3) linear indications approximately 12mm to 20mm in length located at welds SEG32H-065, 123 and 023. These welds have been previously tested and accepted by ZPMC Quality Control MT technicians. Also, ZPMC personnel completed these weld repairs without prior Engineer approval or utilizing an approved critical weld repair procedure (CWR).

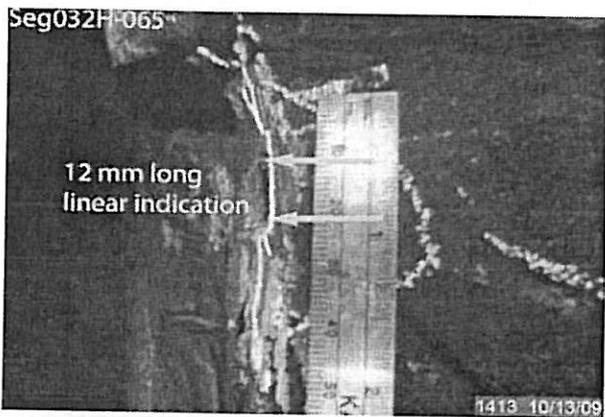
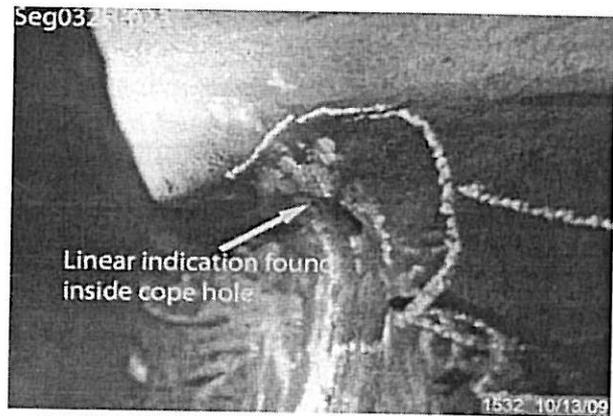
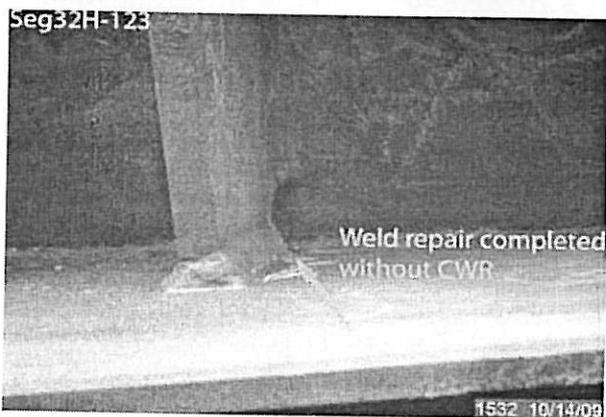
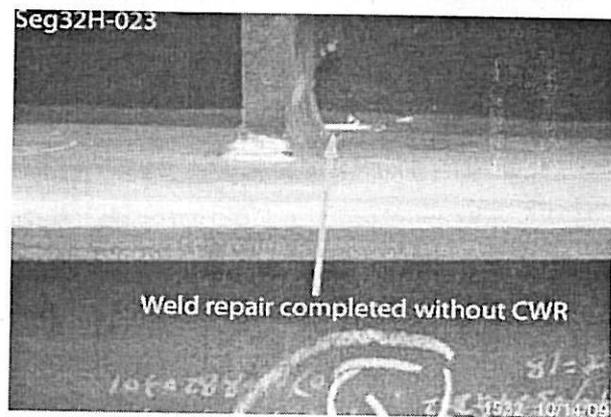
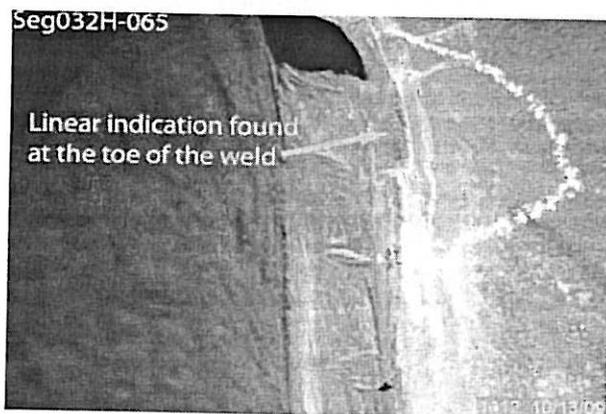
AWS D1.5 (02) Section 6.26.1.1; “Welds shall have no Cracks”.

AWS D1.5 (02) Section 6.26.2; “Welds that are subject to MT in addition to visual inspection shall have no Cracks”

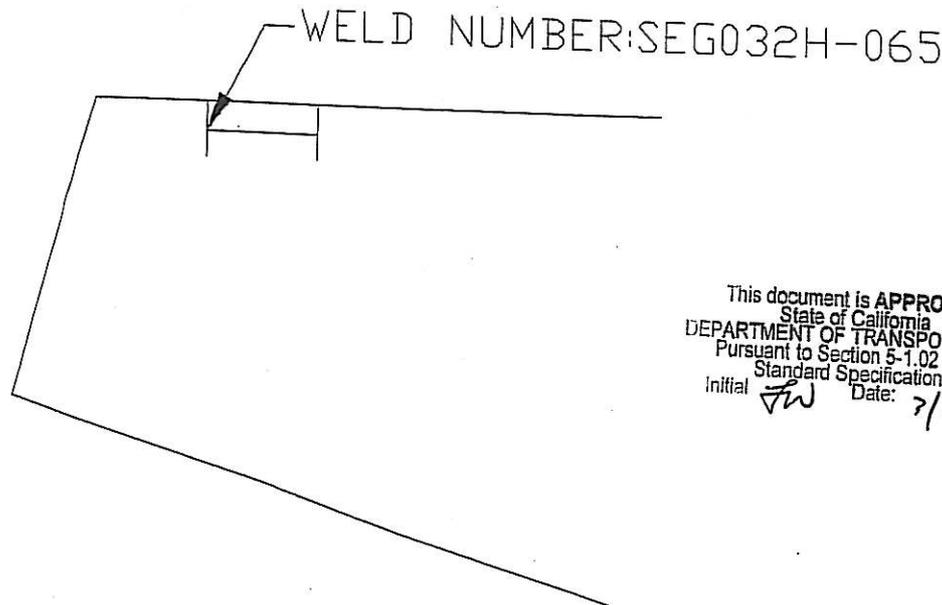
Draft of Welding Discontinuity:

Description of Welding Discontinuity:
在对SEG032H-065检测时, 发现1处纵向裂纹。1、L=12mm.

One longitudinal crack was found by use of MT on SEG032H-065.

1. 火焰加热时, 水汽没有完全的去掉或者这个区域预热不够;
1. Moisture wasn't completely removed during drying operation (preheating) or the area wasn't preheated sufficiently.

1. QC and a Lead CWI shall be present, direct and supervise all grinding and welding operations during this repair to ensure the repair is per the disposition requirements

2. QC and a Lead CWI shall have an approved copy of the CWR in hand prior to the repair.
3. Remove paint $\geq 25\text{mm}$ in all direction of HAZ prior to MT.

4. Clean the excavation area of all loose debris including MT powder. Preheat to 65° C before removing cracks by grinding, repair area shall extend a minimum of 50mm beyond each end of single crack repairs.

5. If base metal is damaged by grinding, the damaged area shall be ground clean prior to performing weld repair. If gap $> 5\text{mm}$ is found during or after grinding, comply with the notification on changing fillet weld to CJP which is submitted for Engineer's review and approval form.

6. Prepare excavation in accordance with the New Repair Procedure prior to welding.
7. Before this repair, Verify with VT and MT repair areas are defects free, and also MT shall be performed on the base metal laying abroad cracks to ensure that no cracks were propagated to the base metal. Separate CWR approval is needed if cracks are found in the base metal, and only after this new CWR's approval can continue the repair.

8. Clean excavation area of all loose debris including MT powder after excavation. Preheat and weld according to repair WPS, the preheat shall between 160° C-230° C

9. Perform post weld heating according to repair WPS, the postheat shall between 230° C-315° C and for one hour minimum.
10. Allow the weld to cool to ambient temperature gradually. Control cooling rate after PWHT to no more than 50° C per hour.

11. Grind the repaired area flush with base metal or the adjacent weld after post weld heating.
12. Wait 48 hours at least after the repair area has cooled to ambient temperature before performing NDT.

13. Perform MT inspection to all repair area according to Contract Drawings along with all additional NDT required by the applicable notes Special Provision Section 10-1.59 'Steel Structure', subsection 'inspection testing'. NDT include VT, MT and UT if it is a CJP weld.

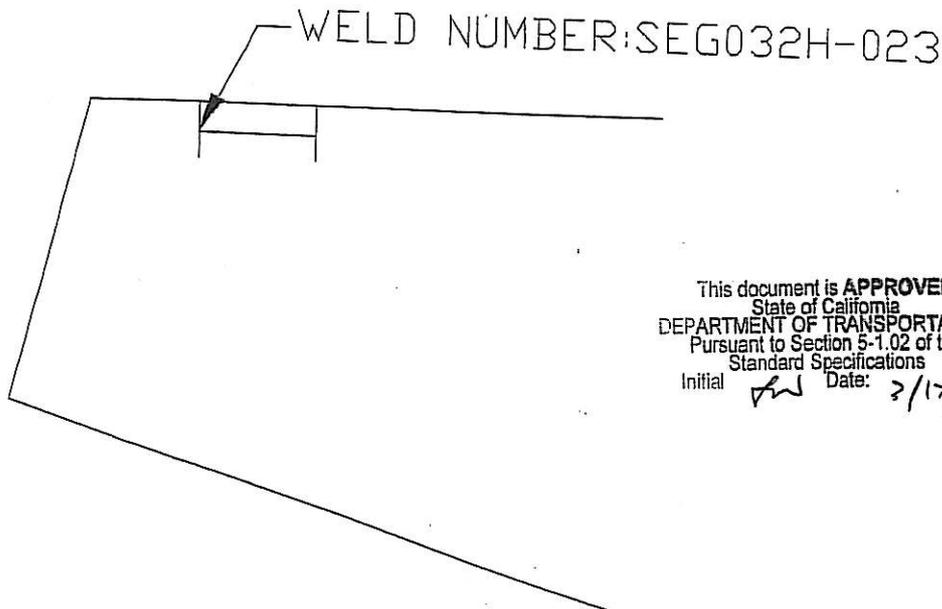
Draft of Welding Discontinuity:

在对SEG032H-023检测时, 发现1处纵向裂纹。1、L=20mm

One longitudinal crack was found by use of MT on SEG032H-023.

1. 火焰加热时, 水汽没有完全的去掉或者这个区域预热不够
1. Moisture wasn't completely removed during drying operation (preheating) or the area wasn't preheated sufficiently.

1. QC and a Lead CWI shall be present, direct and supervise all grinding and welding operations during this repair to ensure the repair is per the disposition requirements

2. QC and a Lead CWI shall have an approved copy of the CWR in hand prior to the repair.
3. Remove paint $\geq 25\text{mm}$ in all direction of HAZ prior to MT.

4. Clean the excavation area of all loose debris including MT powder. Preheat to 65° C before removing cracks by grinding, repair area shall extend a minimum of 50mm beyond each end of single crack repairs.

5. If base metal is damaged by grinding, the damaged area shall be ground clean prior to performing weld repair. If gap $> 5\text{mm}$ is found during or after grinding, comply with the notification on changing fillet weld to CJP which is submitted for Engineer's review and approval form.

6. Prepare excavation in accordance with the New Repair Procedure prior to welding.
7. Before this repair, Verify with VT and MT repair areas are defects free, and also MT shall be performed on the base metal laying abroad cracks to ensure that no cracks were propagated to the base metal. Separate CWR approval is needed if cracks are found in the base metal, and only after this new CWR's approval can continue the repair.

8. Clean excavation area of all loose debris including MT powder after excavation. Preheat and weld according to repair WPS, the preheat shall between 160° C-230° C.

9. Perform post weld heating according to repair WPS, the postheat shall between 230° C-315° C and for one hour minimum.
10. Allow the weld to cool to ambient temperature gradually. Control cooling rate after PWHT to no more than 50° C per hour.

11. Grind the repaired area flush with base metal or the adjacent weld after post weld heating.
12. Wait 48 hours at least after the repair area has cooled to ambient temperature before performing NDT.

13. Perform MT inspection to all repair area according to Contract Drawings along with all additional NDT required by the applicable notes Special Provision Section 10-1.59 'Steel Structure', subsection 'inspection testing'. NDT include VT, MT and UT if it is a CJP weld.

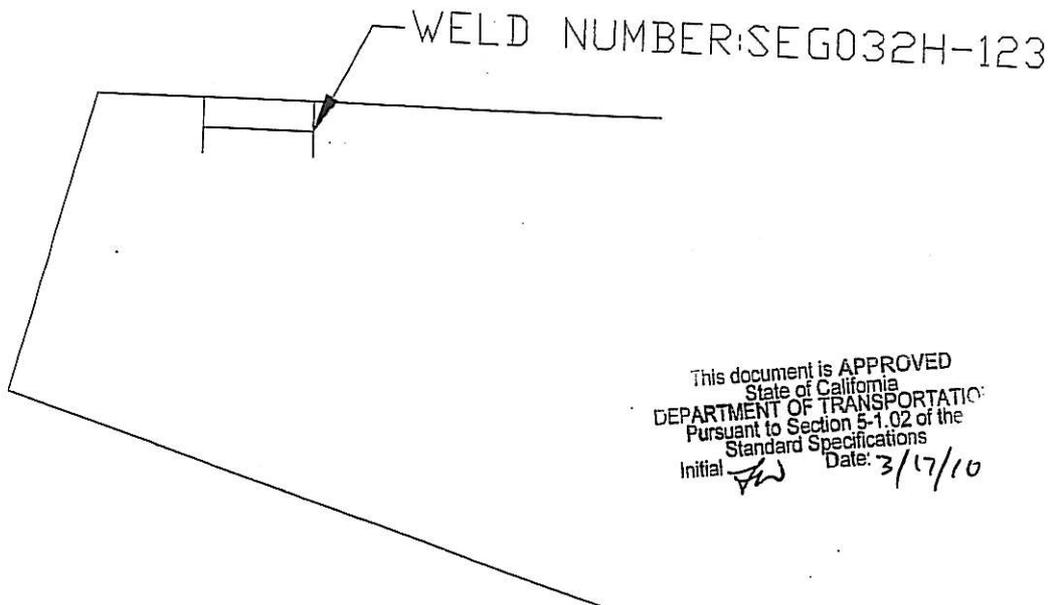
Draft of Welding Discontinuity:

在对SEG032H-123检测时, 发现1处纵向裂纹。1、L=15mm.

One longitudinal crack was found by use of MT on SEG032H-123.

1. 火焰加热时, 水汽没有完全的去掉或者这个区域预热不够;
1. Moisture wasn't completely removed during drying operation (preheating) or the area wasn't preheated sufficiently.

1. QC and a Lead CWI shall be present, direct and supervise all grinding and welding operations during this repair to ensure the repair is per the disposition requirements

2. QC and a Lead CWI shall have an approved copy of the CWR in hand prior to the repair.
3. Remove paint ≥ 25mm in all direction of HAZ prior to MT.
4. Clean the excavation area of all loose debris including MT powder. Preheat to 65° C before removing cracks by grinding, repair area shall extend a minimum of 50mm beyond each end of single crack repairs.

5. If base metal is damaged by grinding, the damaged area shall be ground clean prior to performing weld repair. If gap > 5mm is found during or after grinding, comply with the notification on changing fillet weld to CJP which is submitted for Engineer's review and approval form.

6. Prepare excavation in accordance with the New Repair Procedure prior to welding.
7. Before this repair, Verify with VT and MT repair areas are defects free, and also MT shall be performed on the base metal laying abroad cracks to ensure that no cracks were propagated to the base metal. Separate CWR approval is needed if cracks are found in the base metal, and only after this new CWR's approval can continue the repair.

8. Clean excavation area of all loose debris including MT powder after excavation. Preheat and weld according to repair WPS, the preheat shall between 160° C-230° C.

9. Perform post weld heating according to repair WPS, the postheat shall between 230° C-315° C and for one hour minimum.
10. Allow the weld to cool to ambient temperature gradually. Control cooling rate after PWHT to no more than 50° C per hour.

11. Grind the repaired area flush with base metal or the adjacent weld after post weld heating.
12. Wait 48 hours at least after the repair area has cooled to ambient temperature before performing NDT.

13. Perform MT inspection to all repair area according to Contract Drawings along with all additional NDT required by the applicable notes Special Provision Section 10-1.59 'Steel Structure', subsection 'inspection testing'. NDT include VT, MT and UT if it is a CJP weld.
